**Feasibility Study for Adaptive Reuse
of the Existing Oakland Army Base Warehouses**

RE: Feasibility Study of Potential Reuse of Existing Warehouses

Seismic Retrofit and Rehabilitation Report
Oakland Army Base Warehouse Buildings
Oakland, CA

Warehouse Deconstruction Study

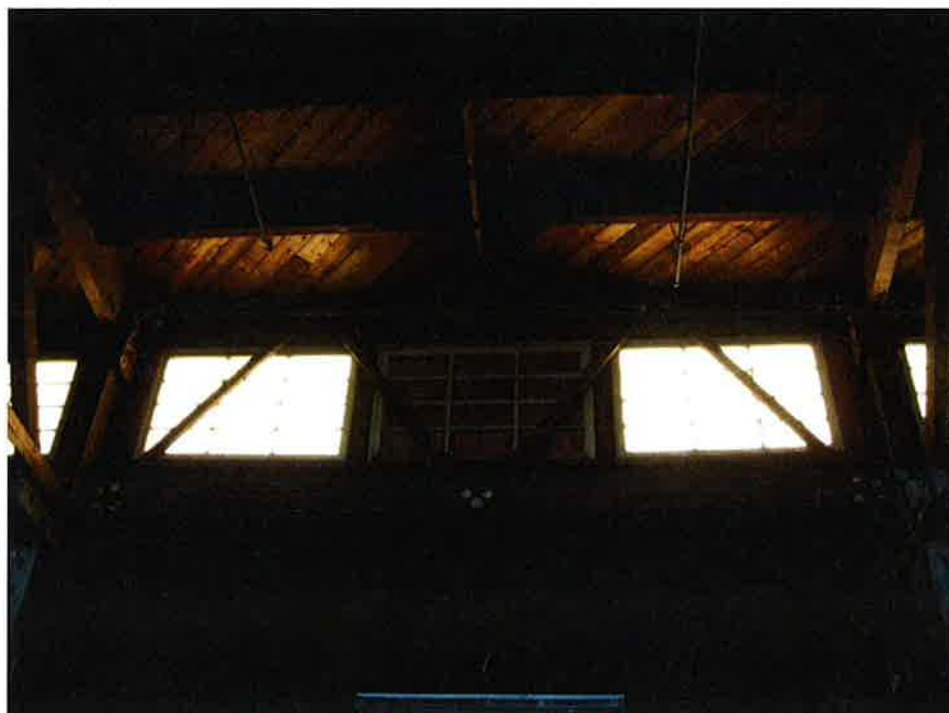
For loads in the transverse direction, the diagonally sheathed roof diaphragm spans between the end walls and/or interior transverse partition walls. These transverse shear walls then transfer the lateral demands down to the foundation and soil. Under longitudinal loading the diaphragm spans between the side walls; no interior walls in this direction are present. At the clerestory roof separation, 3x4 timber bracing was provided to transfer lateral loads from the high roof to the low roof.

Photo 6: Clearstory Bracing

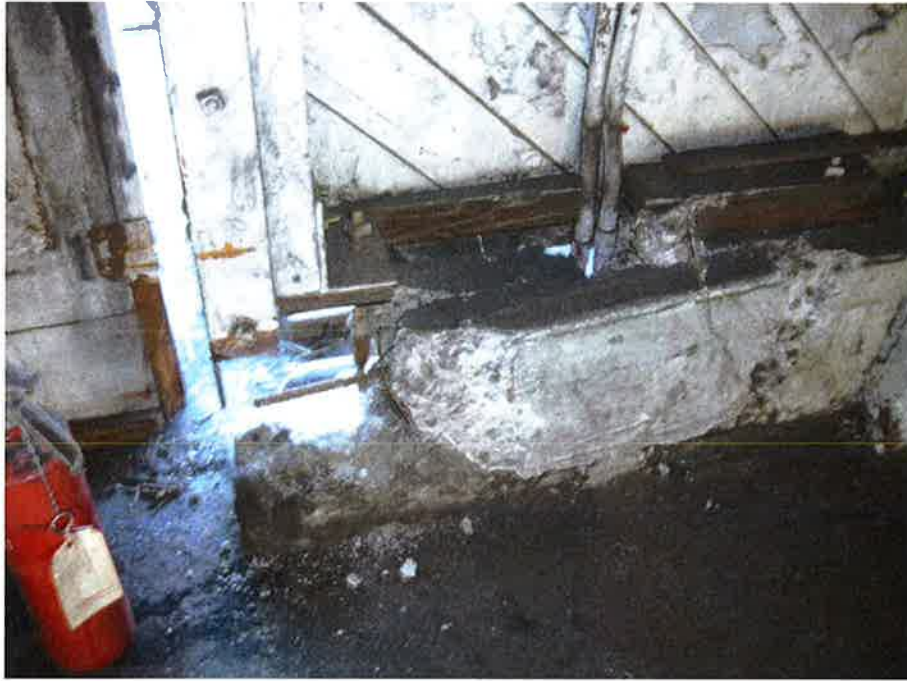
Some cracking of the exterior strip footings/retaining walls was observed (approximately 10 locations), indicating that some minor differential settlement has occurred. Additionally, several of the stem walls adjacent to the loading doors (at approximately 40% of the doors) are damaged. This may have occurred from impact and/or differential settlement. In general the foundation system appears to be carrying existing loads with no significant deficiencies; however we recommend epoxy injection of the cracks and repair of the damaged stem walls noted above.

Photo 7: Damaged Stem Wall at Door

- Epoxy inject cracks at the exterior concrete stem walls (approximately 10 locations observed at this structure).
- Repair damaged concrete stem walls near the loading doors (Observed at approximately 40% of loading doors).
- Repair or replace split interior posts (Approximately 20% of posts).
- Replace damaged windows and building finishes, and weatherproof the structure.
- Repair and/or replace exterior doors.

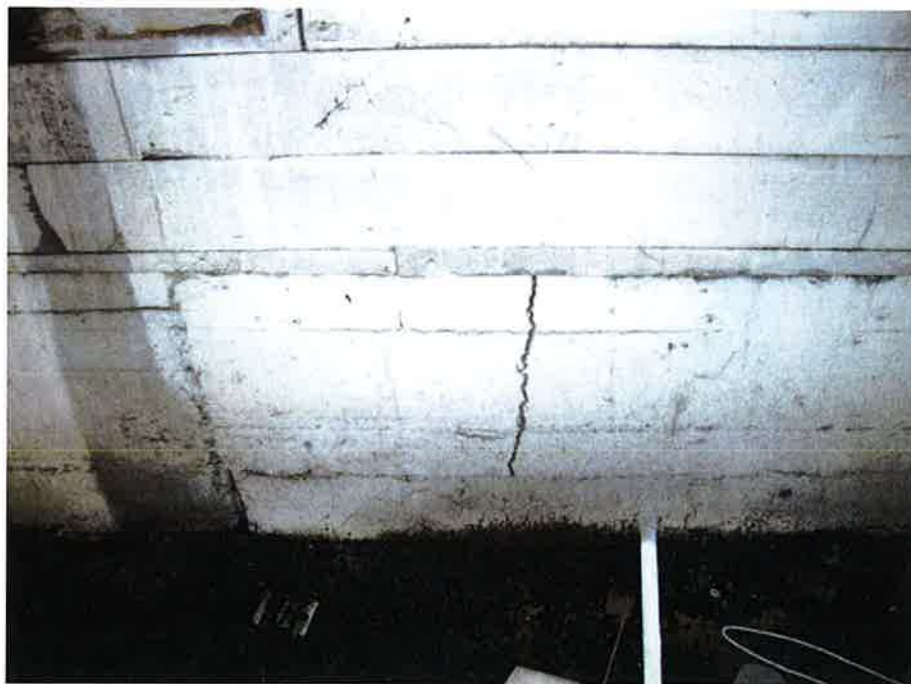
Photo 9: Cracking at Stem Wall (Interior)

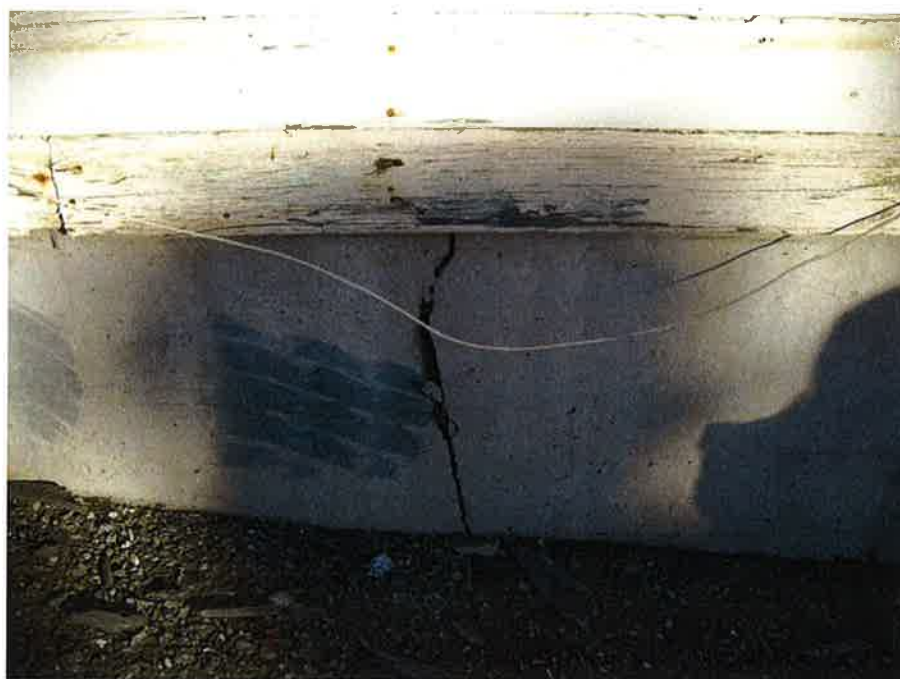
Photo 10: Cracking at Stem Wall (Exterior)

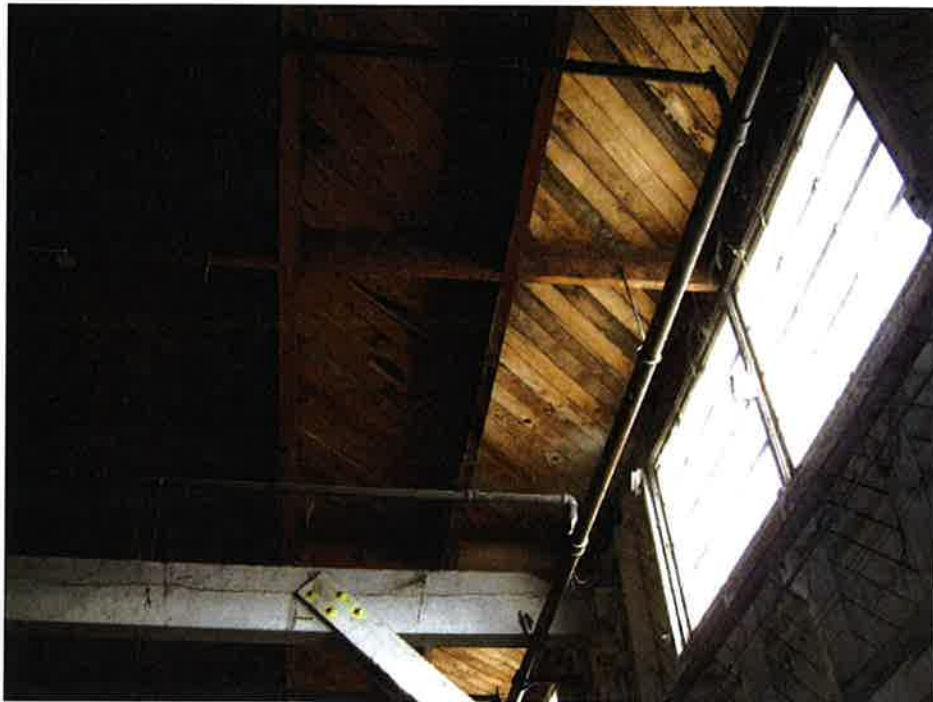
Some leaks were observed in the roof and exterior walls. At one location in the building observed, the leaking roof has caused significant deterioration of the diagonal sheathing at the exterior wall. There are also damaged windows that allow rain inside the building. The painted exterior horizontal siding is showing some signs of wear and deterioration, especially at unprotected end walls. The exterior finishes on the entire structure should be inspected and repaired. If no waterproofing exists under the exterior horizontal siding, consideration should be given to removing the siding, repairing the diagonal sheathing, adding building paper, and replacing the horizontal siding.

Photo 12: Leak at Roof

- Consider replacing the AC pavement at the finish floor with concrete for improved performance.
- Replace roofing.
- Repair horizontal siding.
- Consider the need for adding building paper underneath horizontal siding.
- Repair diagonal sheathing at exterior walls.

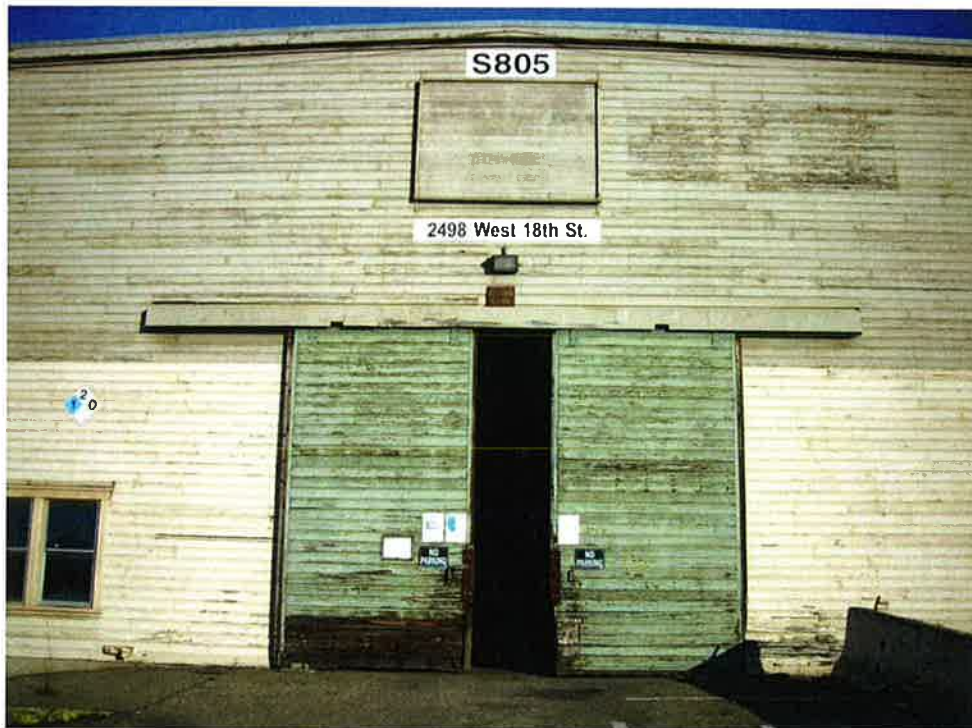
Photo 13: Weathered Siding

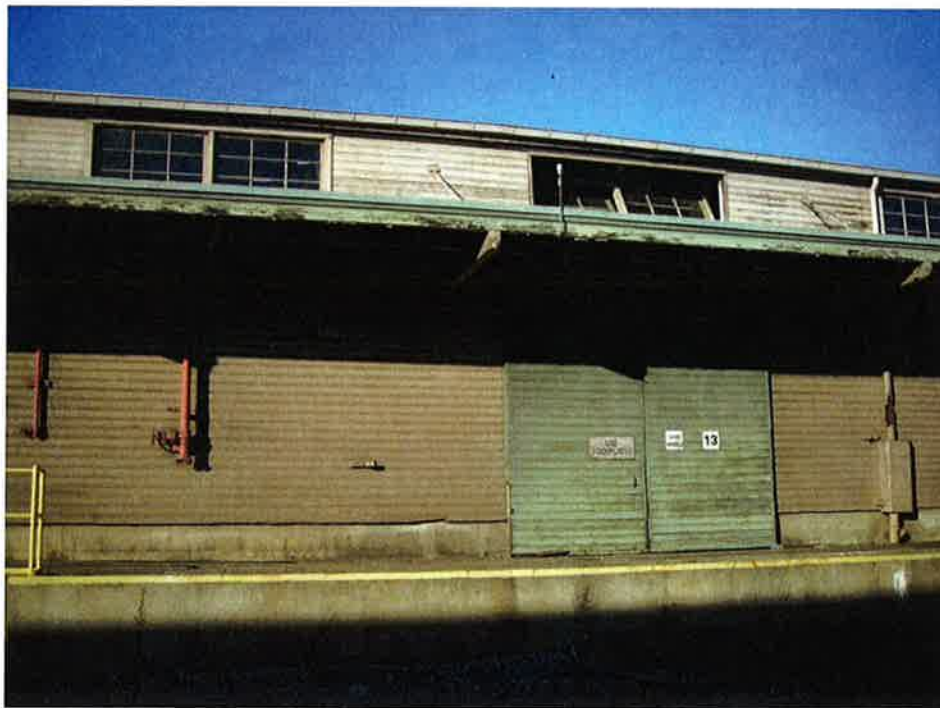
Photo 14: Damaged Window
