**FEASIBILITY STUDY FOR ADAPTIVE REUSE OF THE
EXISTING OAKLAND ARMY BASE WAREHOUSES**

April 13, 2012

RE: Feasibility Study of Potential Reuse of Existing Warehouses

Seismic Retrofit and Rehabilitation Report
Oakland Army Base Warehouse Buildings
Oakland, CA

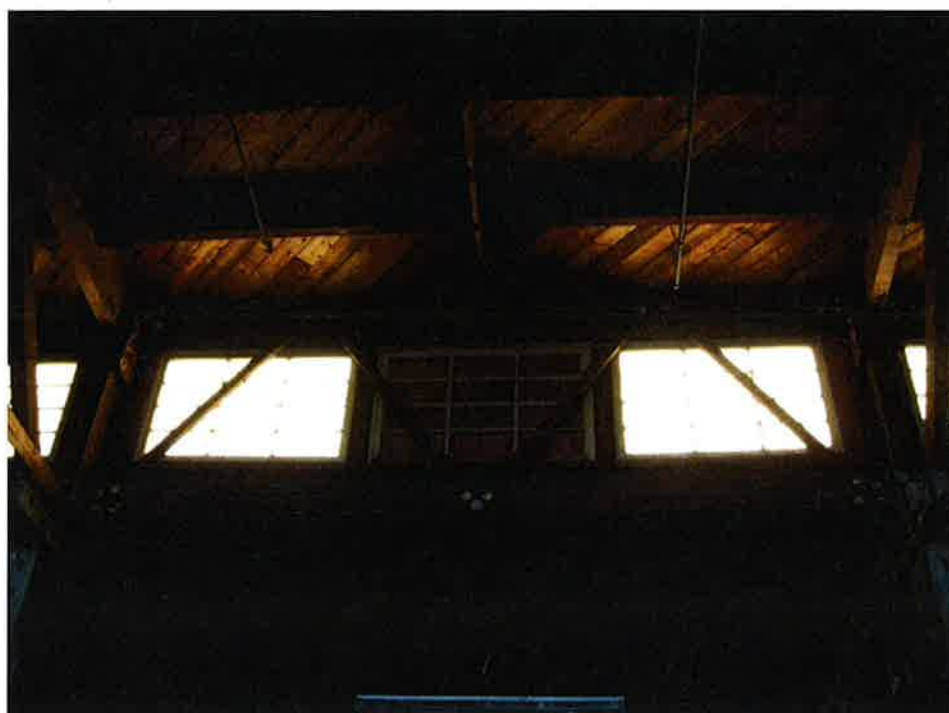
Roof Diaphragms and Continuity: Similar to the stress in the shear walls, the diagonally sheathed diaphragms are overstressed due to the increase in seismic demands since the original design, and the long spans between supports. Furthermore, the discontinuity between the low and high roof, with no continuous roof chord or collectors creates a potential for damage and partial collapse at this location.

Photo 6: Clearstory Bracing

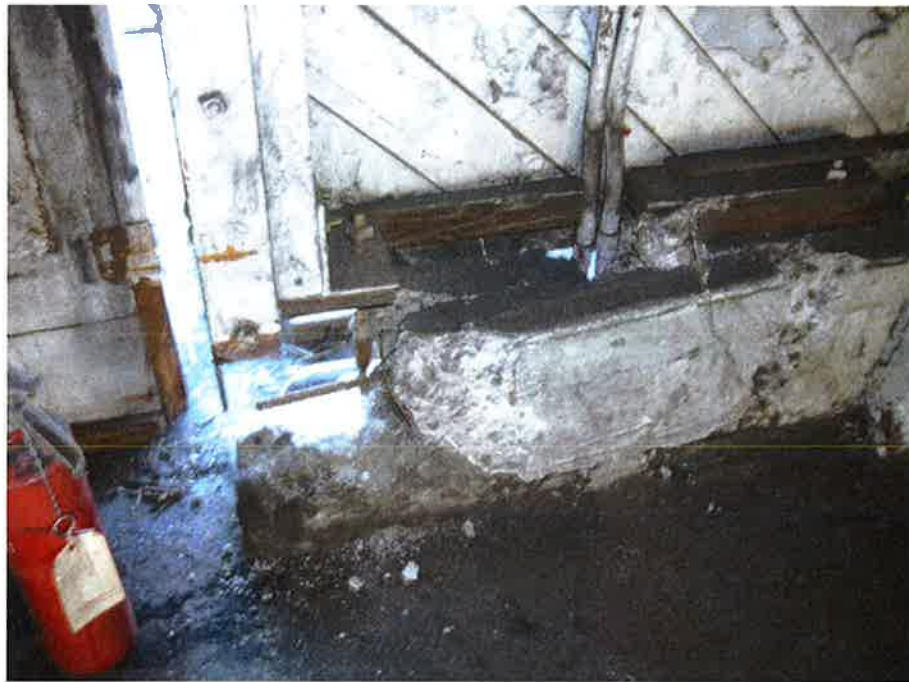
Photo 7: Damaged Stem Wall at Door

- Epoxy inject cracks at the exterior concrete stem walls (approximately 10 locations observed at this structure).
- Repair damaged concrete stem walls near the loading doors (Observed at approximately 40% of loading doors).
- Repair or replace split interior posts (Approximately 20% of posts).
- Replace damaged windows and building finishes, and weatherproof the structure.
- Repair and/or replace exterior doors.

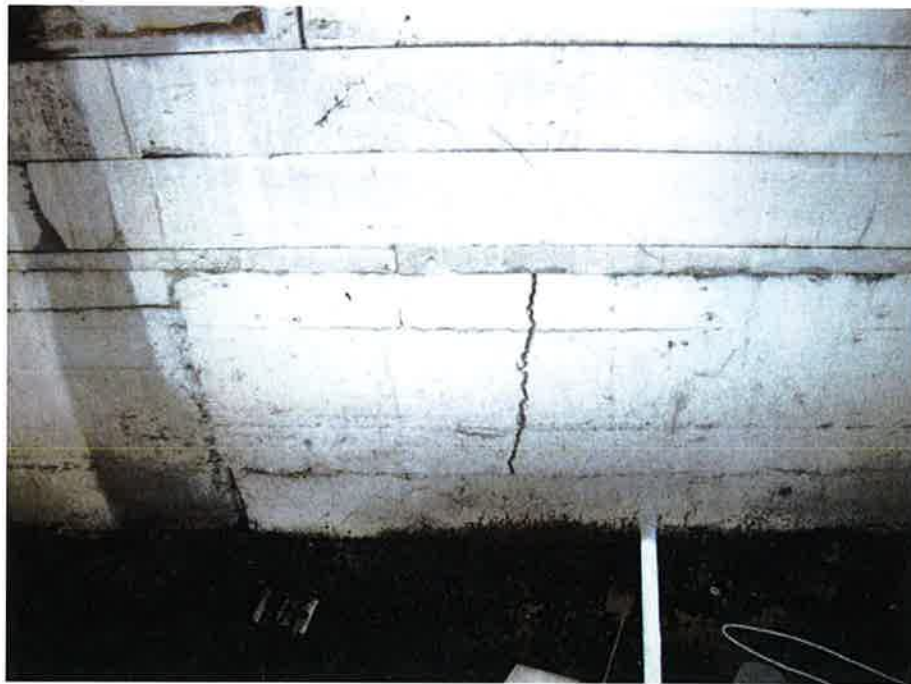
Some cracking of the exterior strip footings/retaining walls was observed (approximately 10 locations), indicating that some minor differential settlement has occurred. Additionally, several of the stem walls adjacent to the loading doors (at approximately 40% of the doors) are damaged. This may have occurred from impact and/or differential settlement. In general the foundation system appears to be carrying existing loads with no significant deficiencies; however we recommend epoxy injection of the cracks and repair of the damaged stem walls noted above.

Photo 9: Cracking at Stem Wall (Interior)

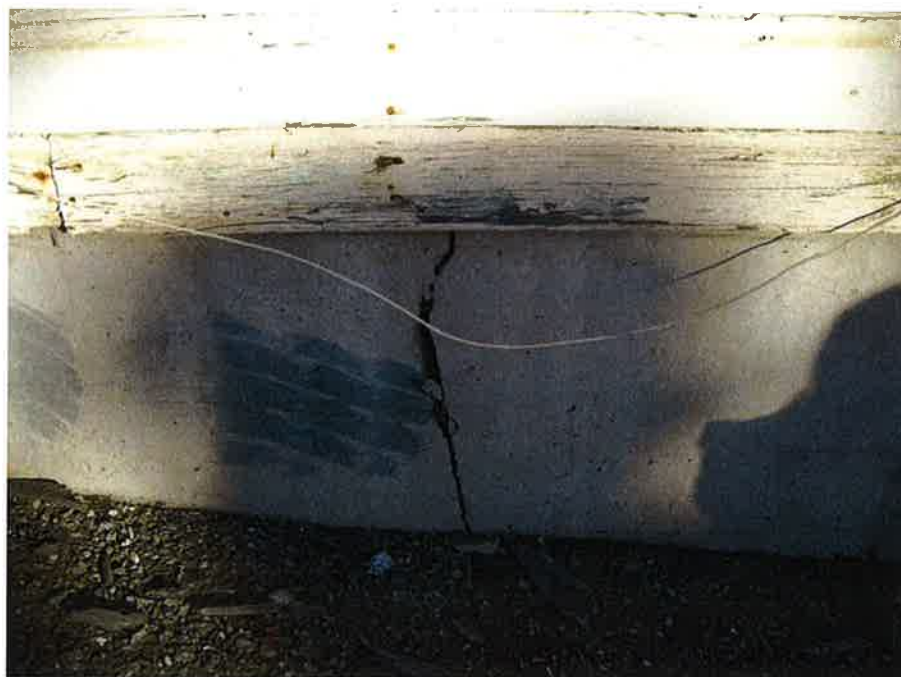
Photo 10: Cracking at Stem Wall (Exterior)

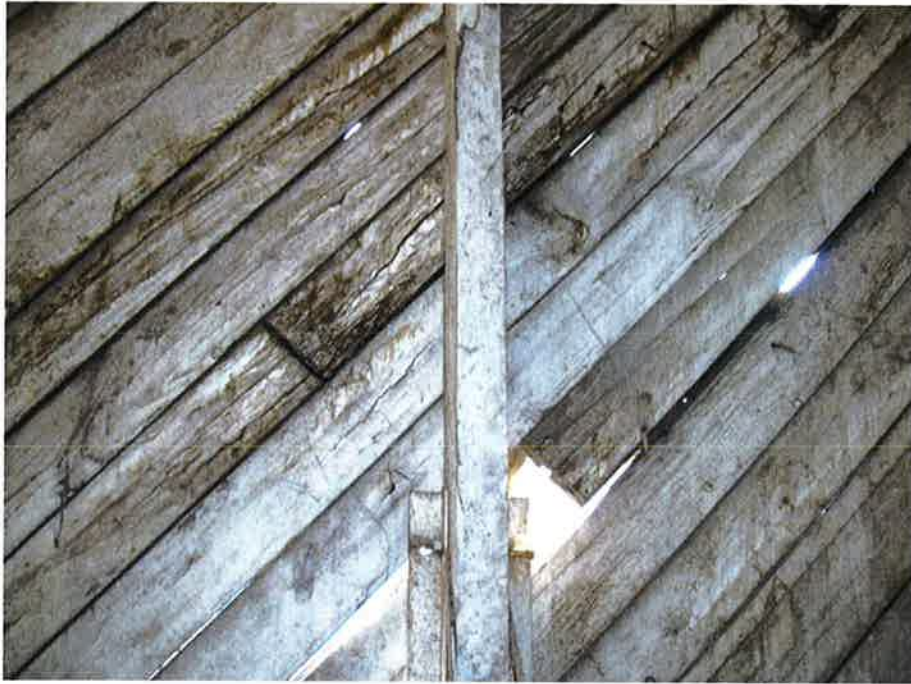
Some leaks were observed in the roof and exterior walls. At one location in the building observed, the leaking roof has caused significant deterioration of the diagonal sheathing at the exterior wall. There are also damaged windows that allow rain inside the building. The painted exterior horizontal siding is showing some signs of wear and deterioration, especially at unprotected end walls. The exterior finishes on the entire structure should be inspected and repaired. If no waterproofing exists under the exterior horizontal siding, consideration should be given to removing the siding, repairing the diagonal sheathing, adding building paper, and replacing the horizontal siding.

Photo 11: Water Damaged Sheathing

- Consider replacing the AC pavement at the finish floor with concrete for improved performance.
- Replace roofing.
- Repair horizontal siding.
- Consider the need for adding building paper underneath horizontal siding.
- Repair diagonal sheathing at exterior walls.

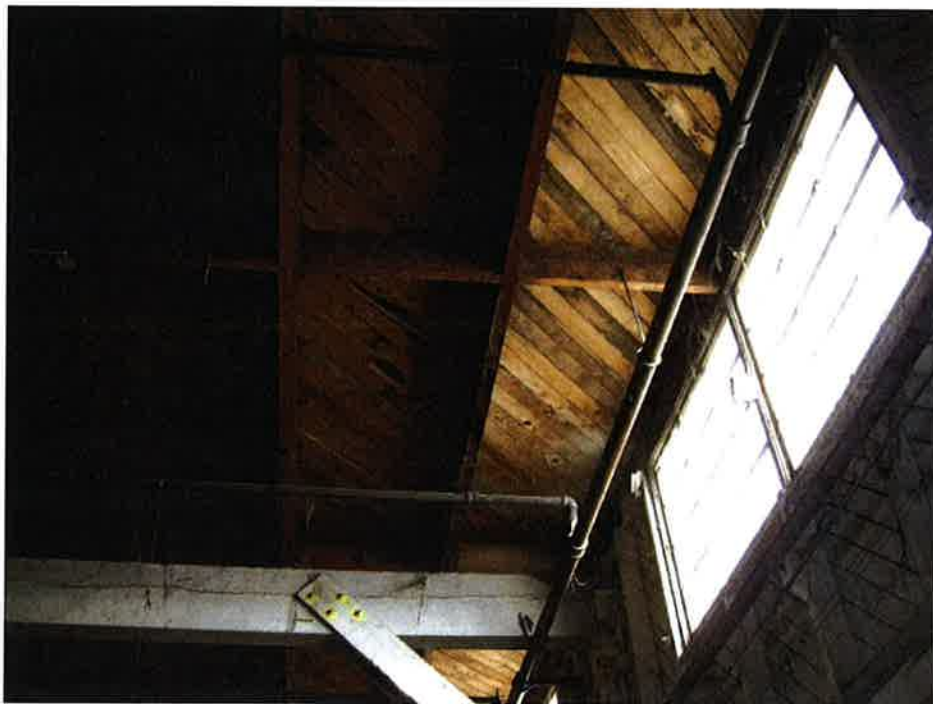
Photo 12: Leak at Roof

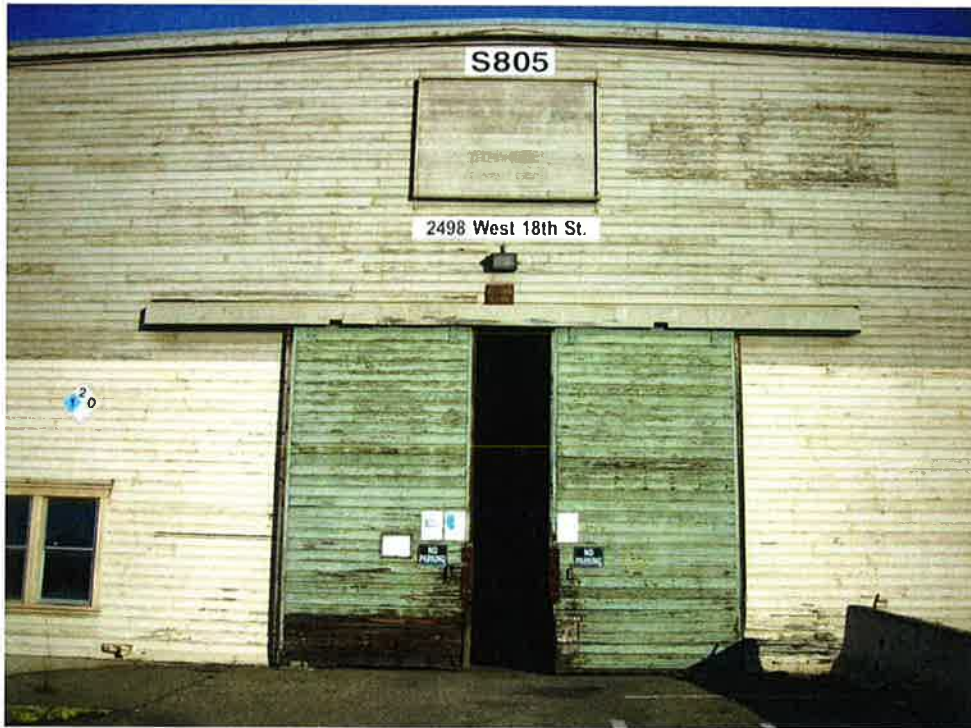
Photo 13: Weathered Siding

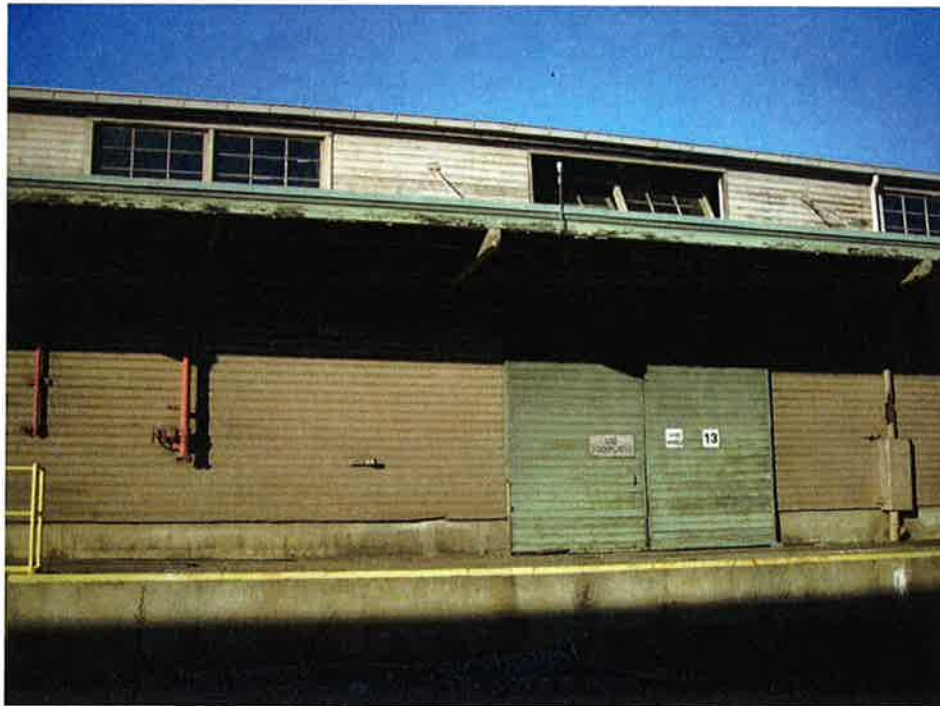
Photo 14: Damaged Window
