WORK PROGRAM 295 MACARTHUR BLVD, OAKLAND

Exterior Details and Work Program Summary:

RE: Structural Observation
295 MacArthur Blvd
Oakland, CA 94610

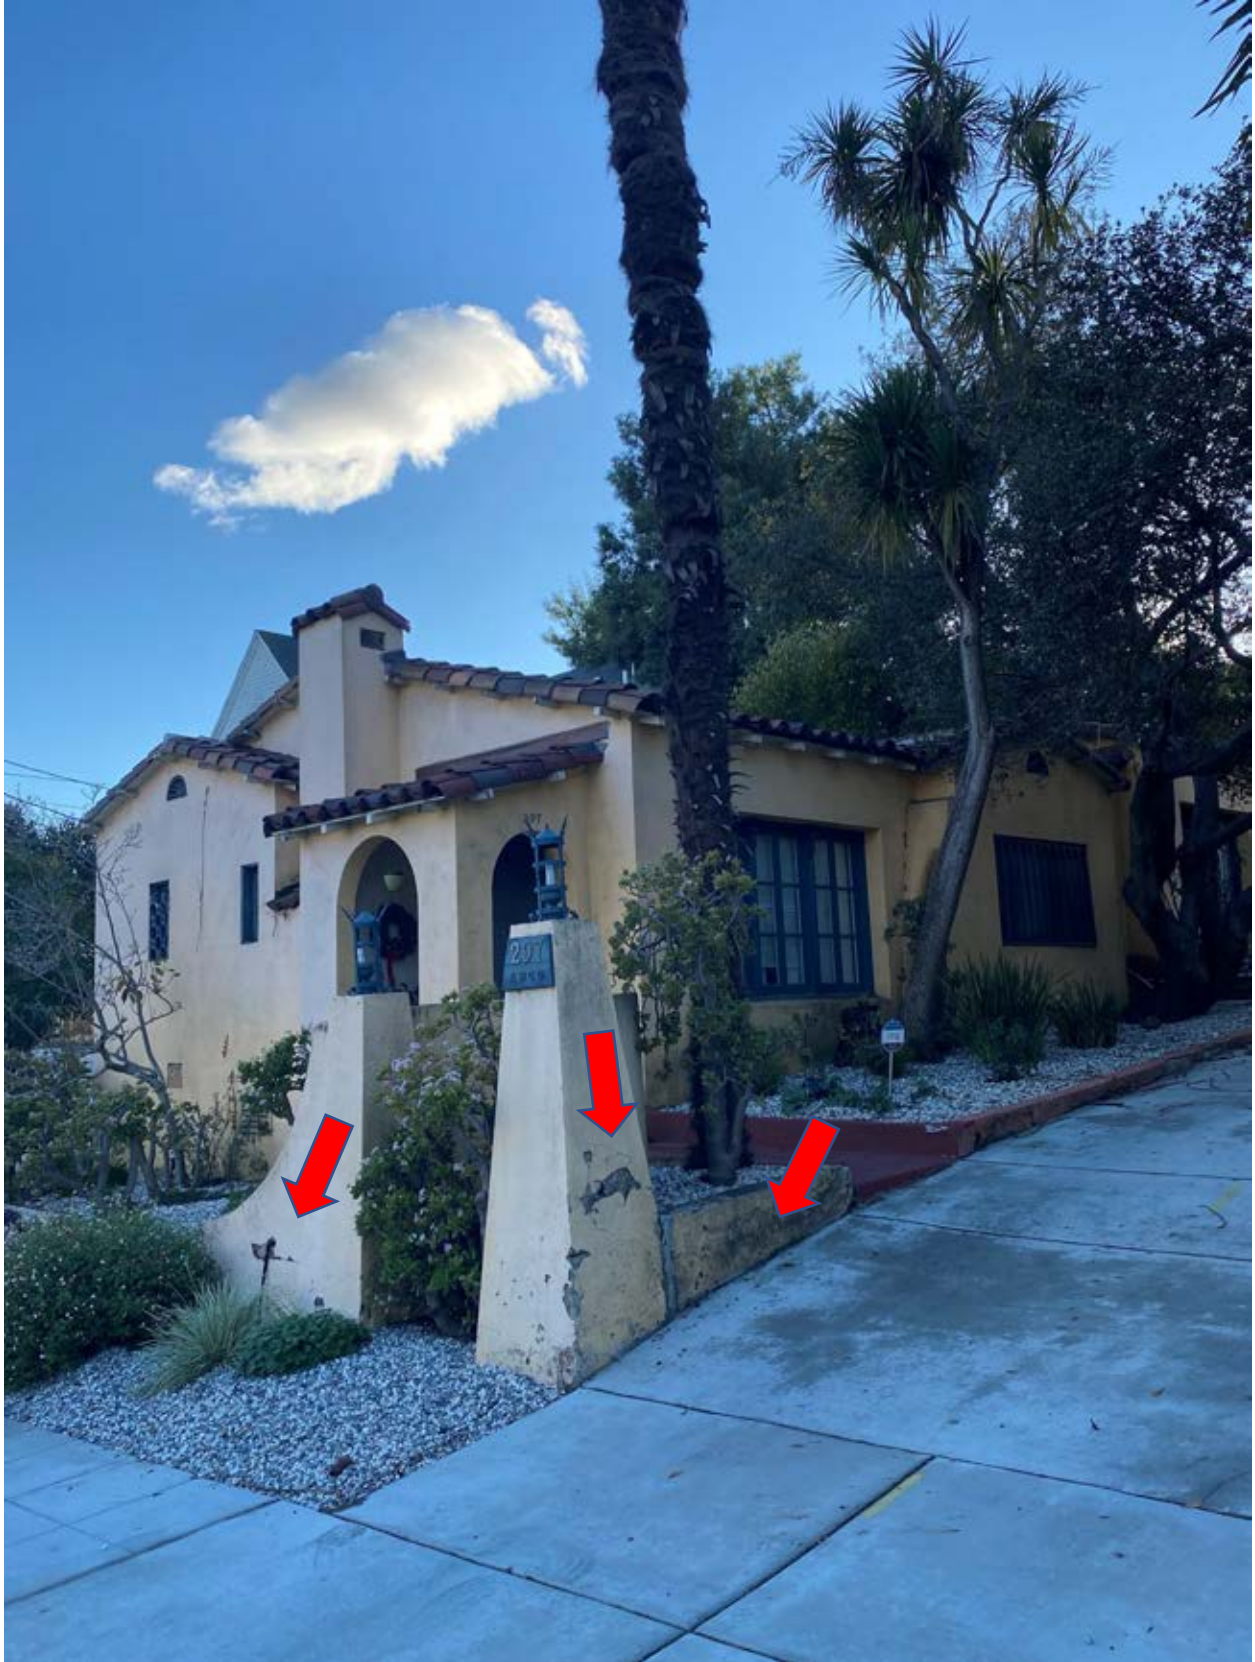
WORK ITEM: #7

(Front entrance damage, cracking and stucco repair)

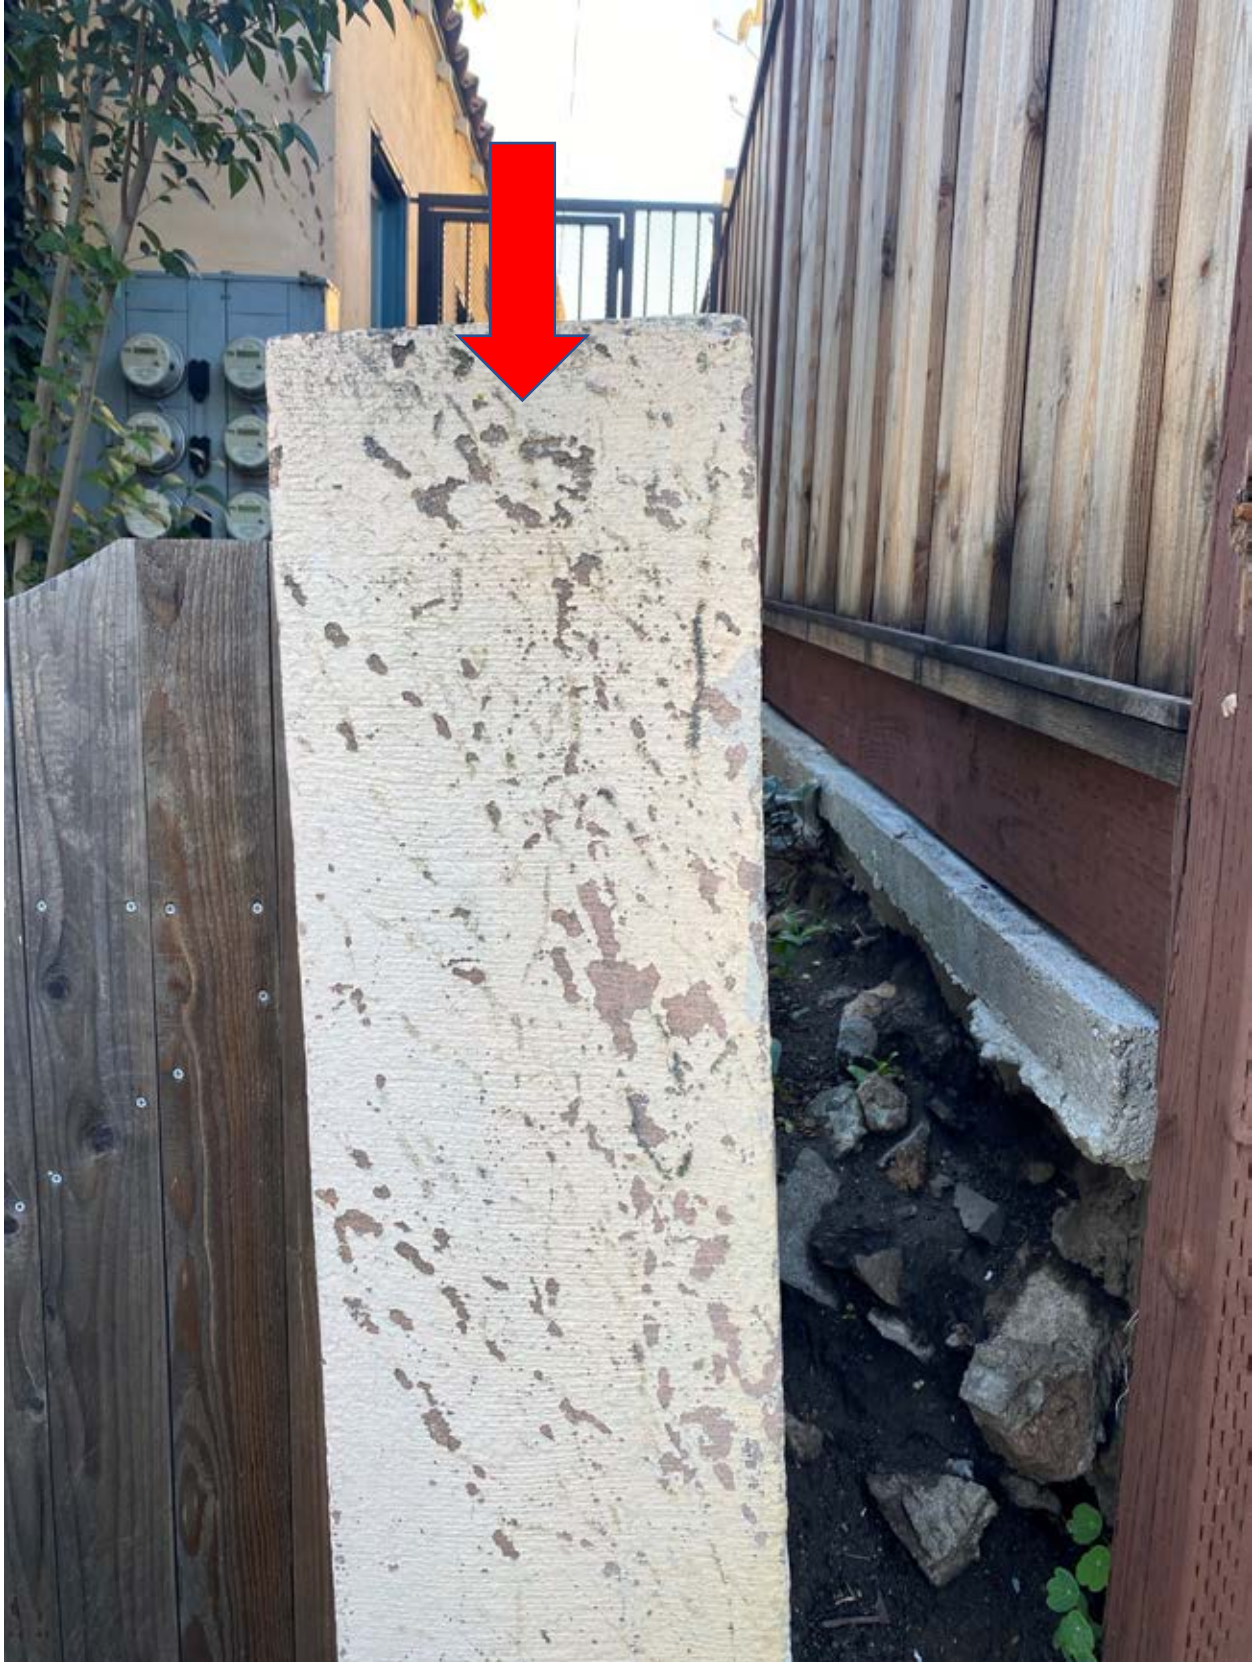
WORK ITEM: #7

(Street facing wall with extensive paint/stucco damage)

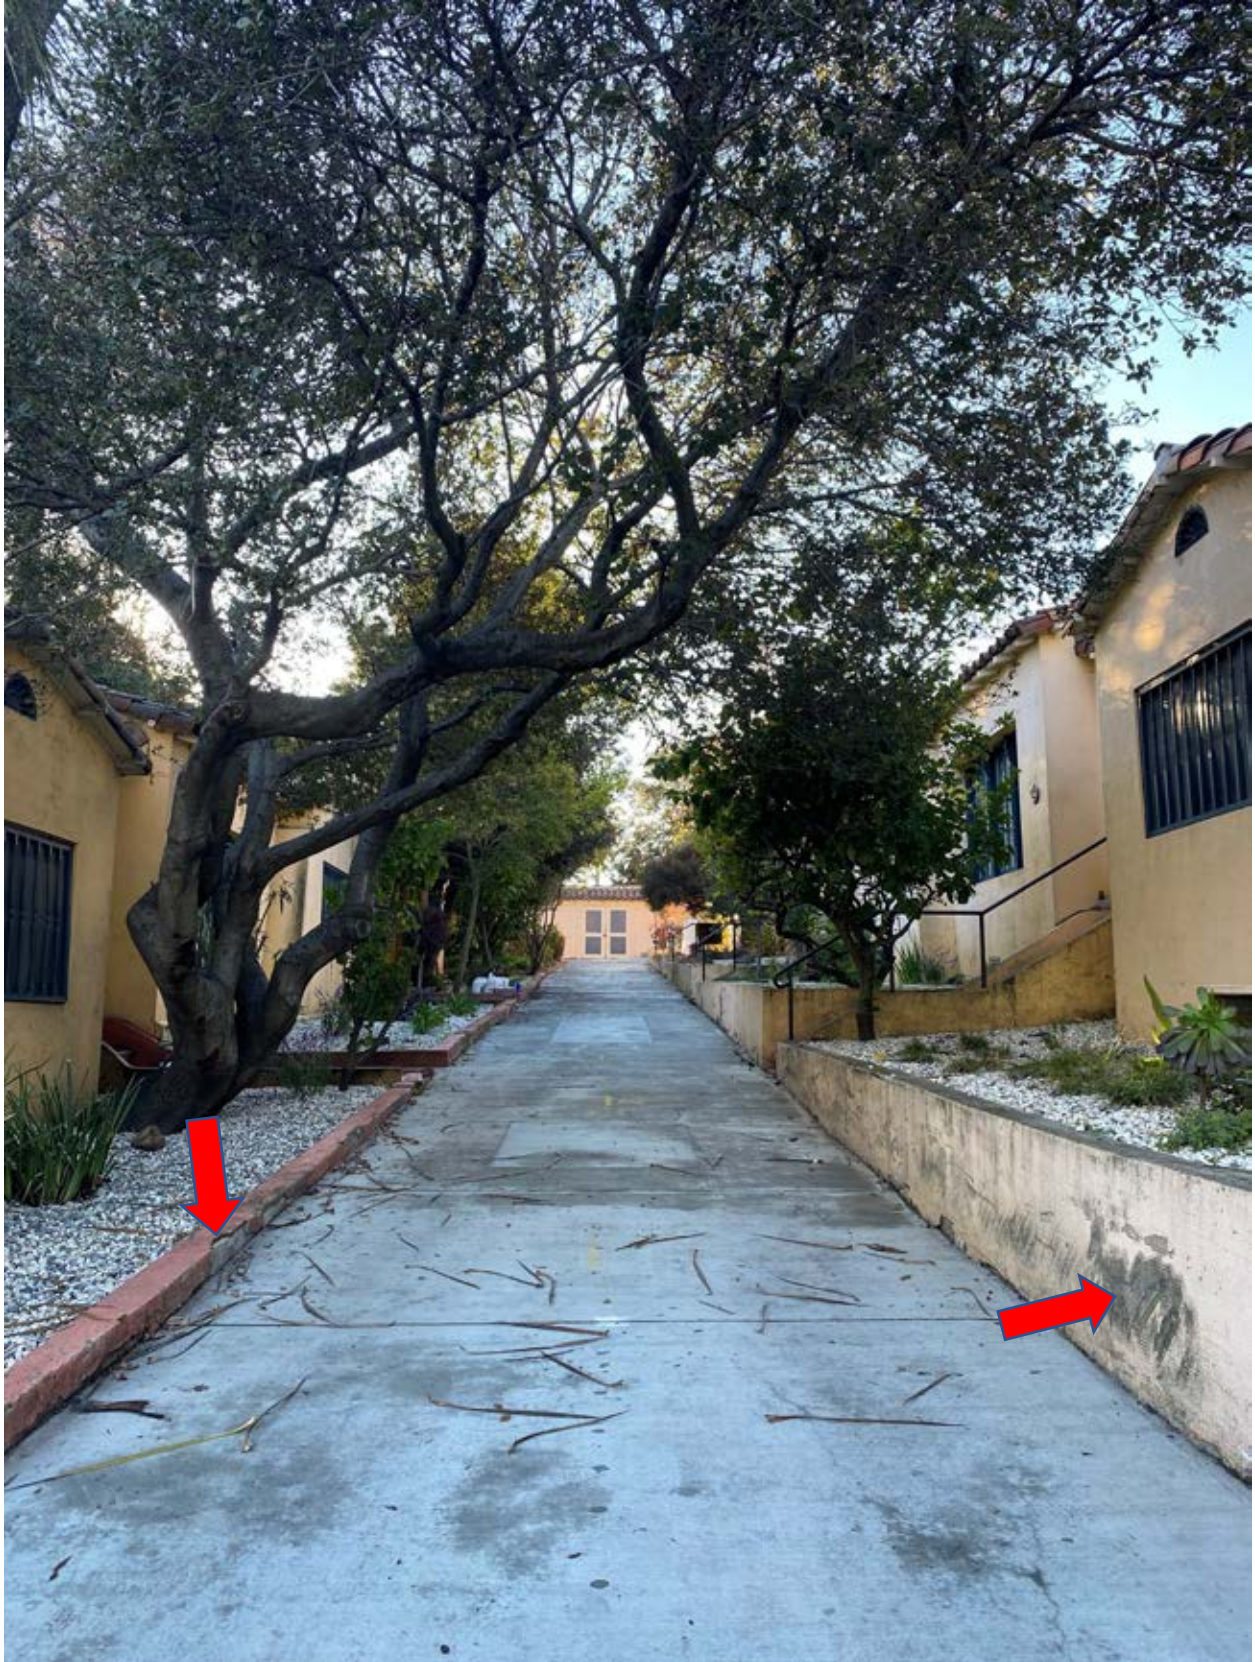
WORK ITEM: #4, #5

(Interior driveway walls heavily damaged, stucco, paint and cement)

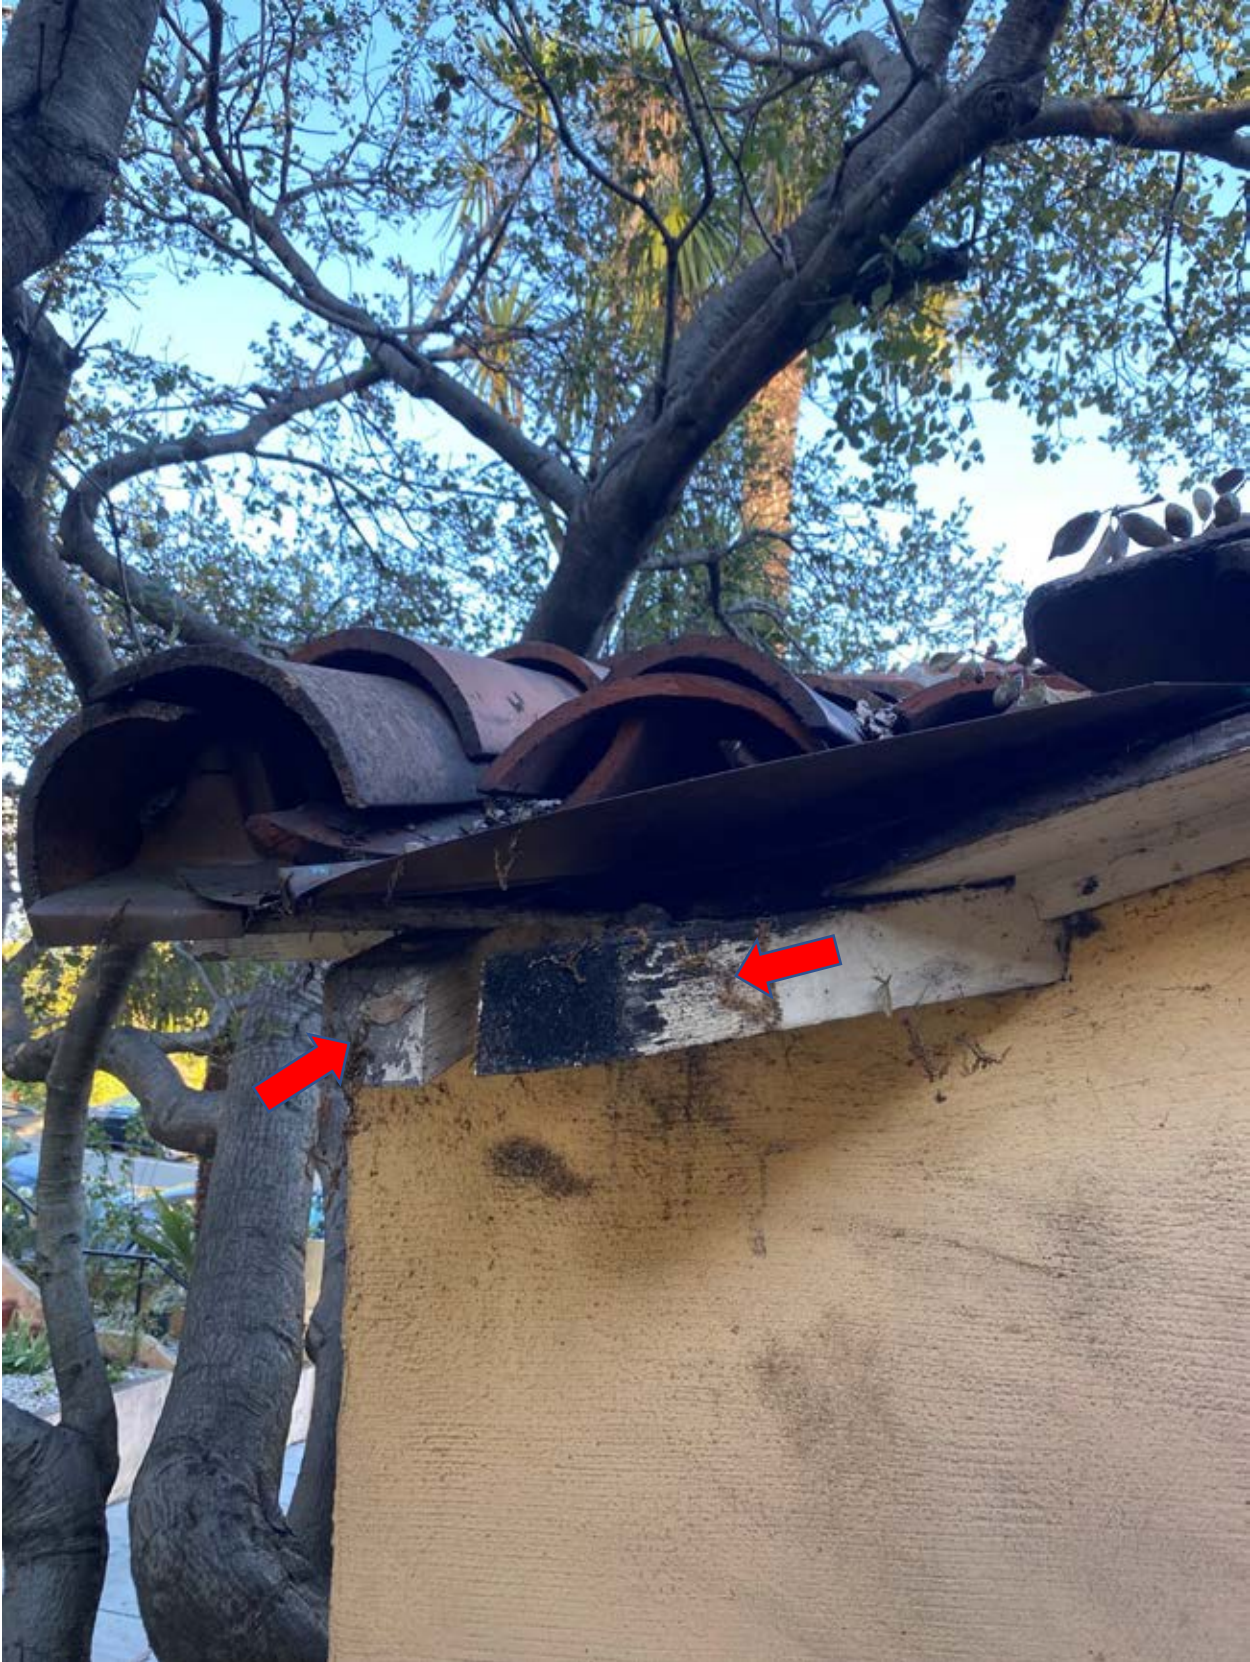
WORK ITEM: #1, #2, #3

(Dry rot repair needed on multiple bungalow roof lines)

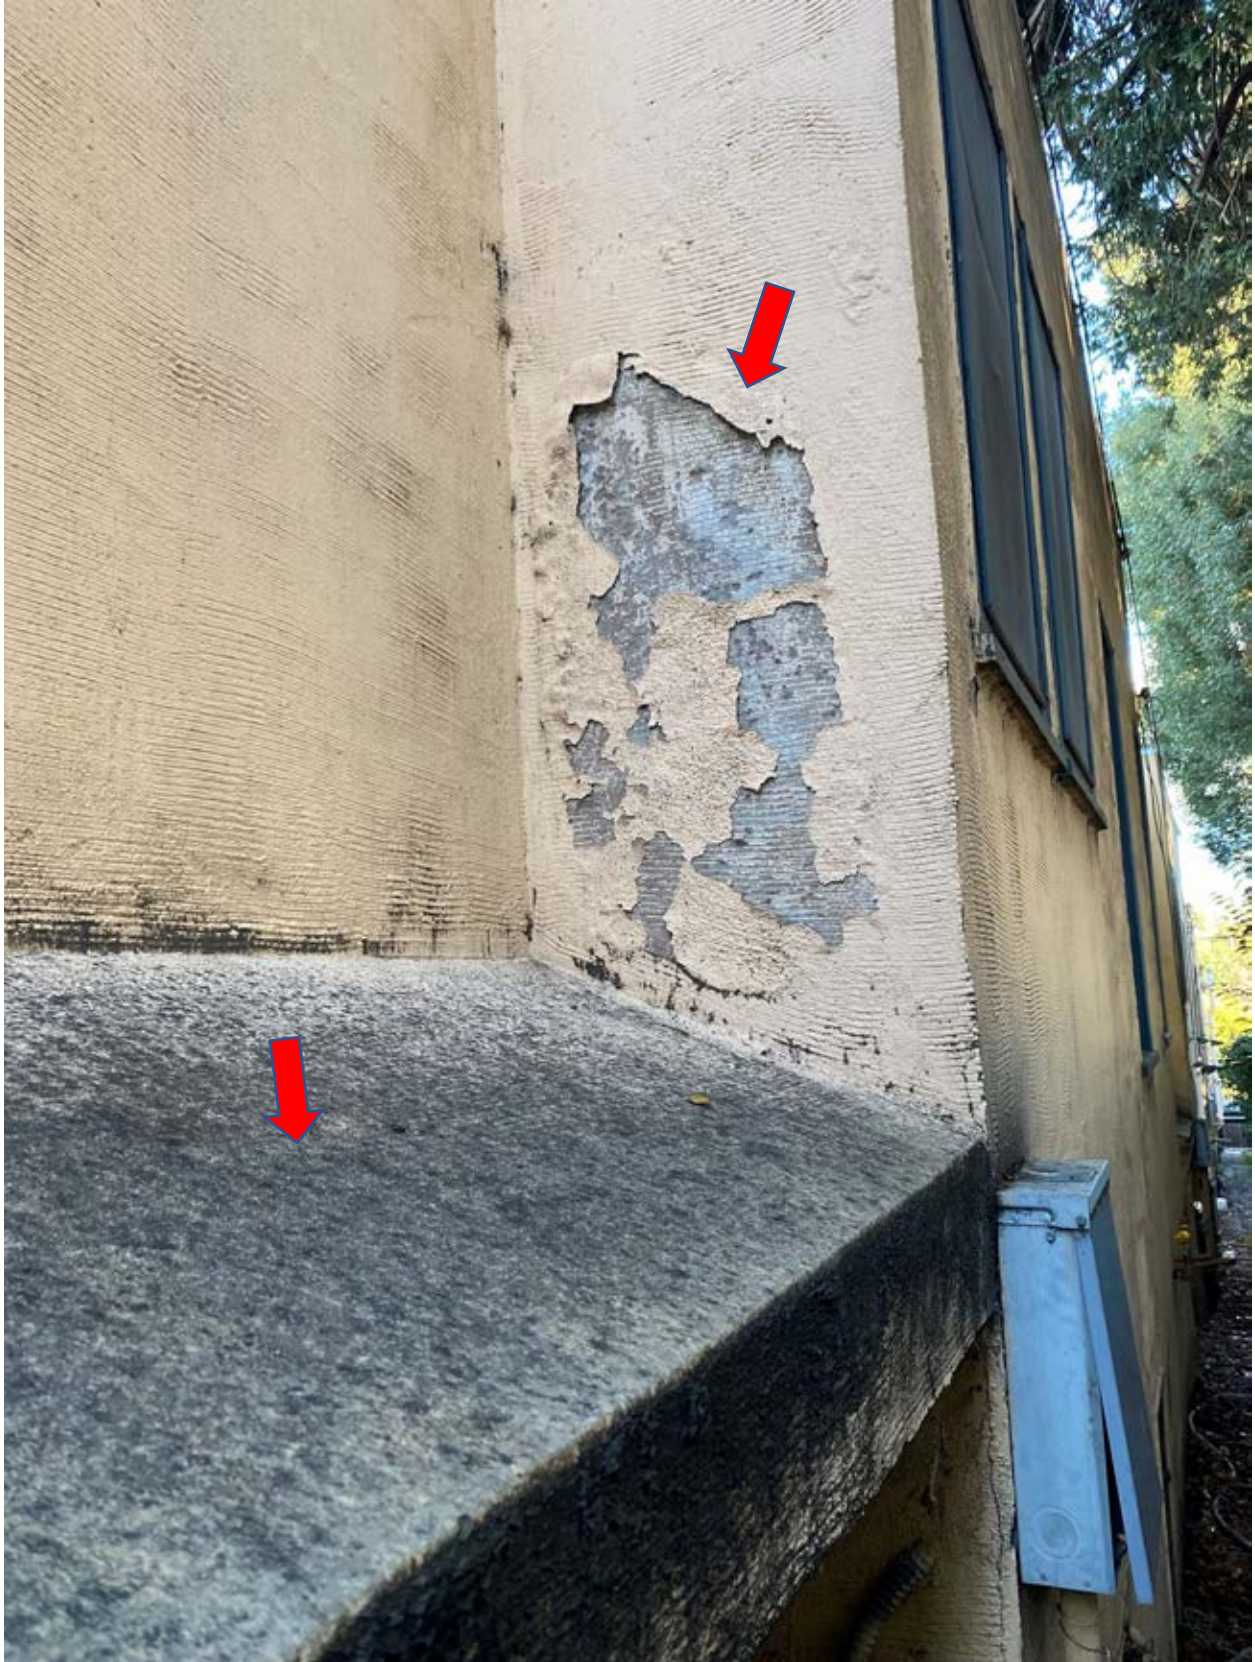
WORK ITEM: #1, #2, #3

(Stucco repair on bungalow)

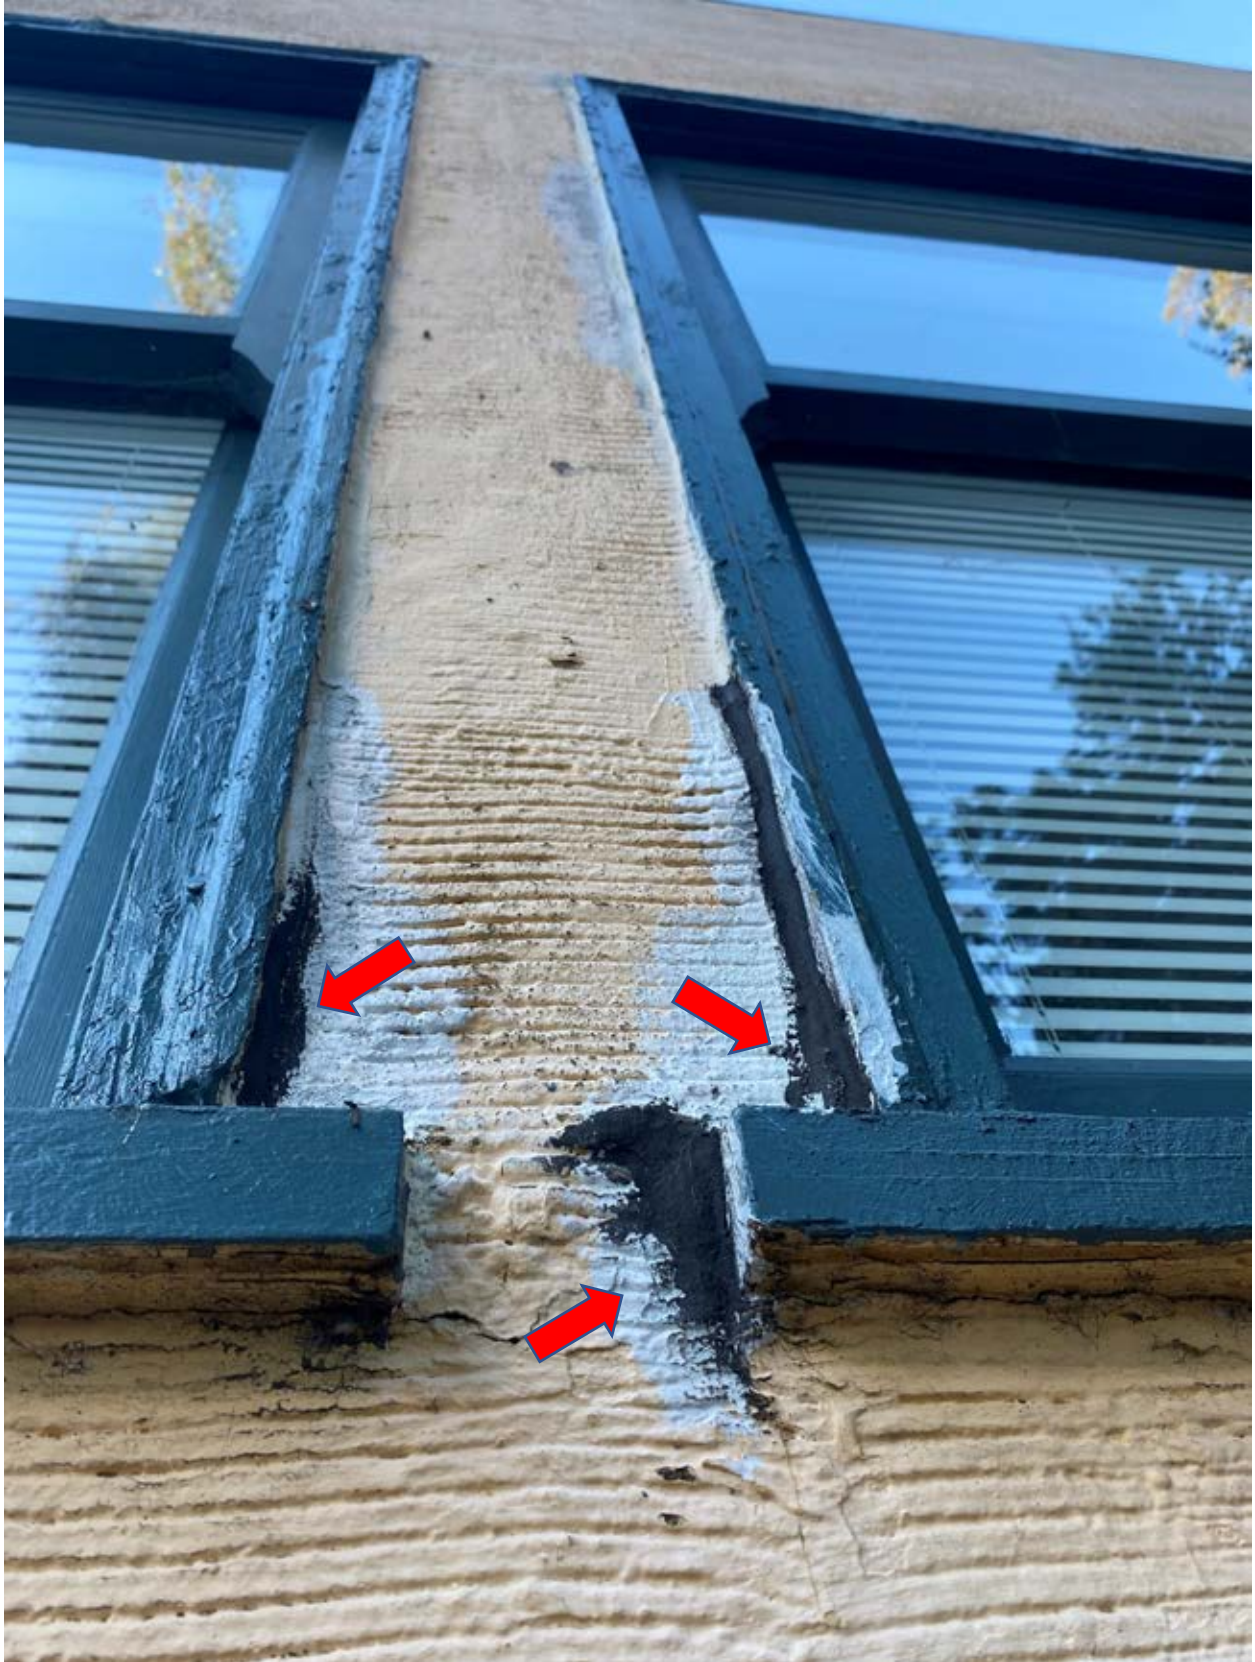
WORK ITEM: #1, #2, #3

(Improper caulking and repair work on windowsill. Needs restoration)

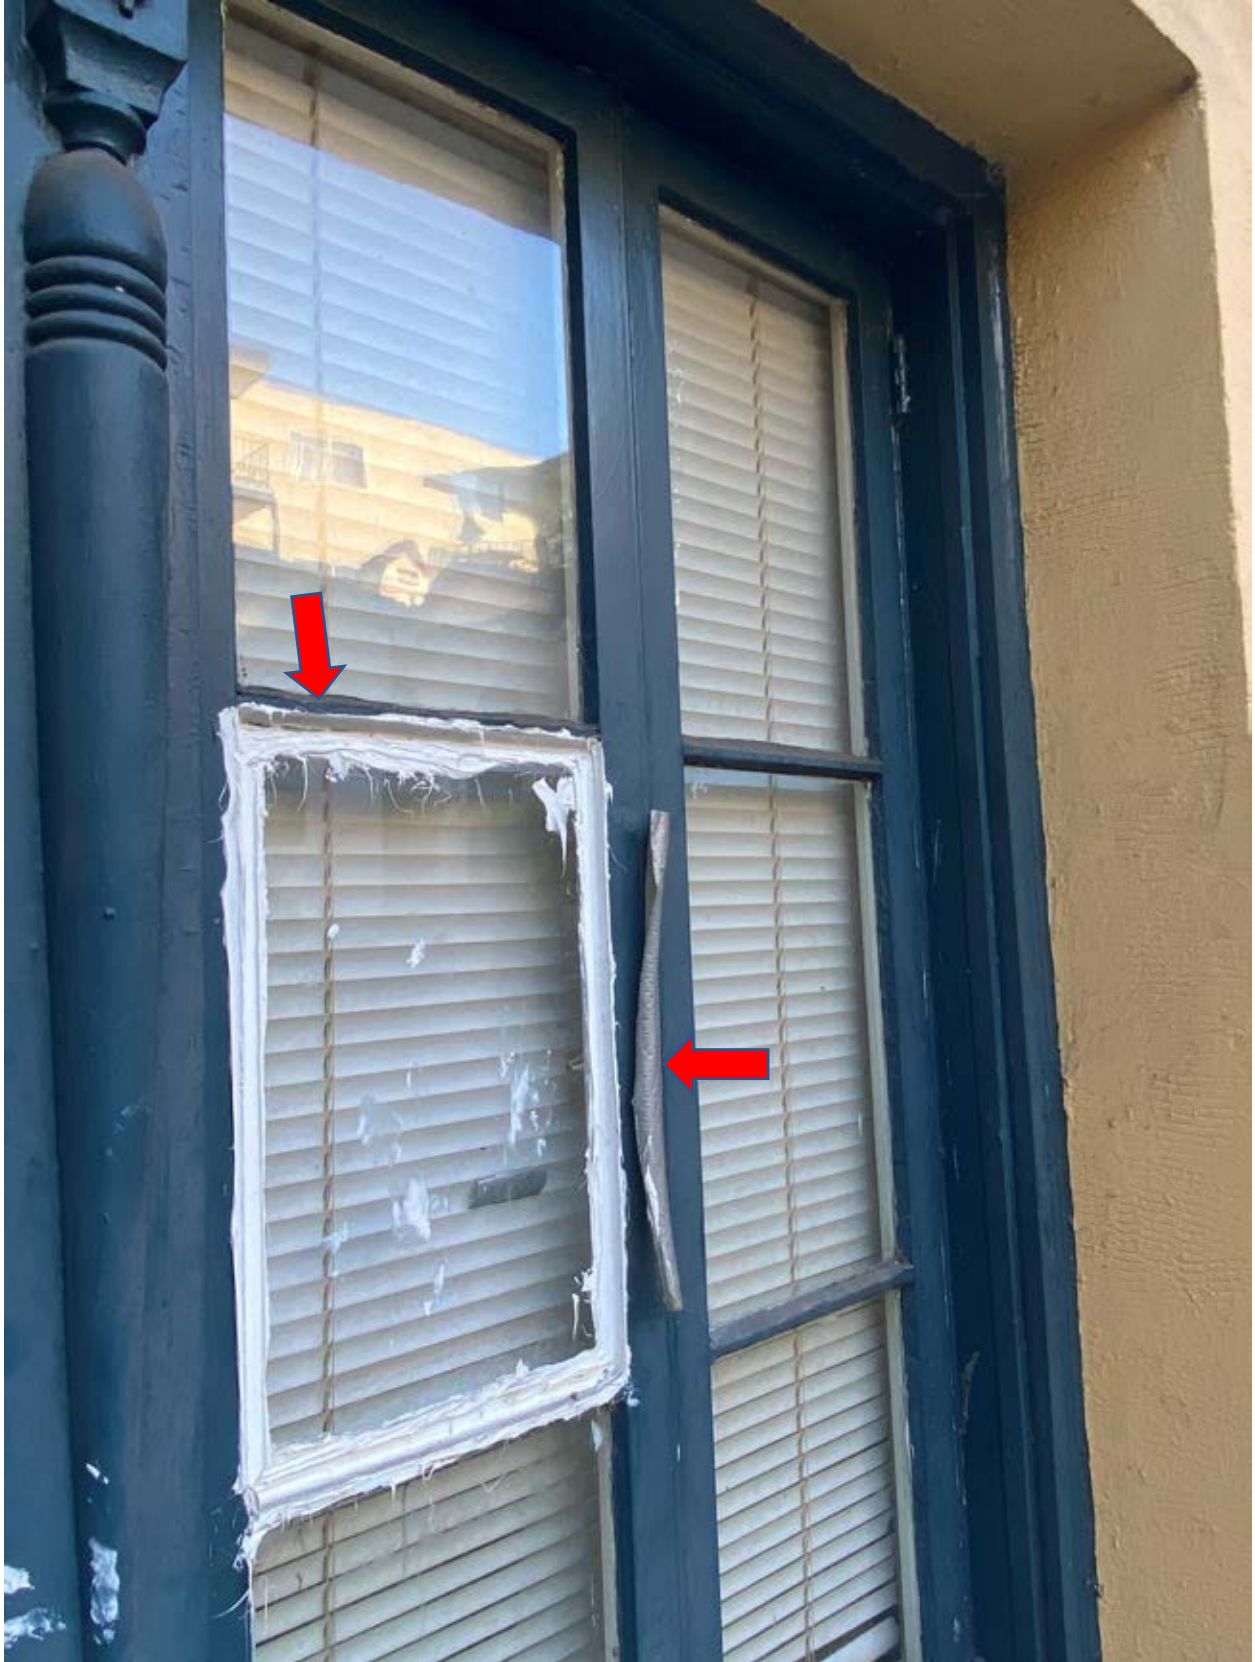
WORK ITEM: #1, #2, #3

(Improper caulking and repair. Needs replacement/restoration) in kind, to match original

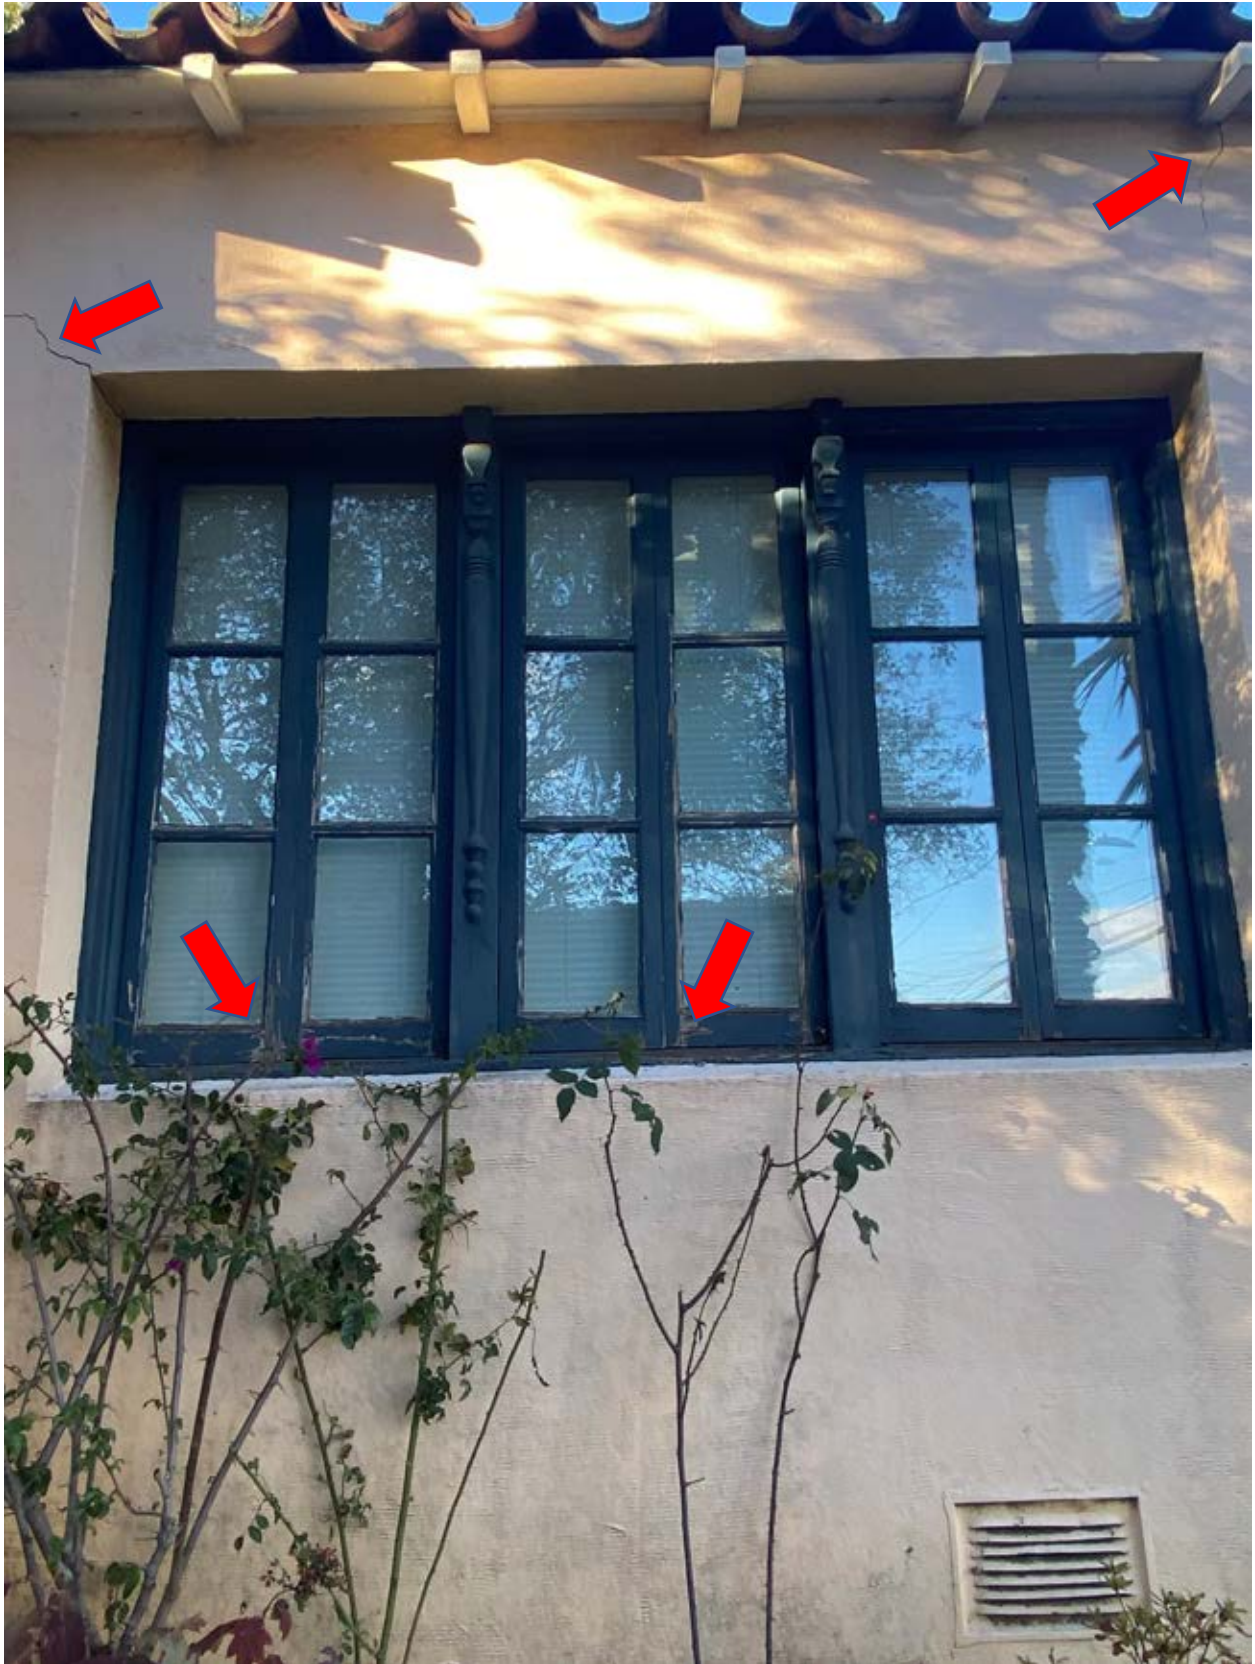
WORK ITEM: #1, #2, #3

(Stucco cracking)

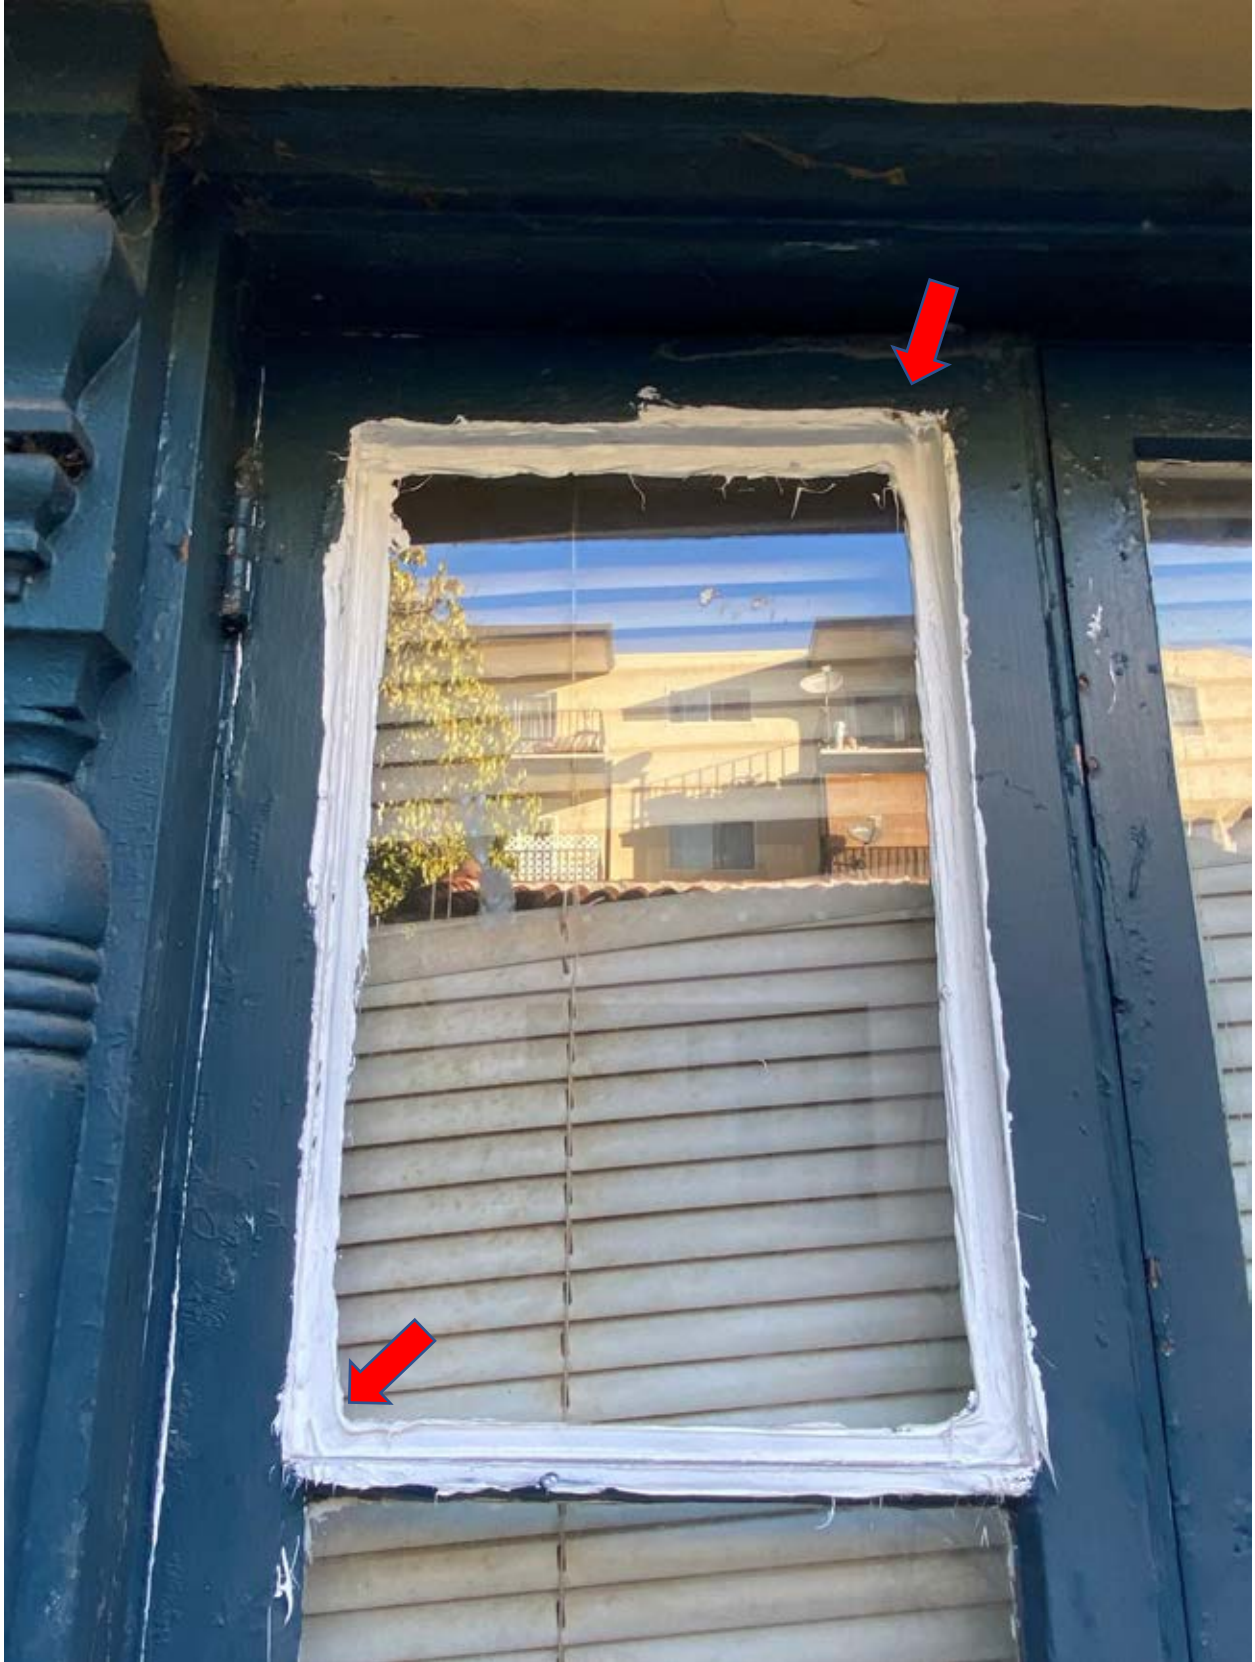
WORK ITEM: #1, #2, #3

(Example of improper caulking/repairs from prior deferred maintenance)

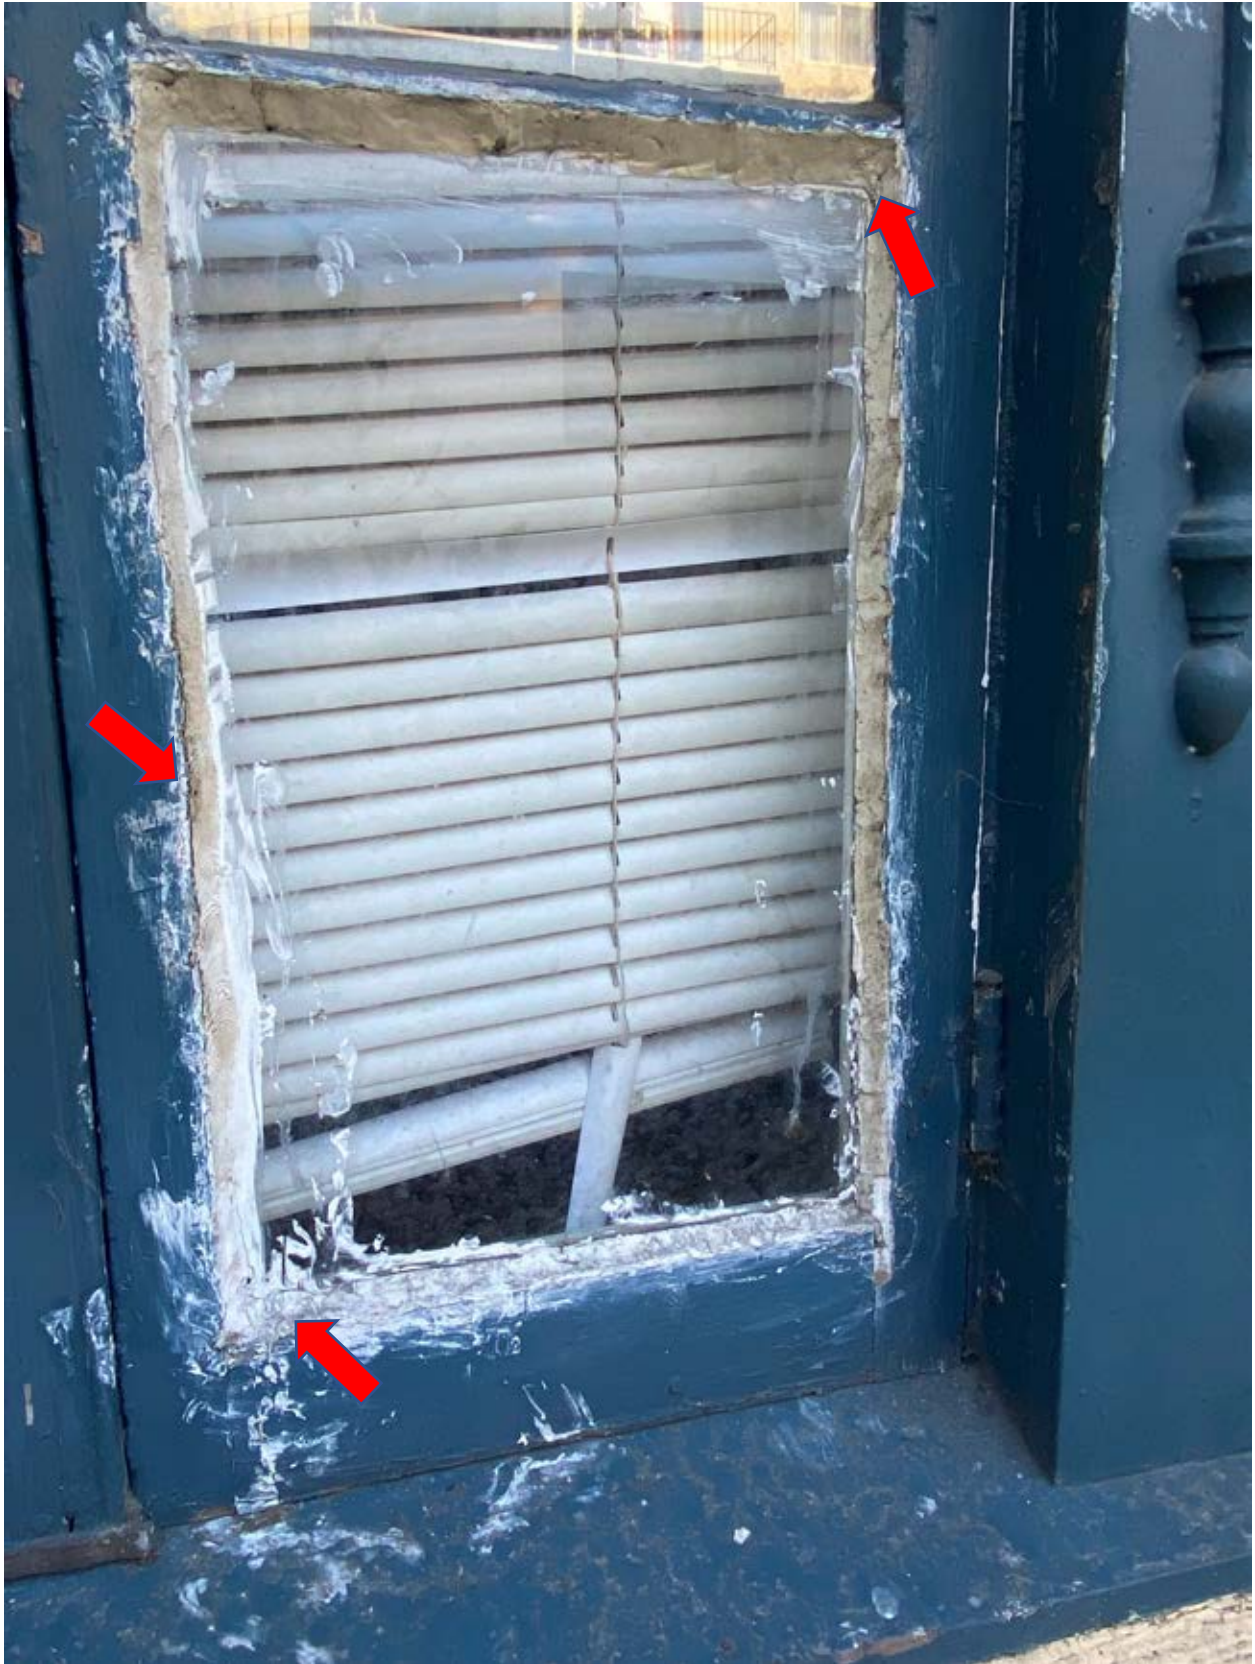
WORK ITEM: #1, #2, #3

(Improper caulking/repairs from prior deferred maintenance)

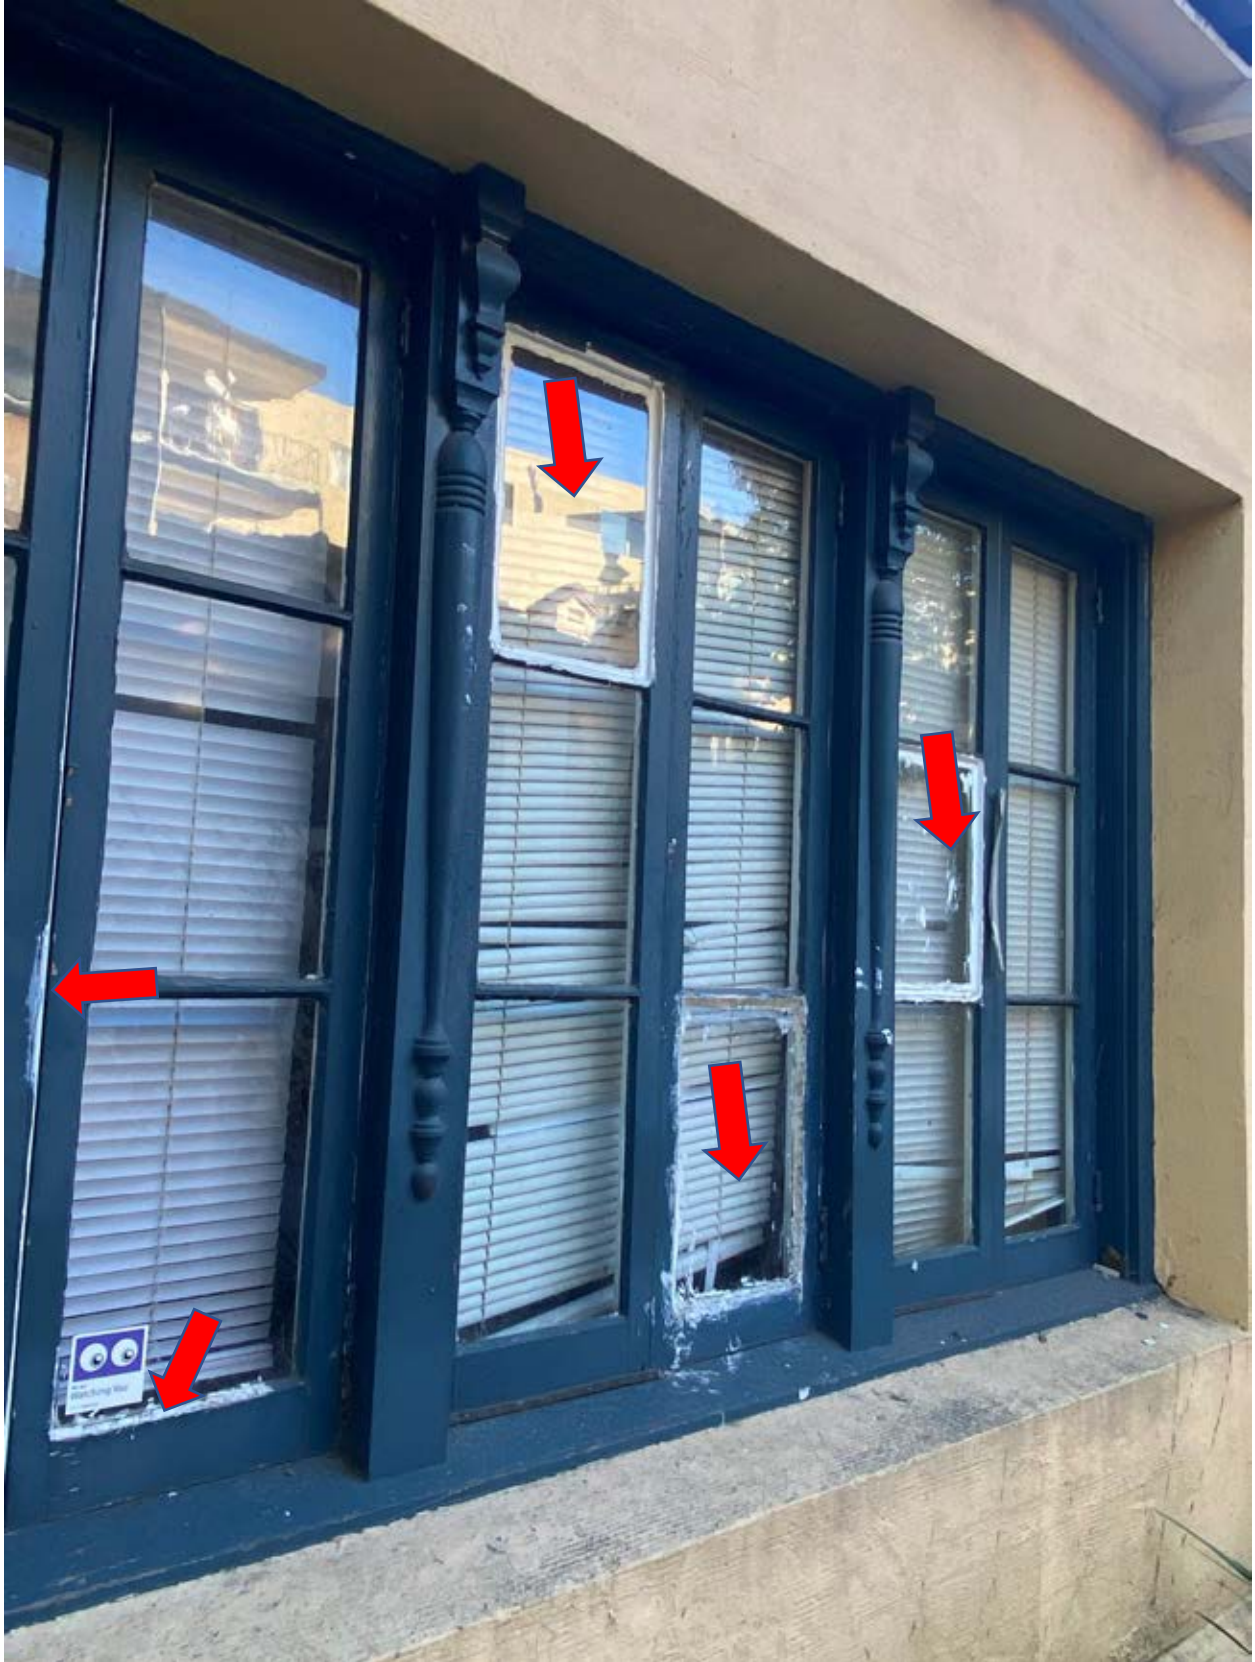
WORK ITEM: #1, #2, #3

(Additional improper caulking/repairs which needs replacement and refurbishment in kind to match original)
