WORK PROGRAM 295 MACARTHUR BLVD, OAKLAND

Exterior Details and Work Program Summary:

RE: Structural Observation
295 MacArthur Blvd
Oakland, CA 94610

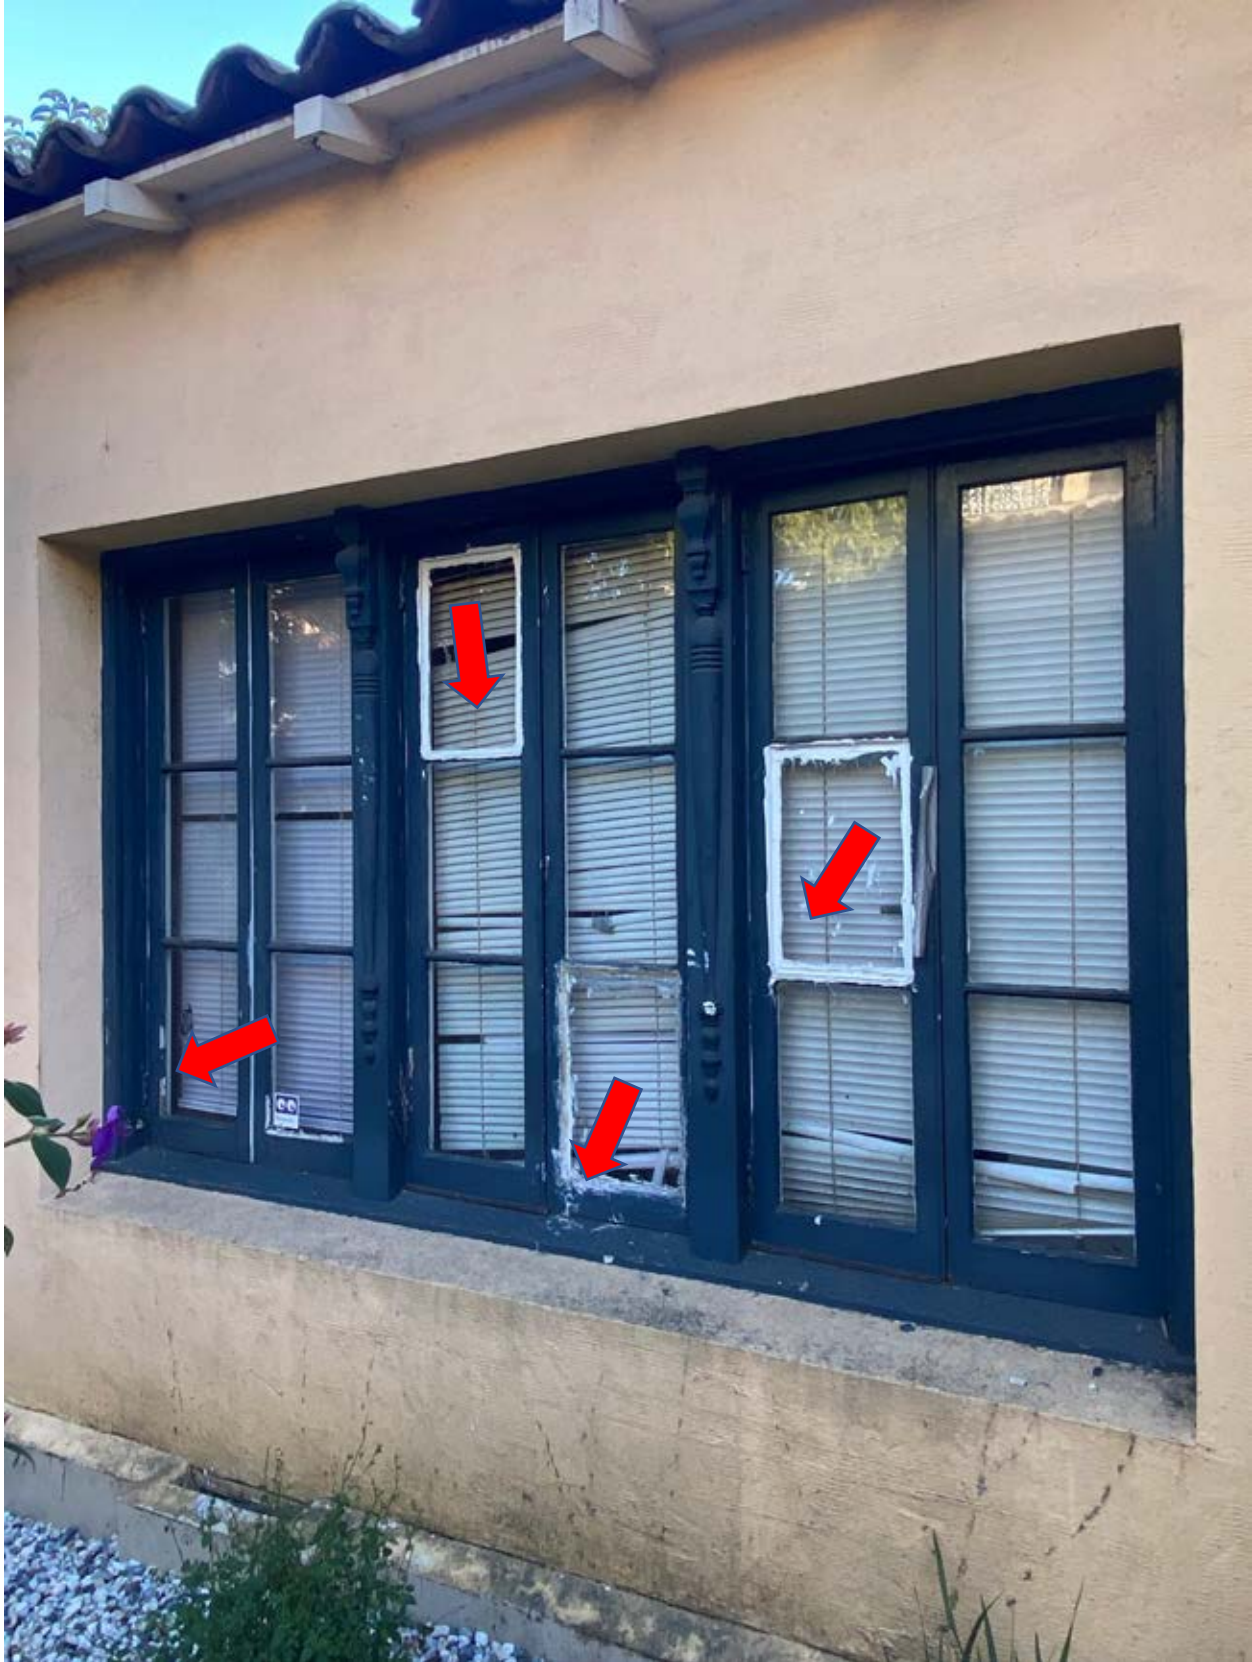
WORK ITEM: #1, #2, #3

(Additional improper caulking/repairs)

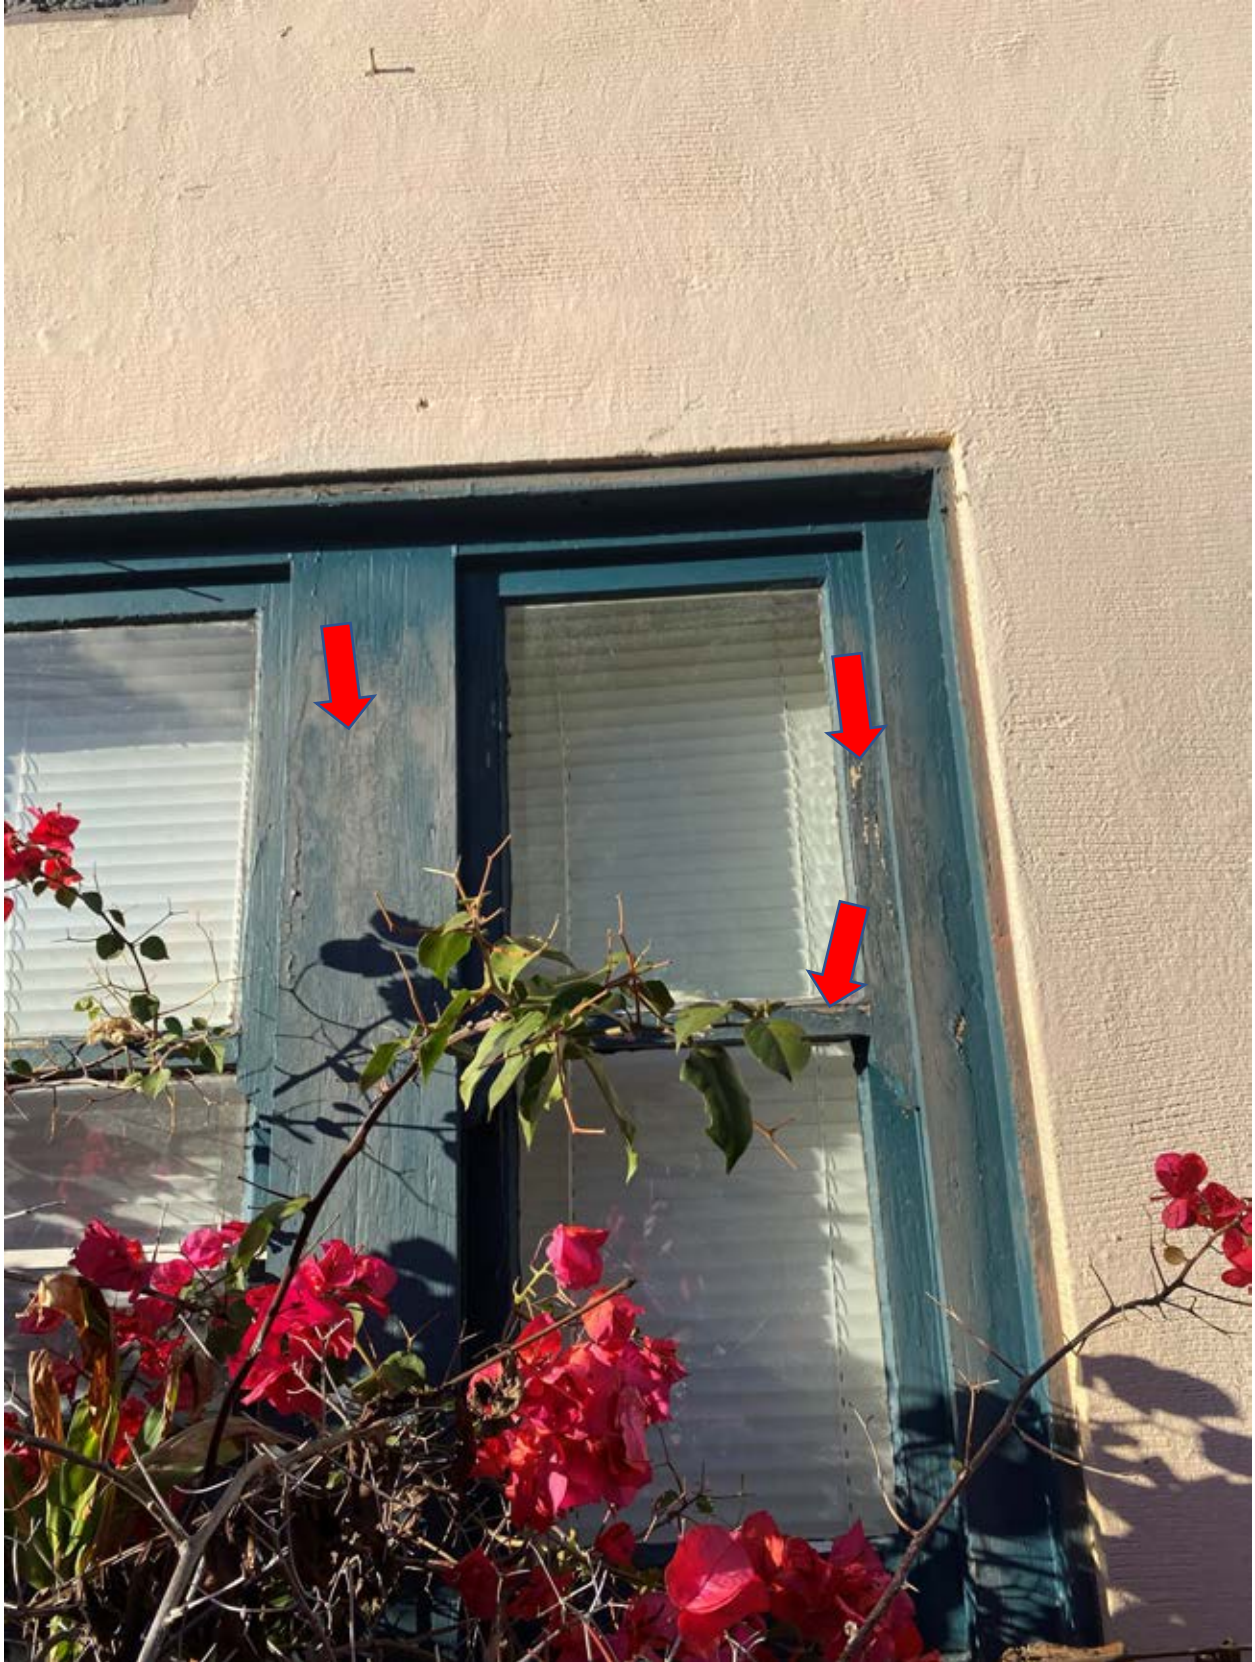
WORK ITEM: #1, #2, #3

(Window framing containing dry rot and in need of restoration in kind to match original)

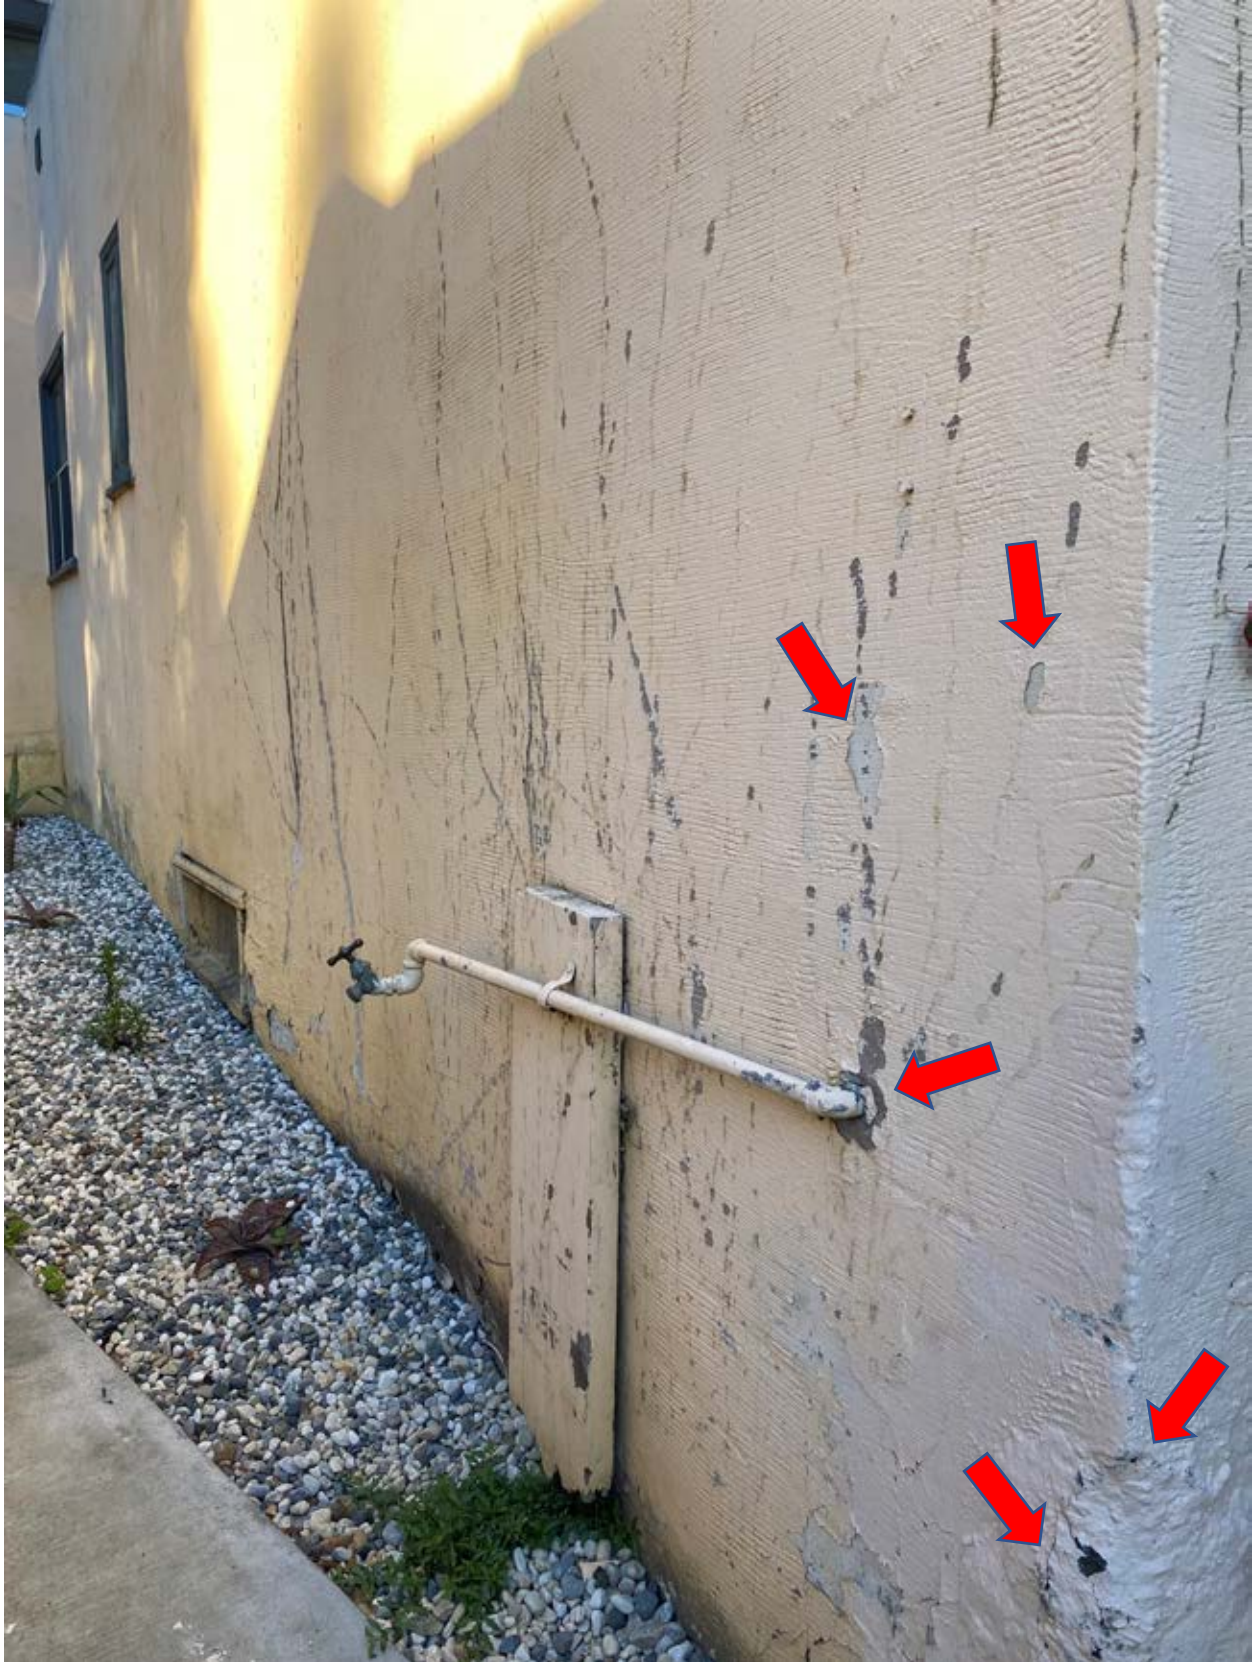
WORK ITEM: #1, #2, #3

(Damaged Stucco siding)

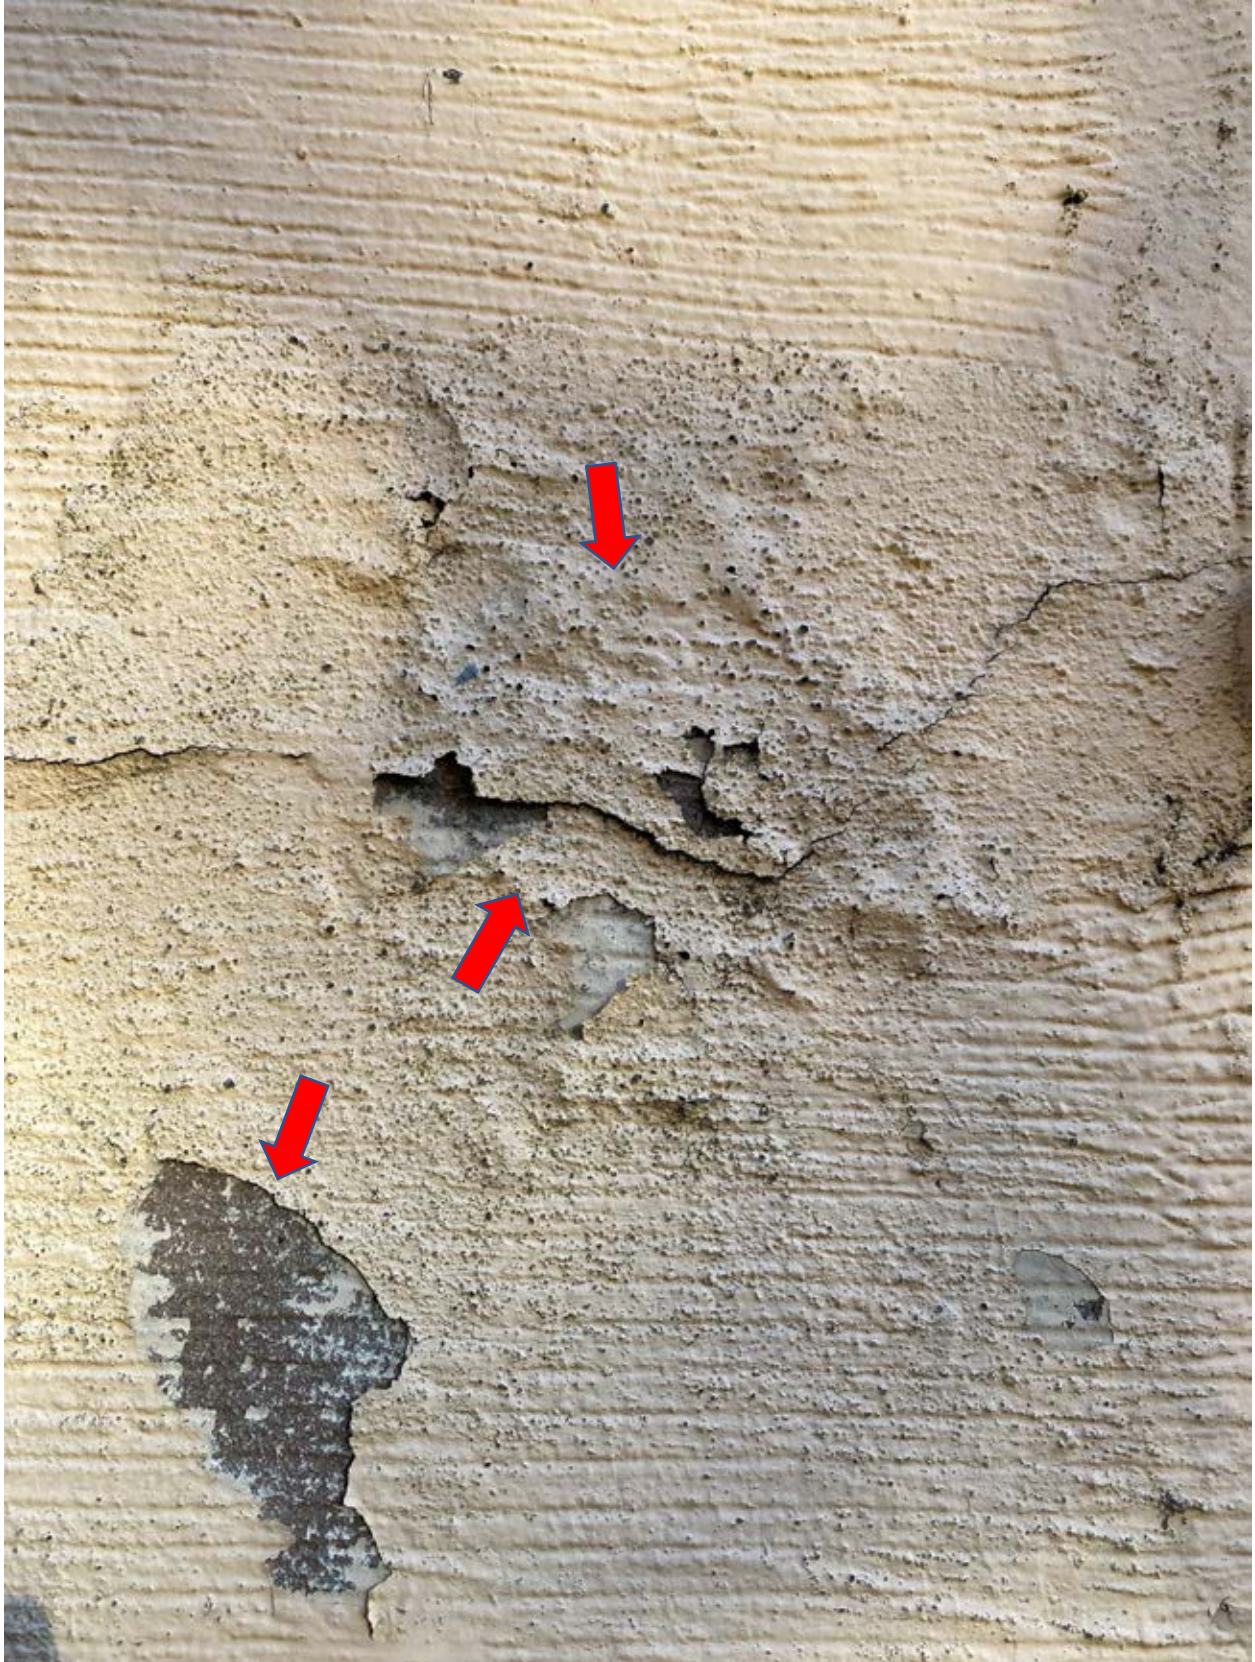
WORK ITEM: #1, #2, #3

(Damaged Stucco siding)

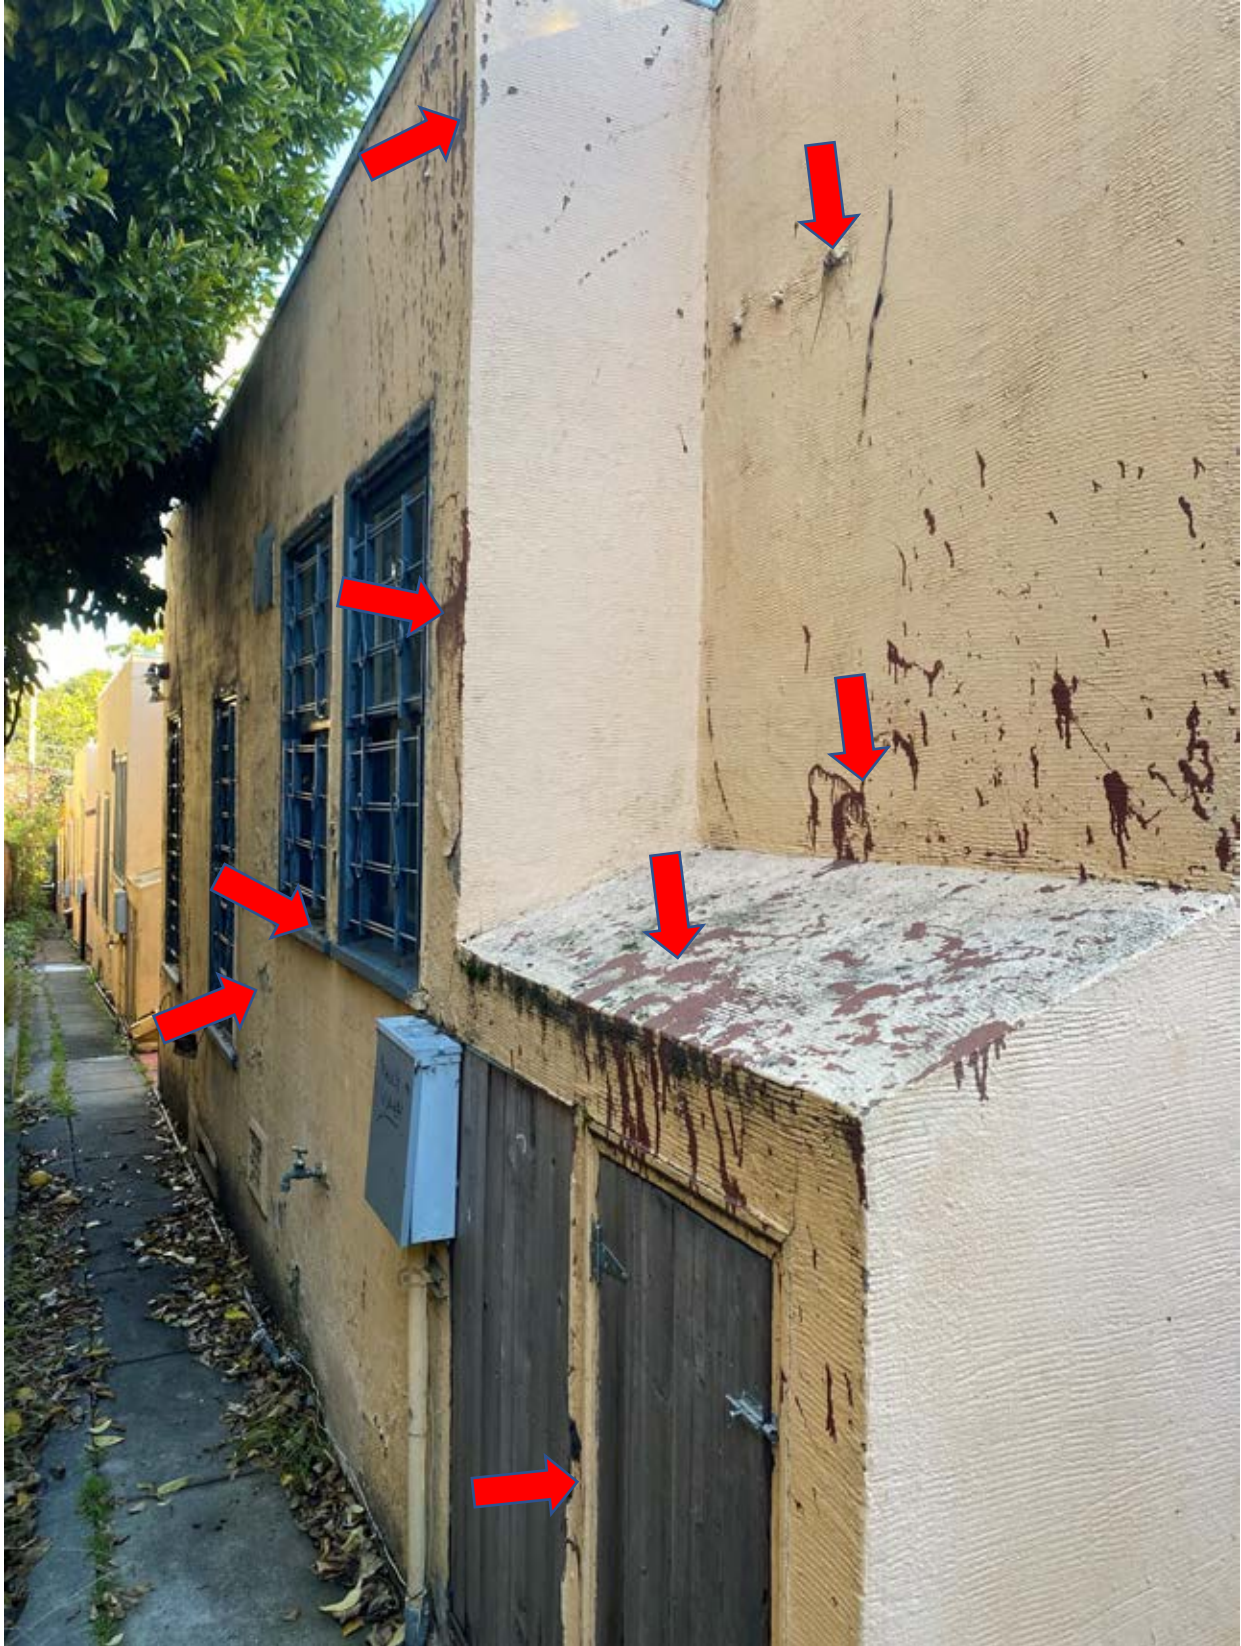
WORK ITEM: #1, #2, #3

(Damaged stucco siding, paint spillage and cracking)

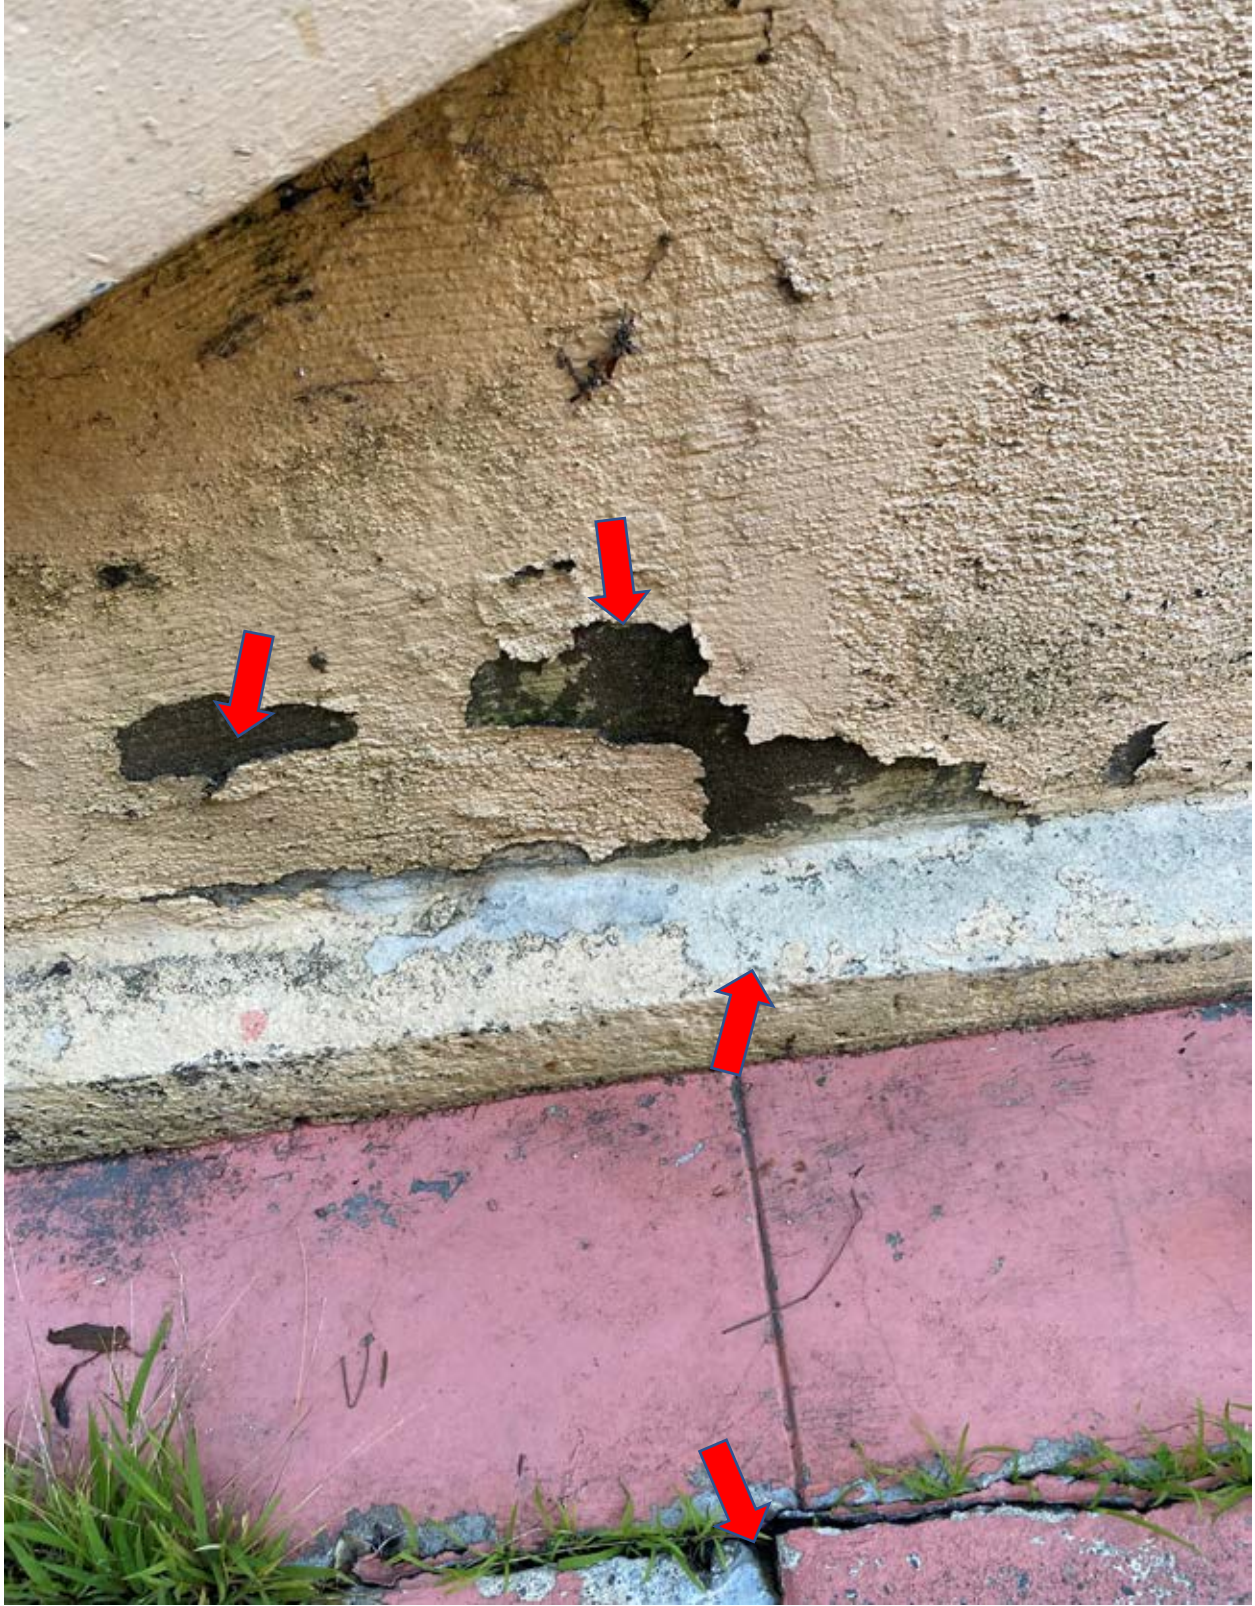
WORK ITEM: #4, #5

(Damaged walkway and stucco siding)

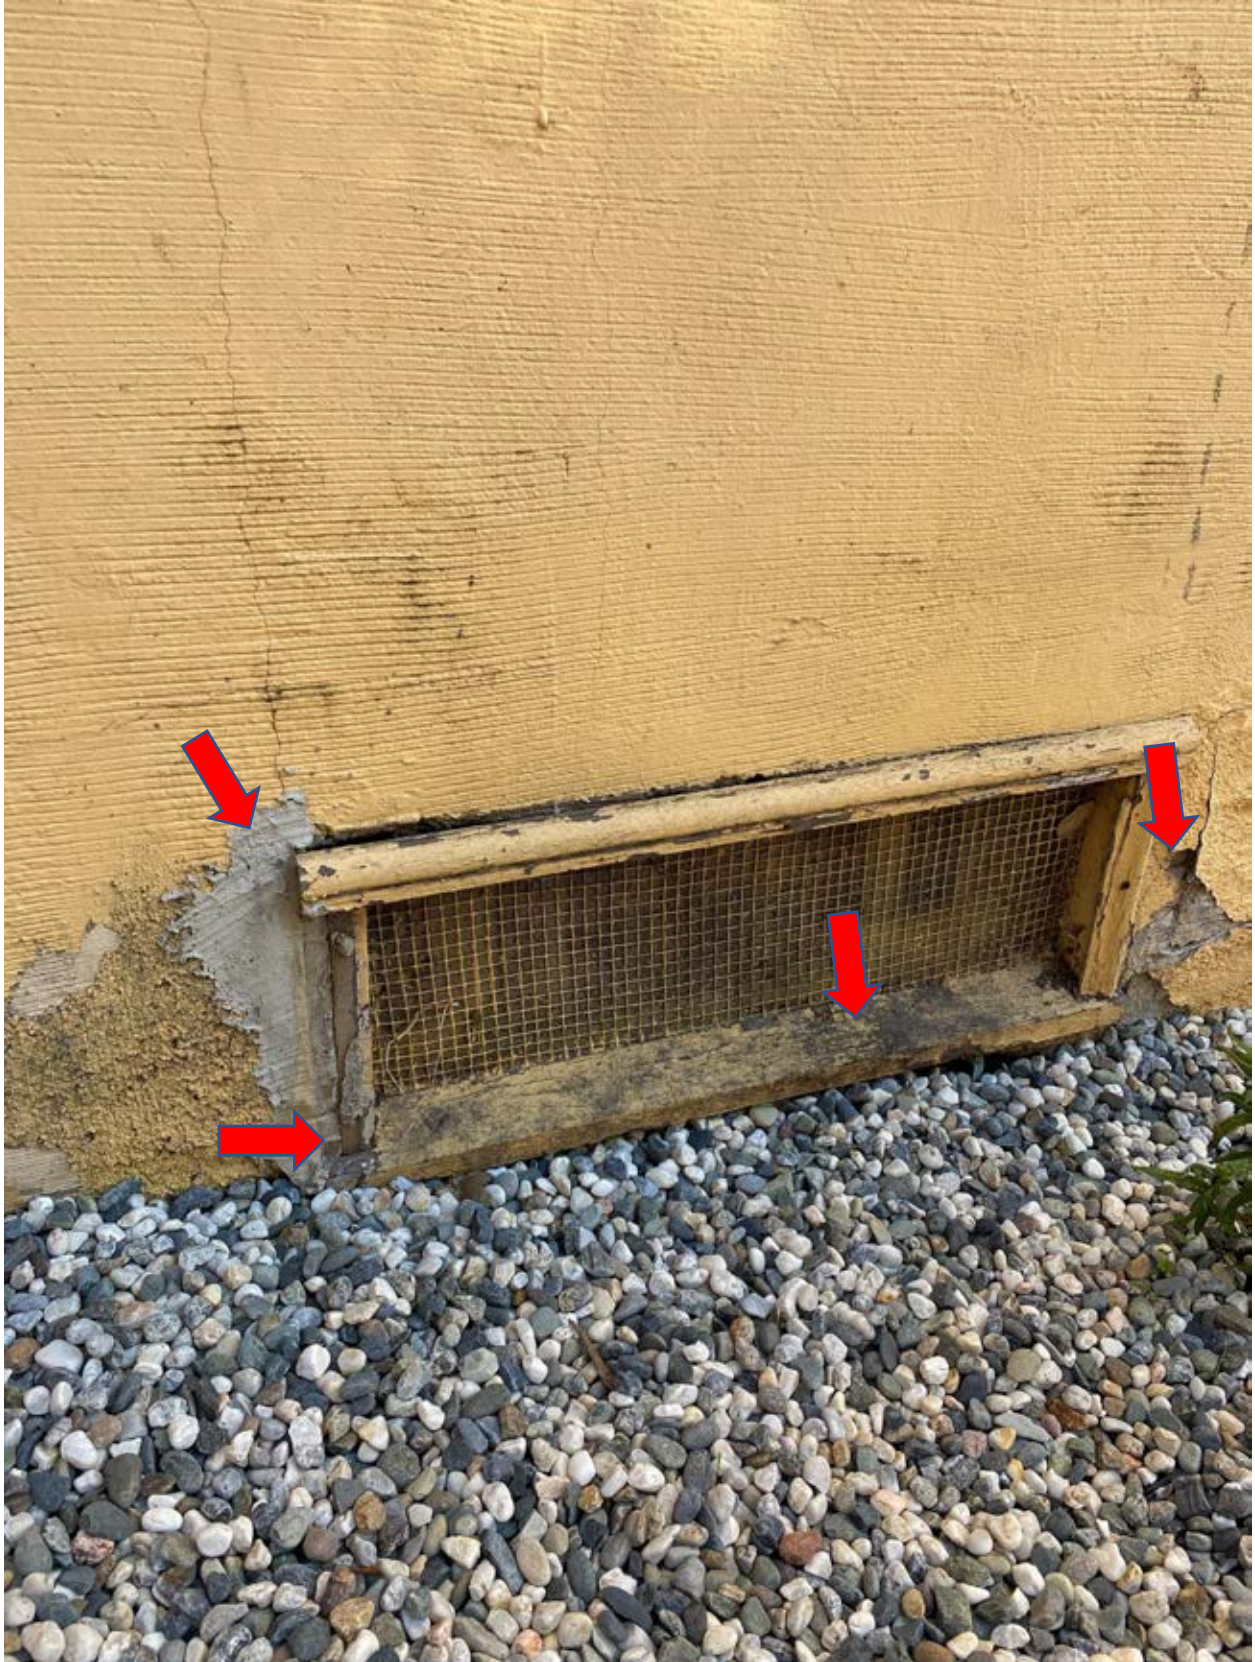
WORK ITEM: #1, #2, #3

(Improper repairs, dry rot, and stucco cracking)

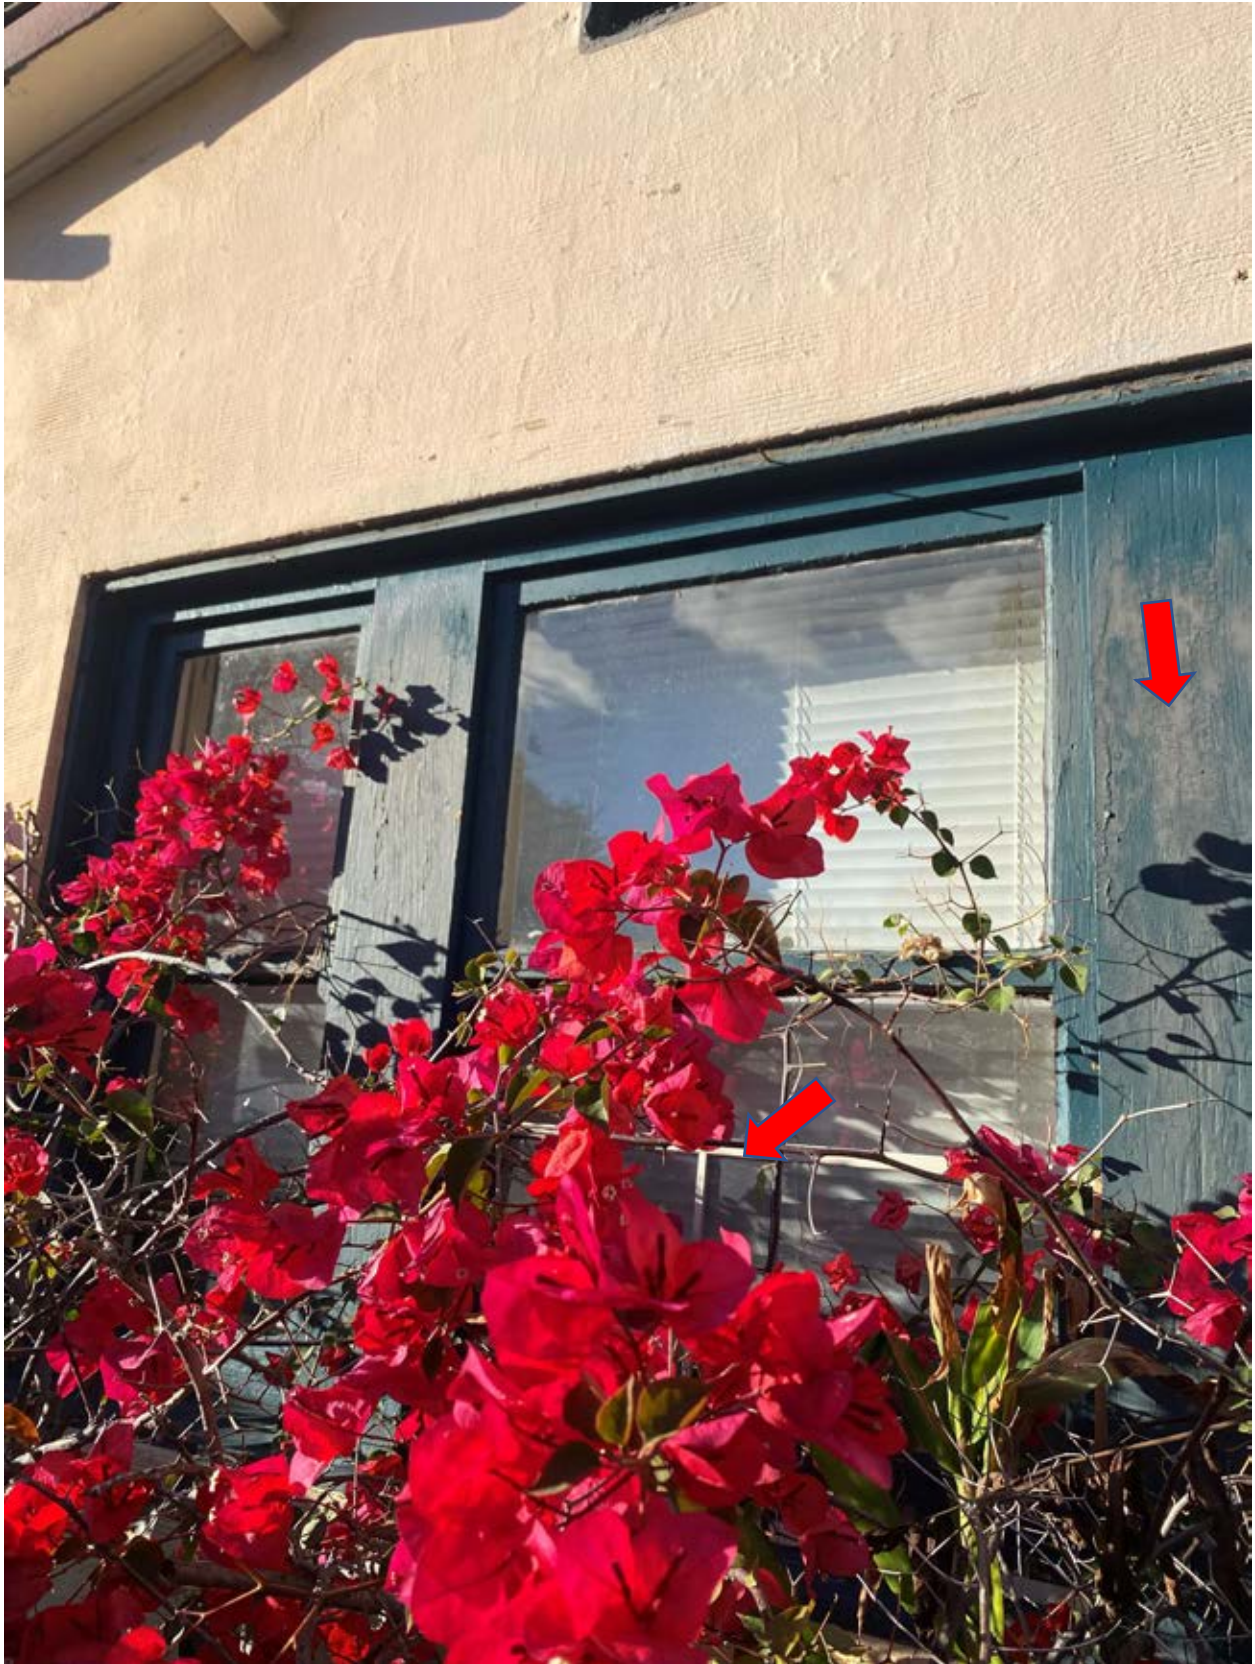
WORK ITEM: #1, #2, #3

(Windowsill paint cracking)

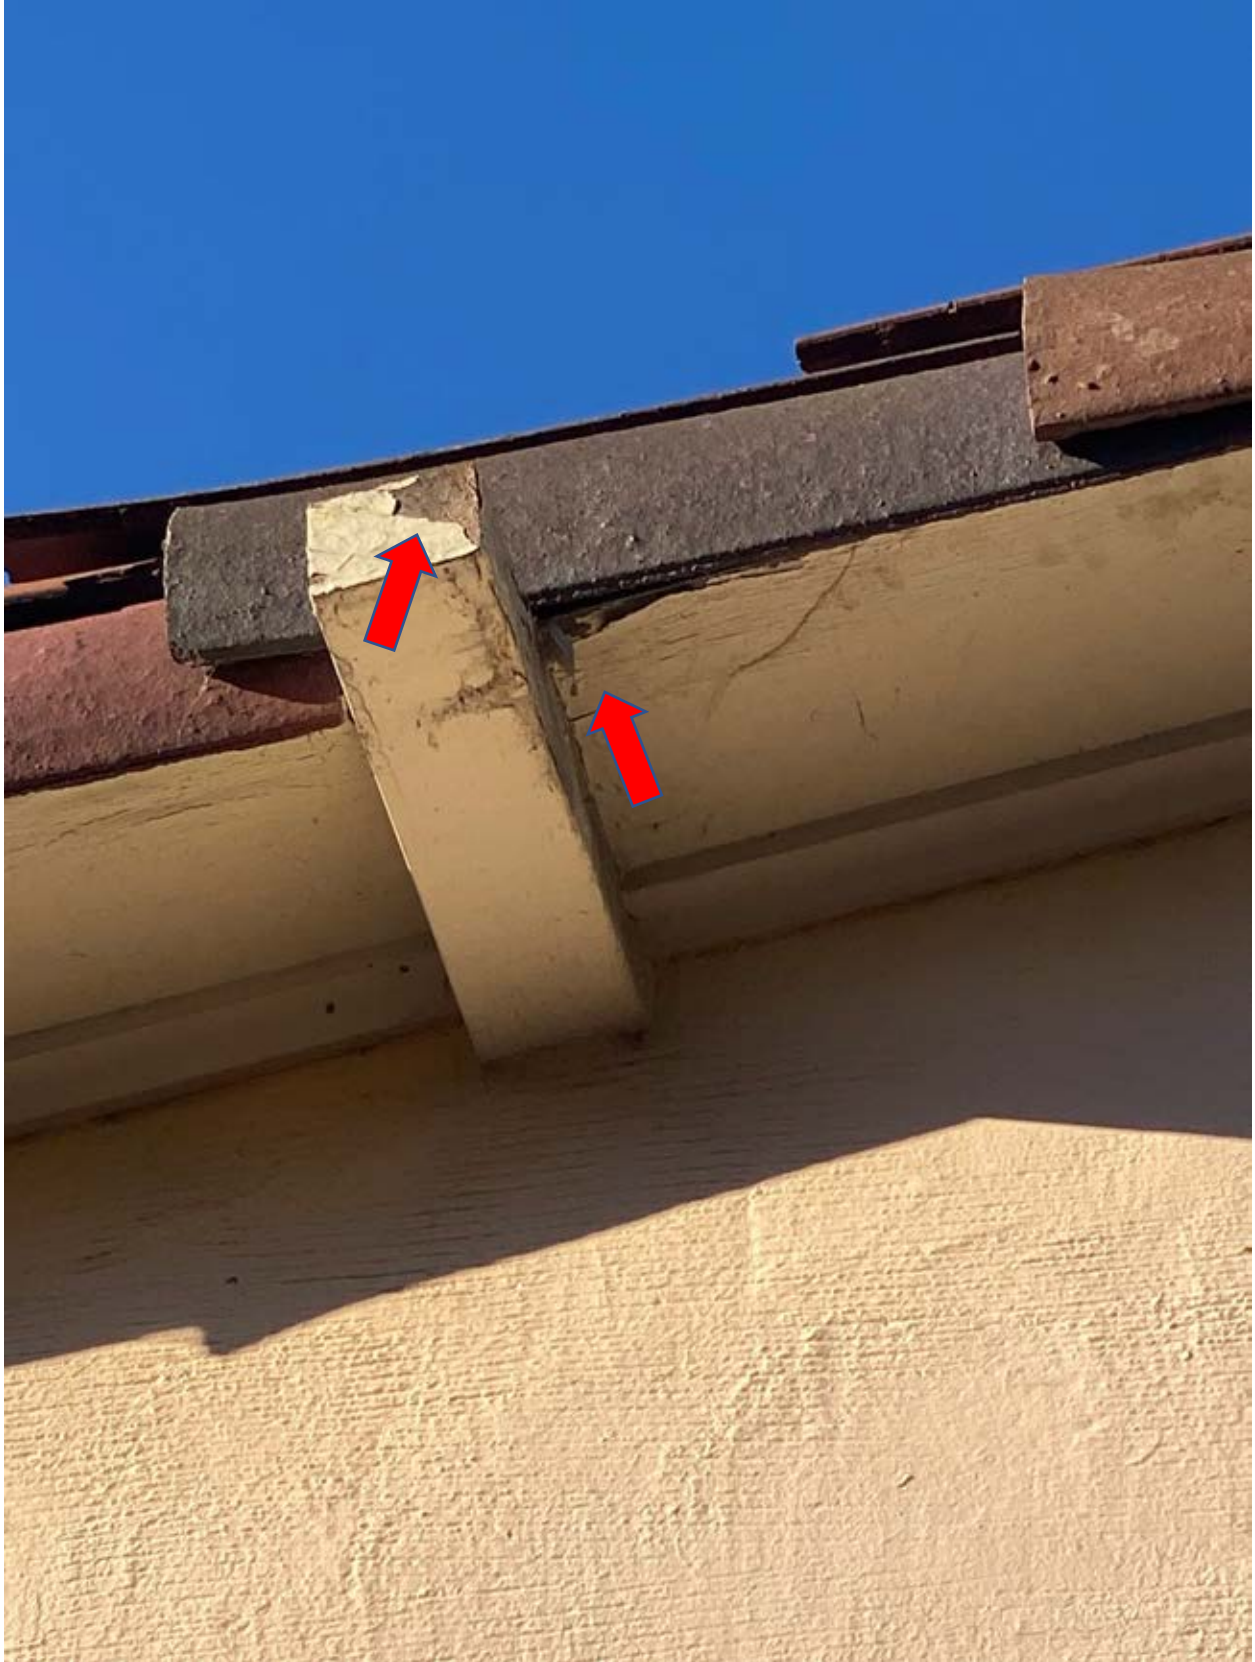
WORK ITEM: #1, #2, #3

(Roofline dry rot on multiple bungalows)

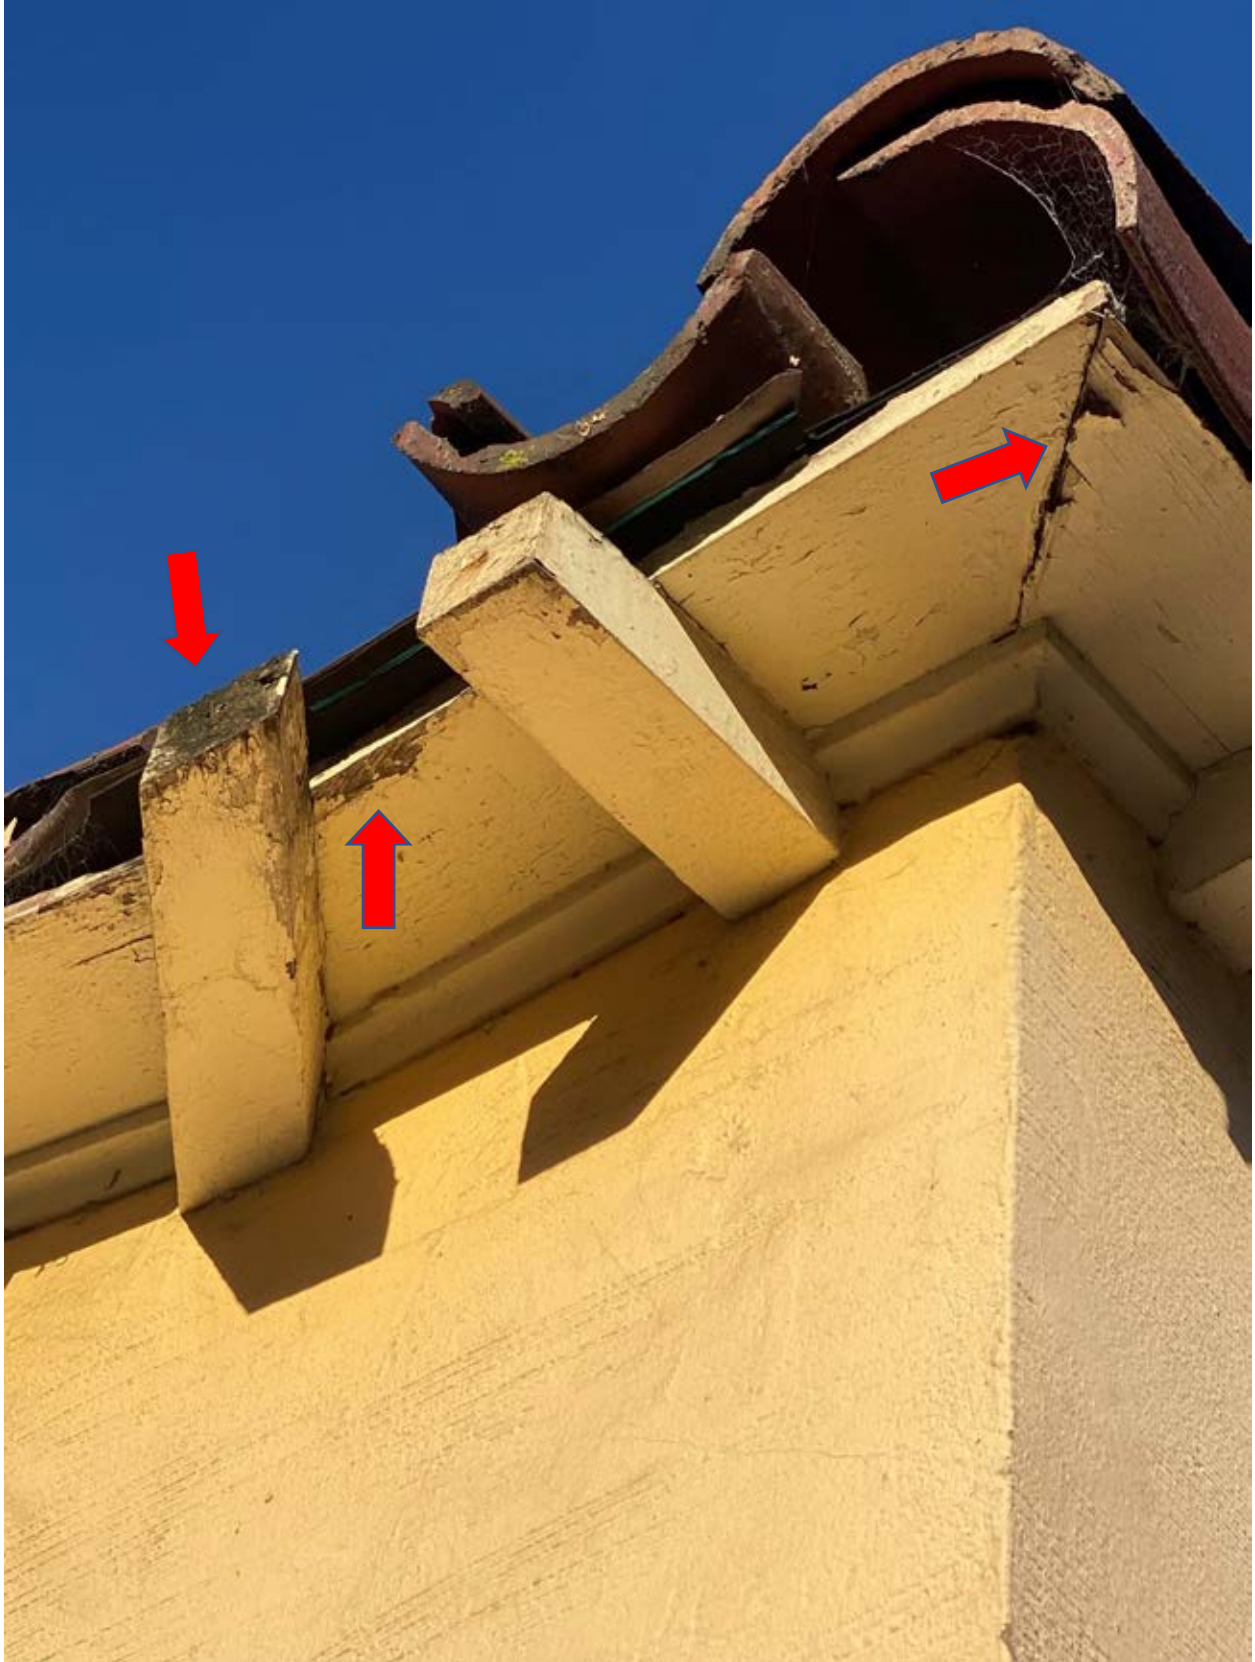
WORK ITEM: #1, #2, #3

(Additional roofline dry rot)

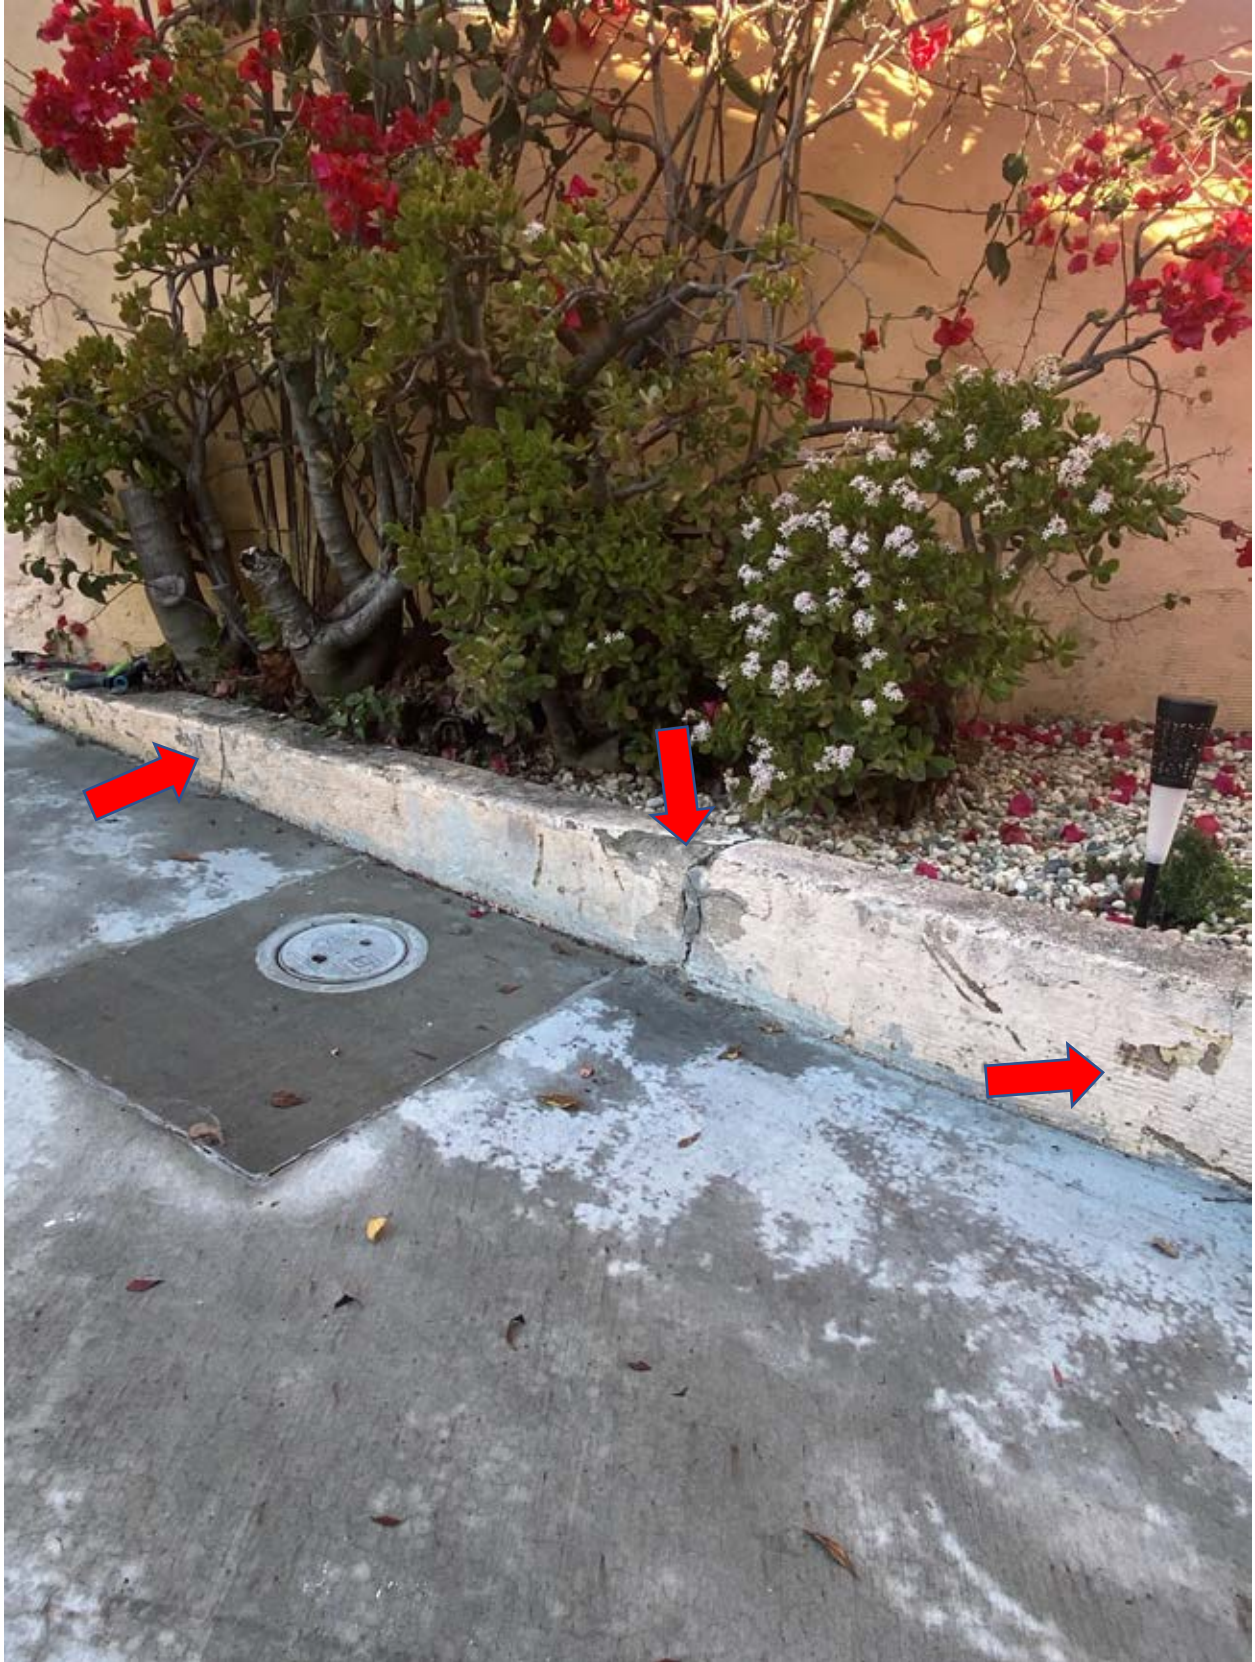
WORK ITEM: #6

(Driveway retaining wall cracking, settling, stucco damage. Needs repair/replacement)
