WORK PROGRAM 295 MACARTHUR BLVD, OAKLAND

Exterior Details and Work Program Summary:

RE: Structural Observation
295 MacArthur Blvd
Oakland, CA 94610

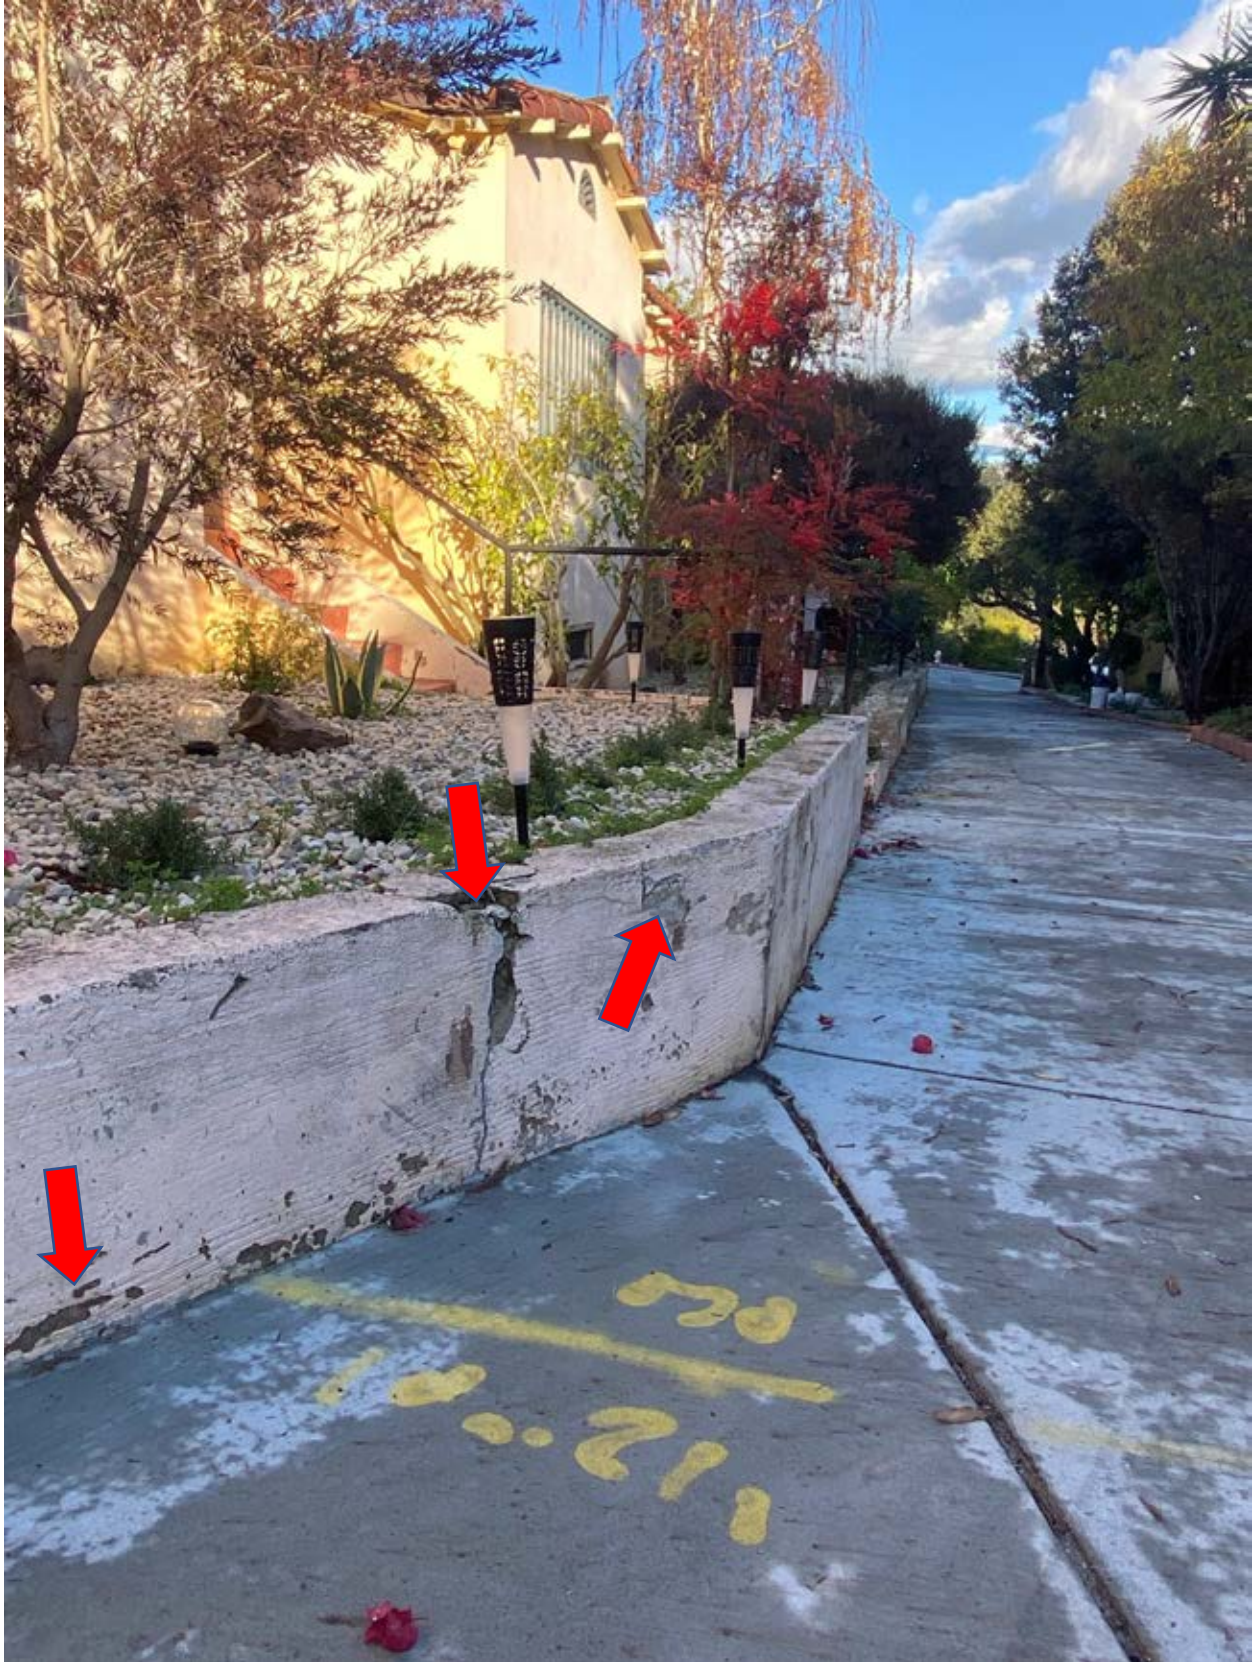
WORK ITEM: #6

(Additional driveway retaining wall damage)

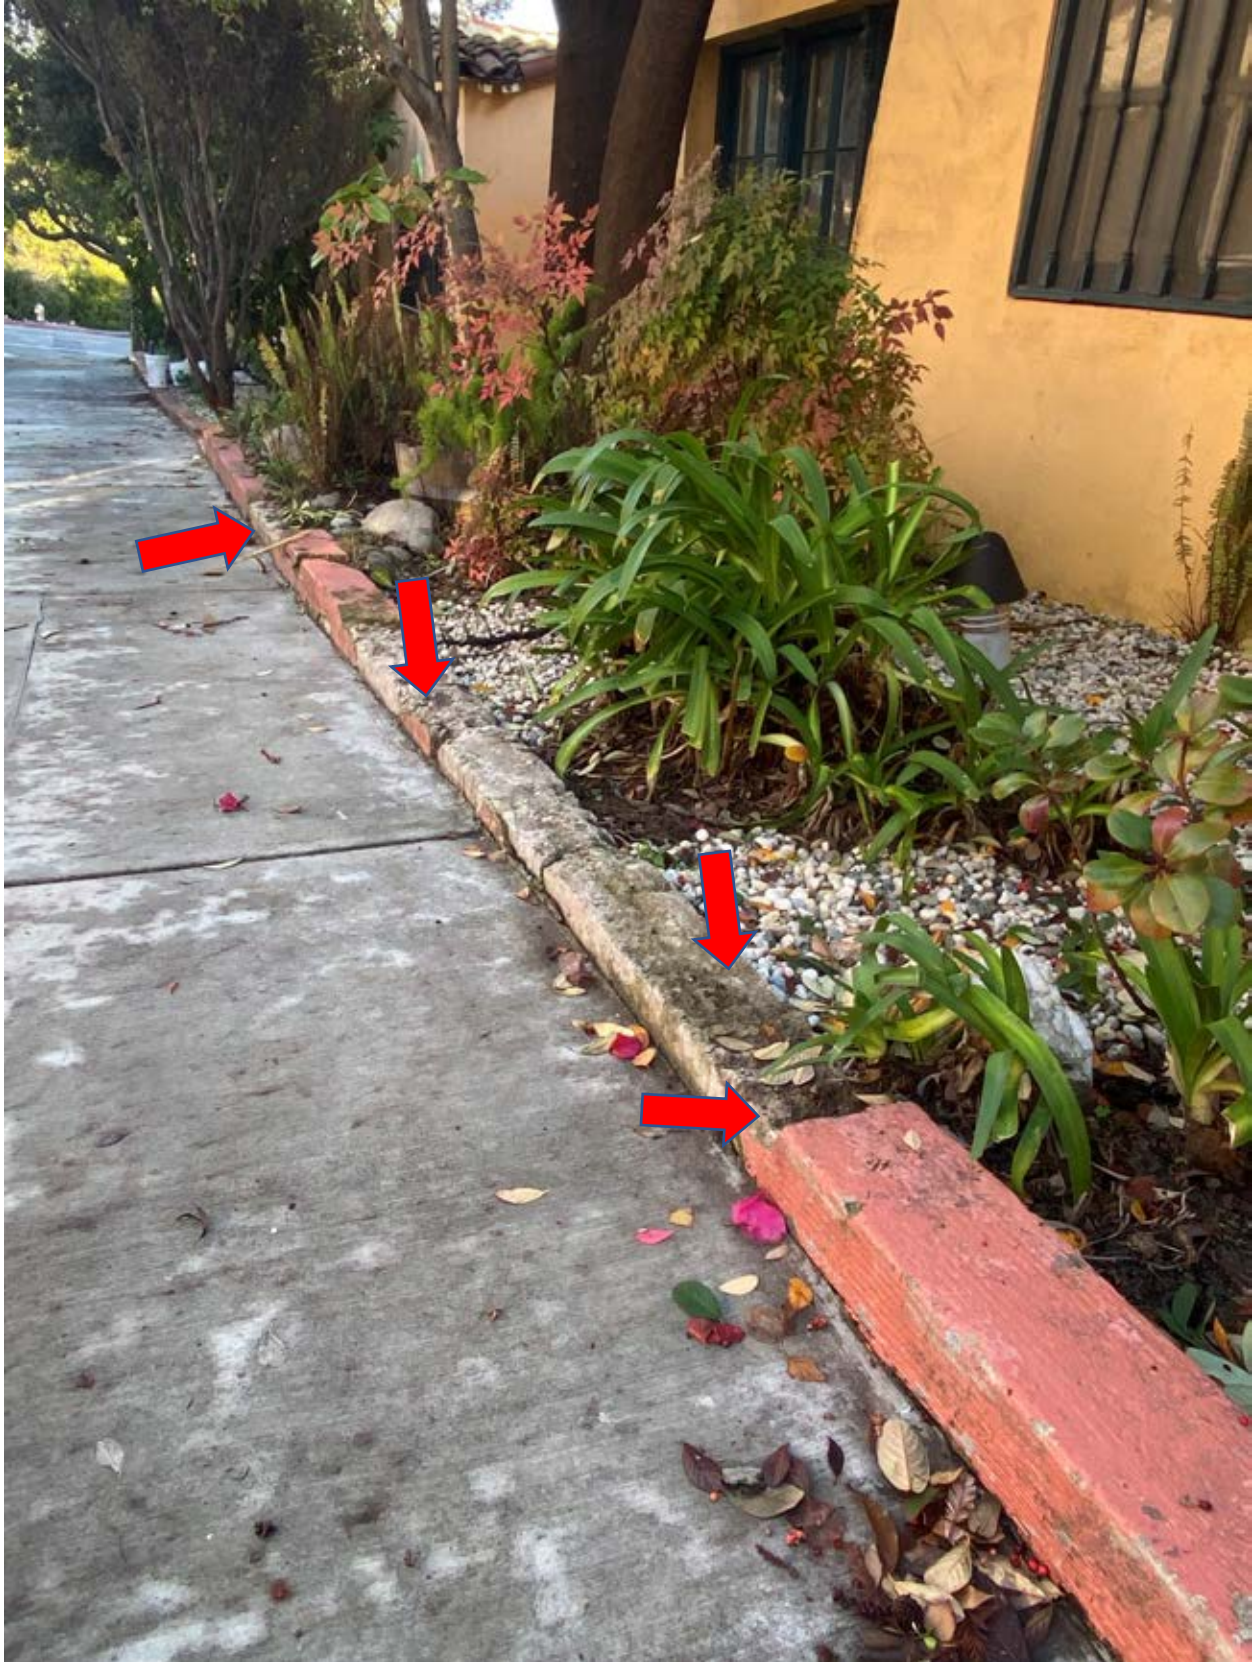
WORK ITEM: #4, #5

(Driveway landscaping wall damage. Broken pieces and concrete damage)

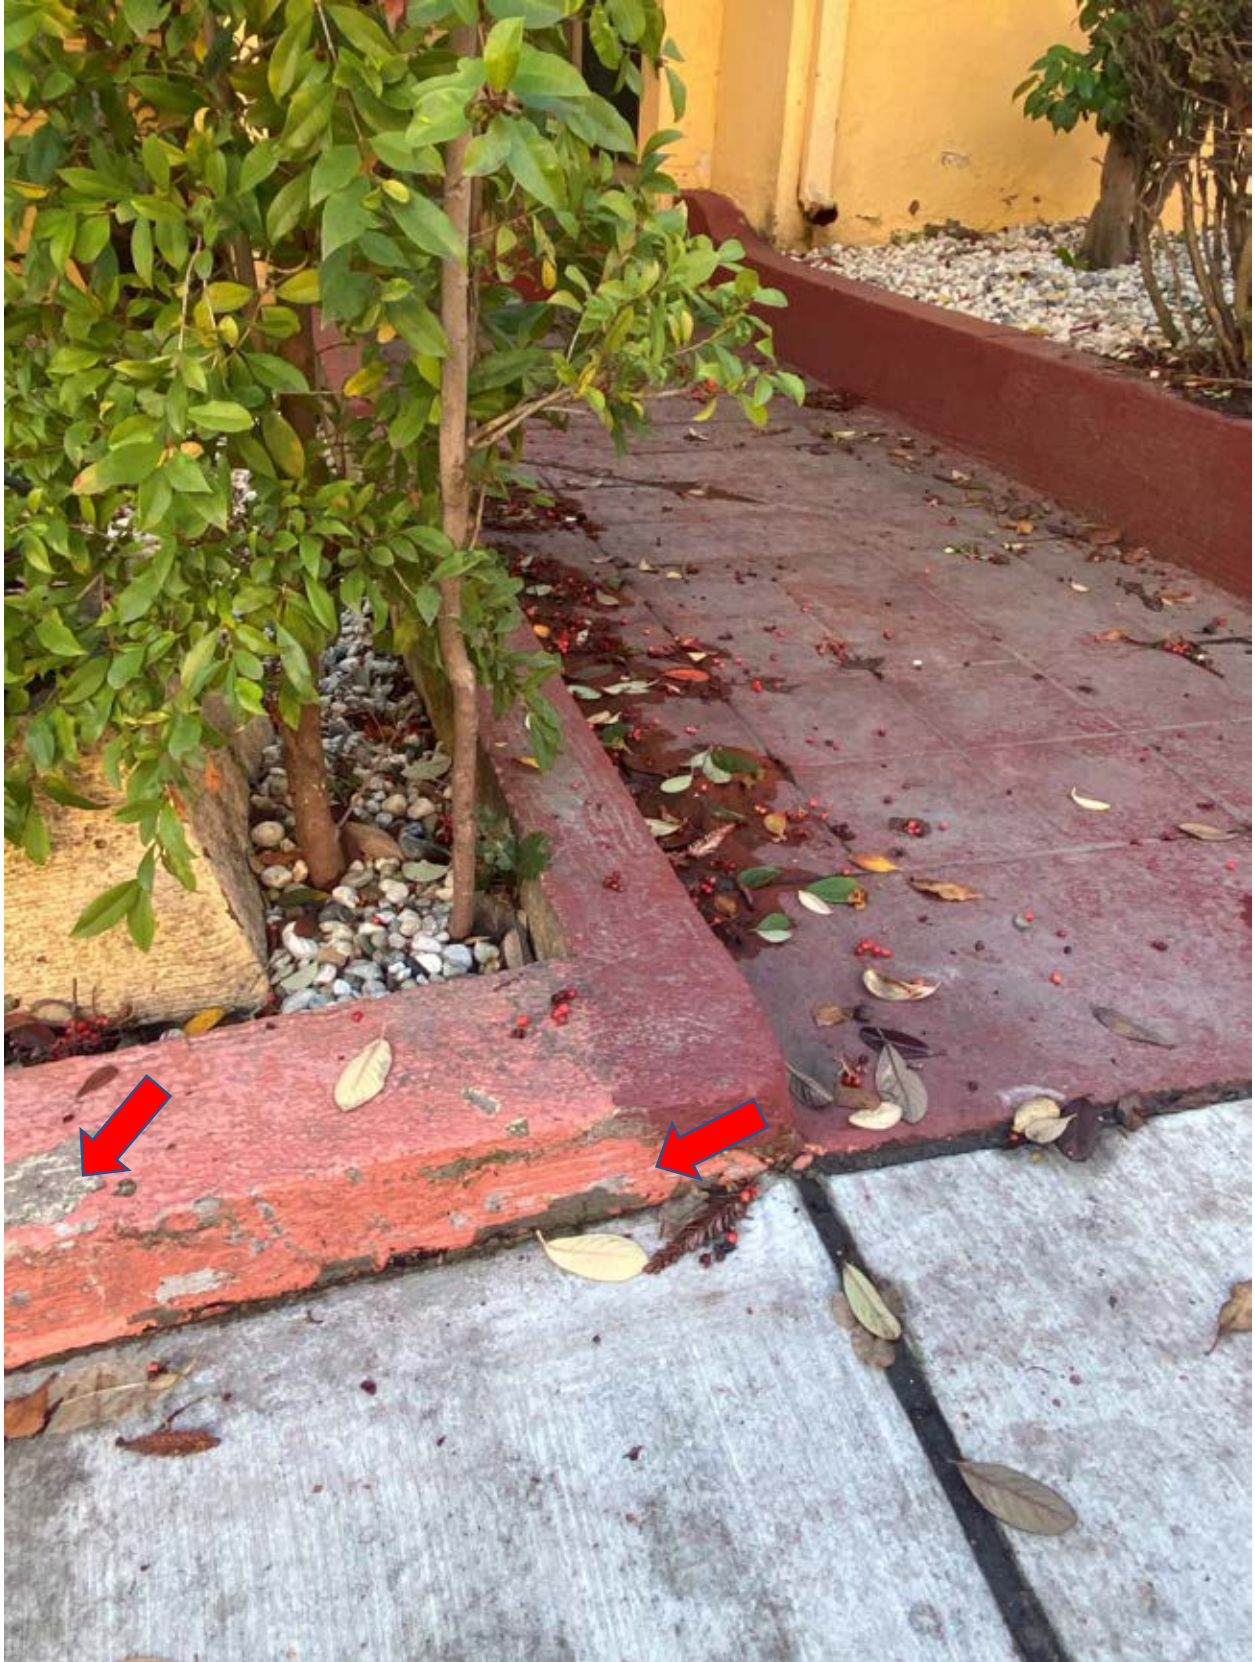
WORK ITEM: #4, #5

(Concrete damage and paint mismatch on bungalow walkways)

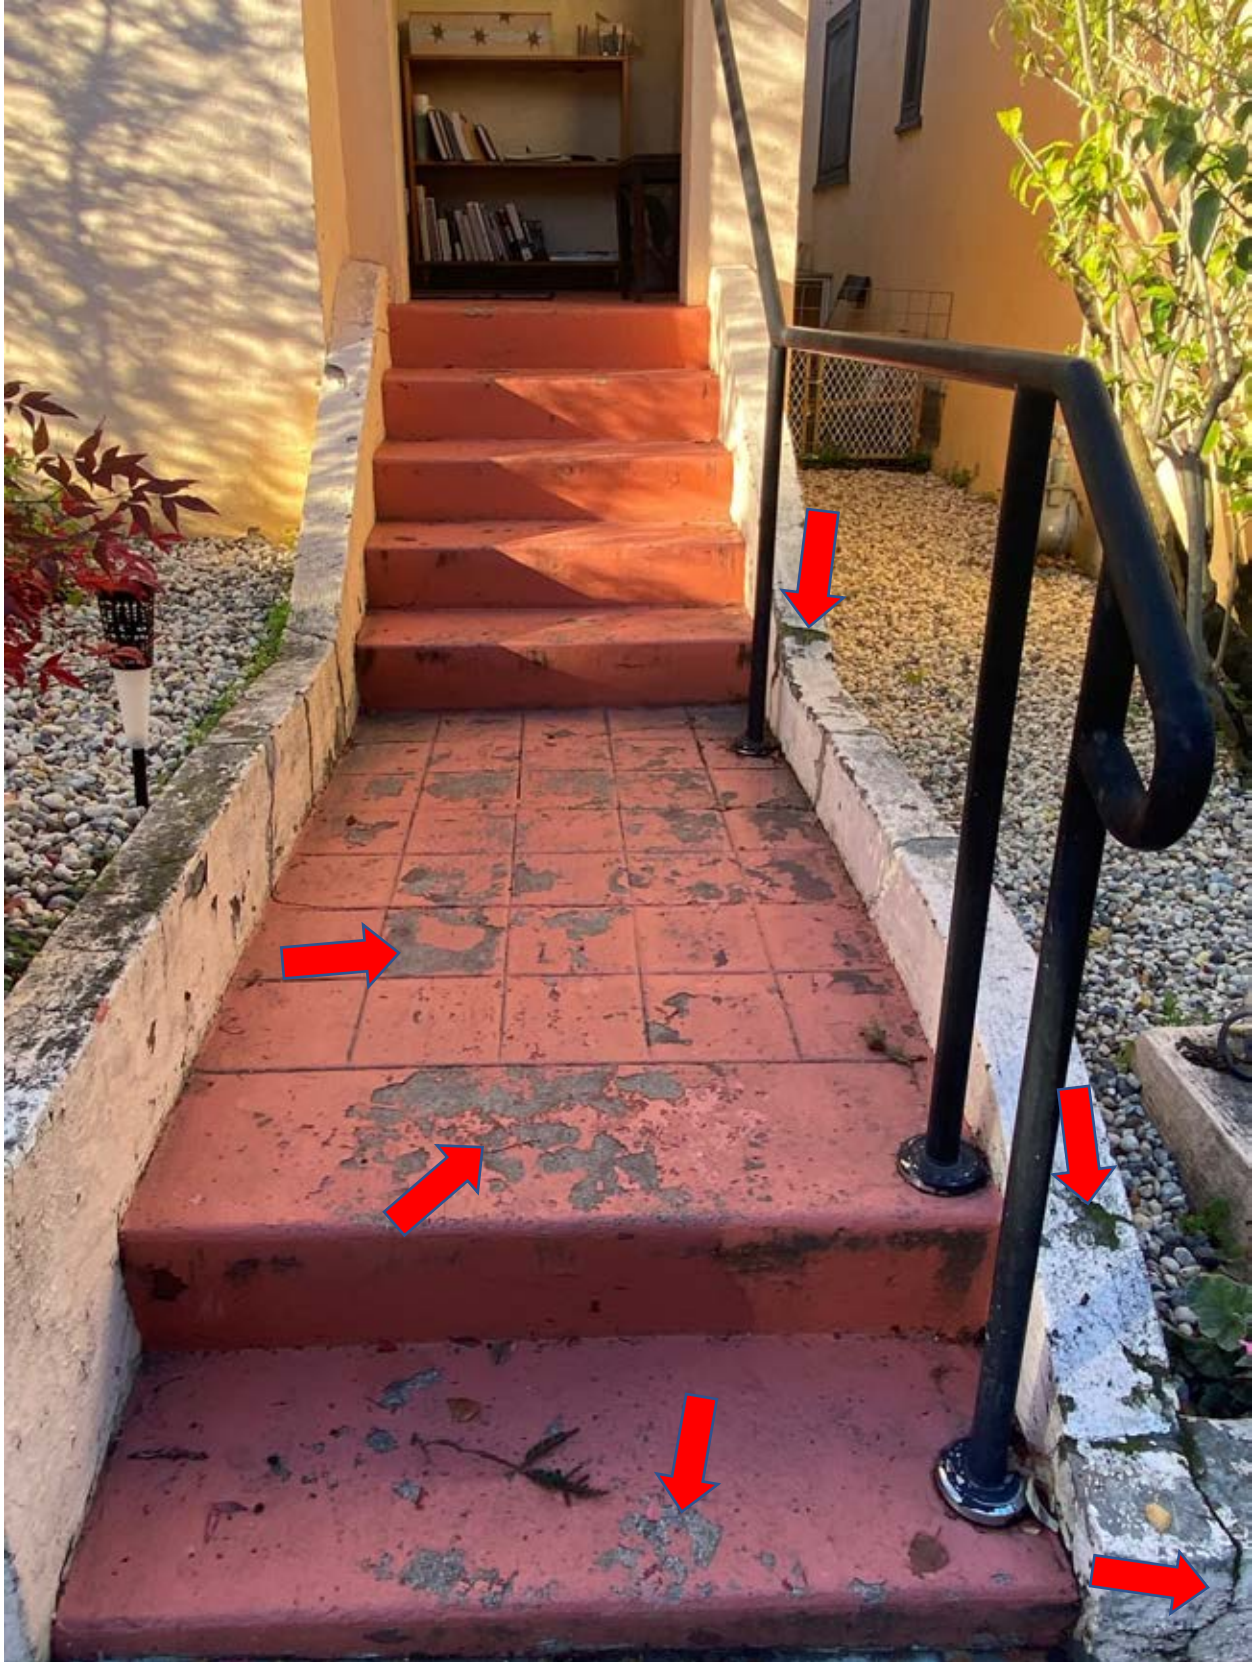
WORK ITEM: #4, #5

(Paint peeling and damage on bungalow walkway. Stucco cracking and damage on retaining walls)

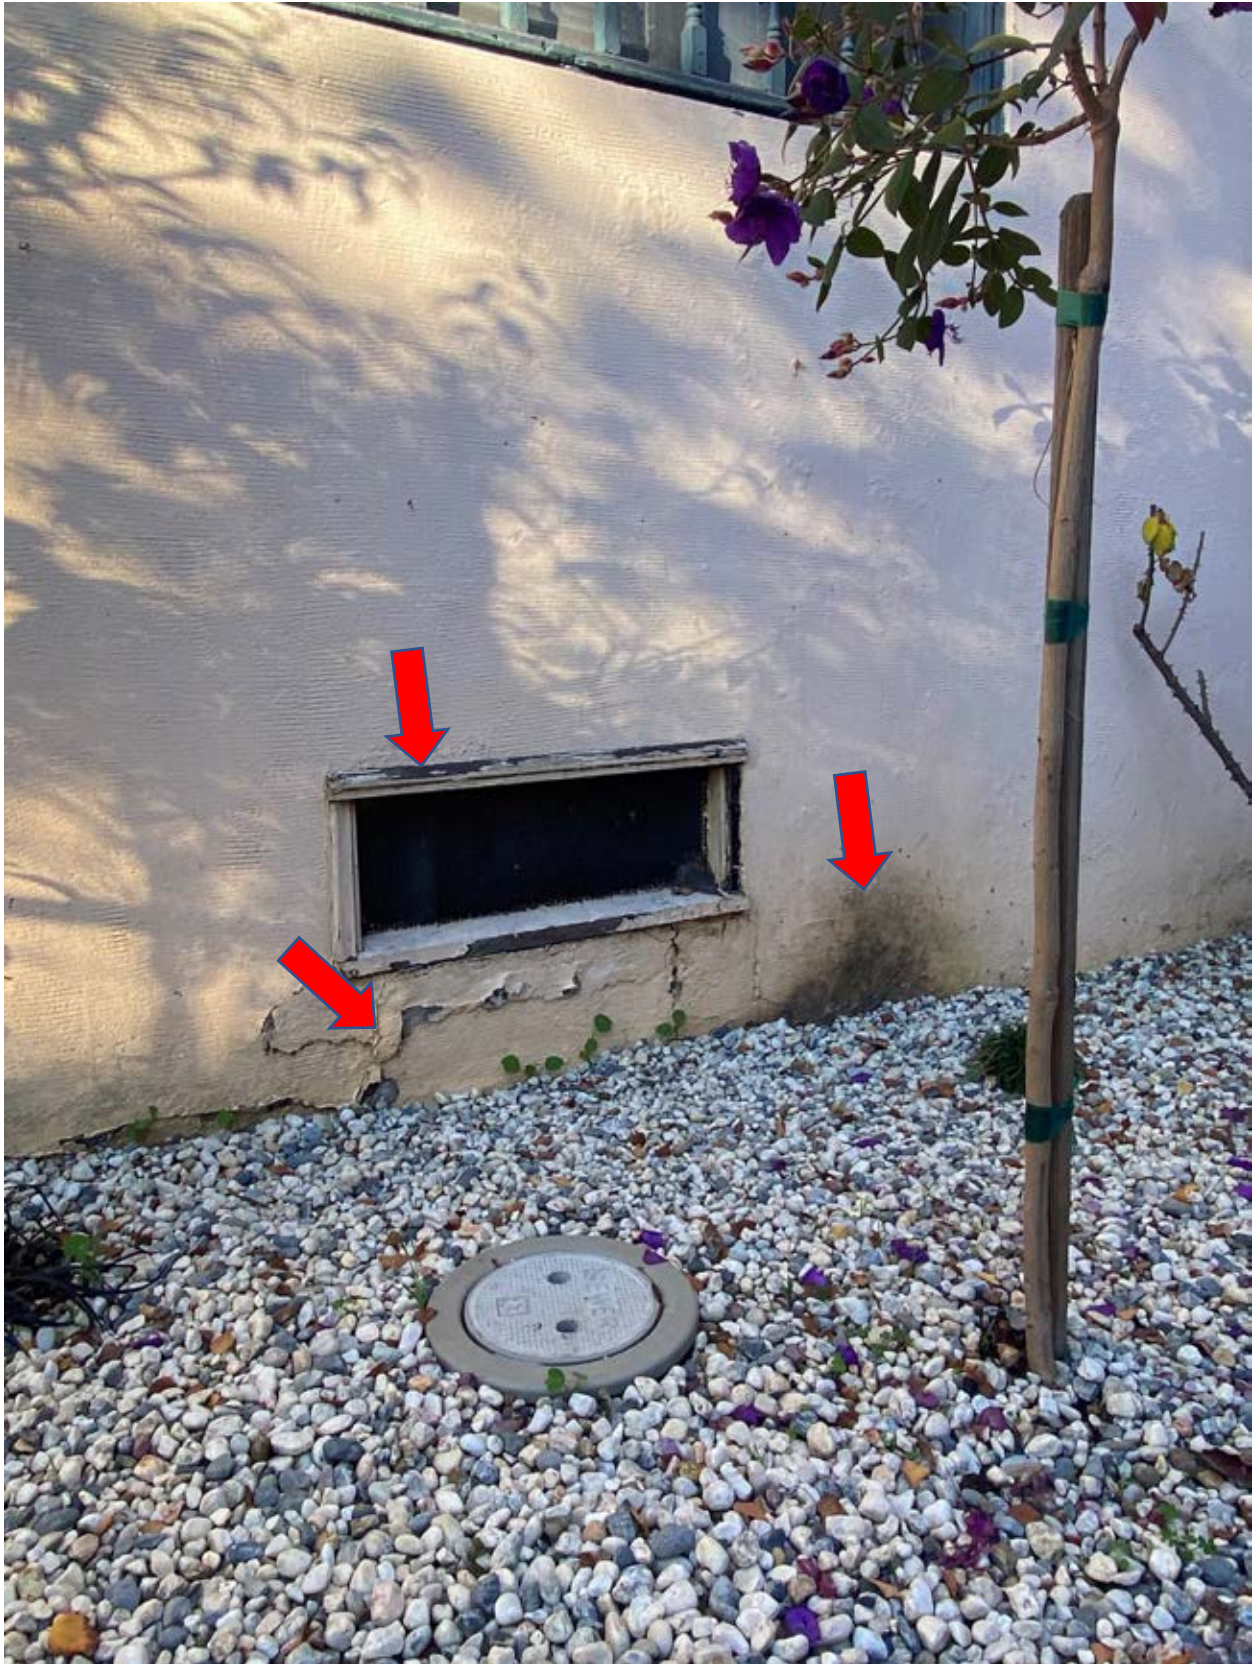
WORK ITEM: #1, #2, #3

(Dry rot and stucco damage)

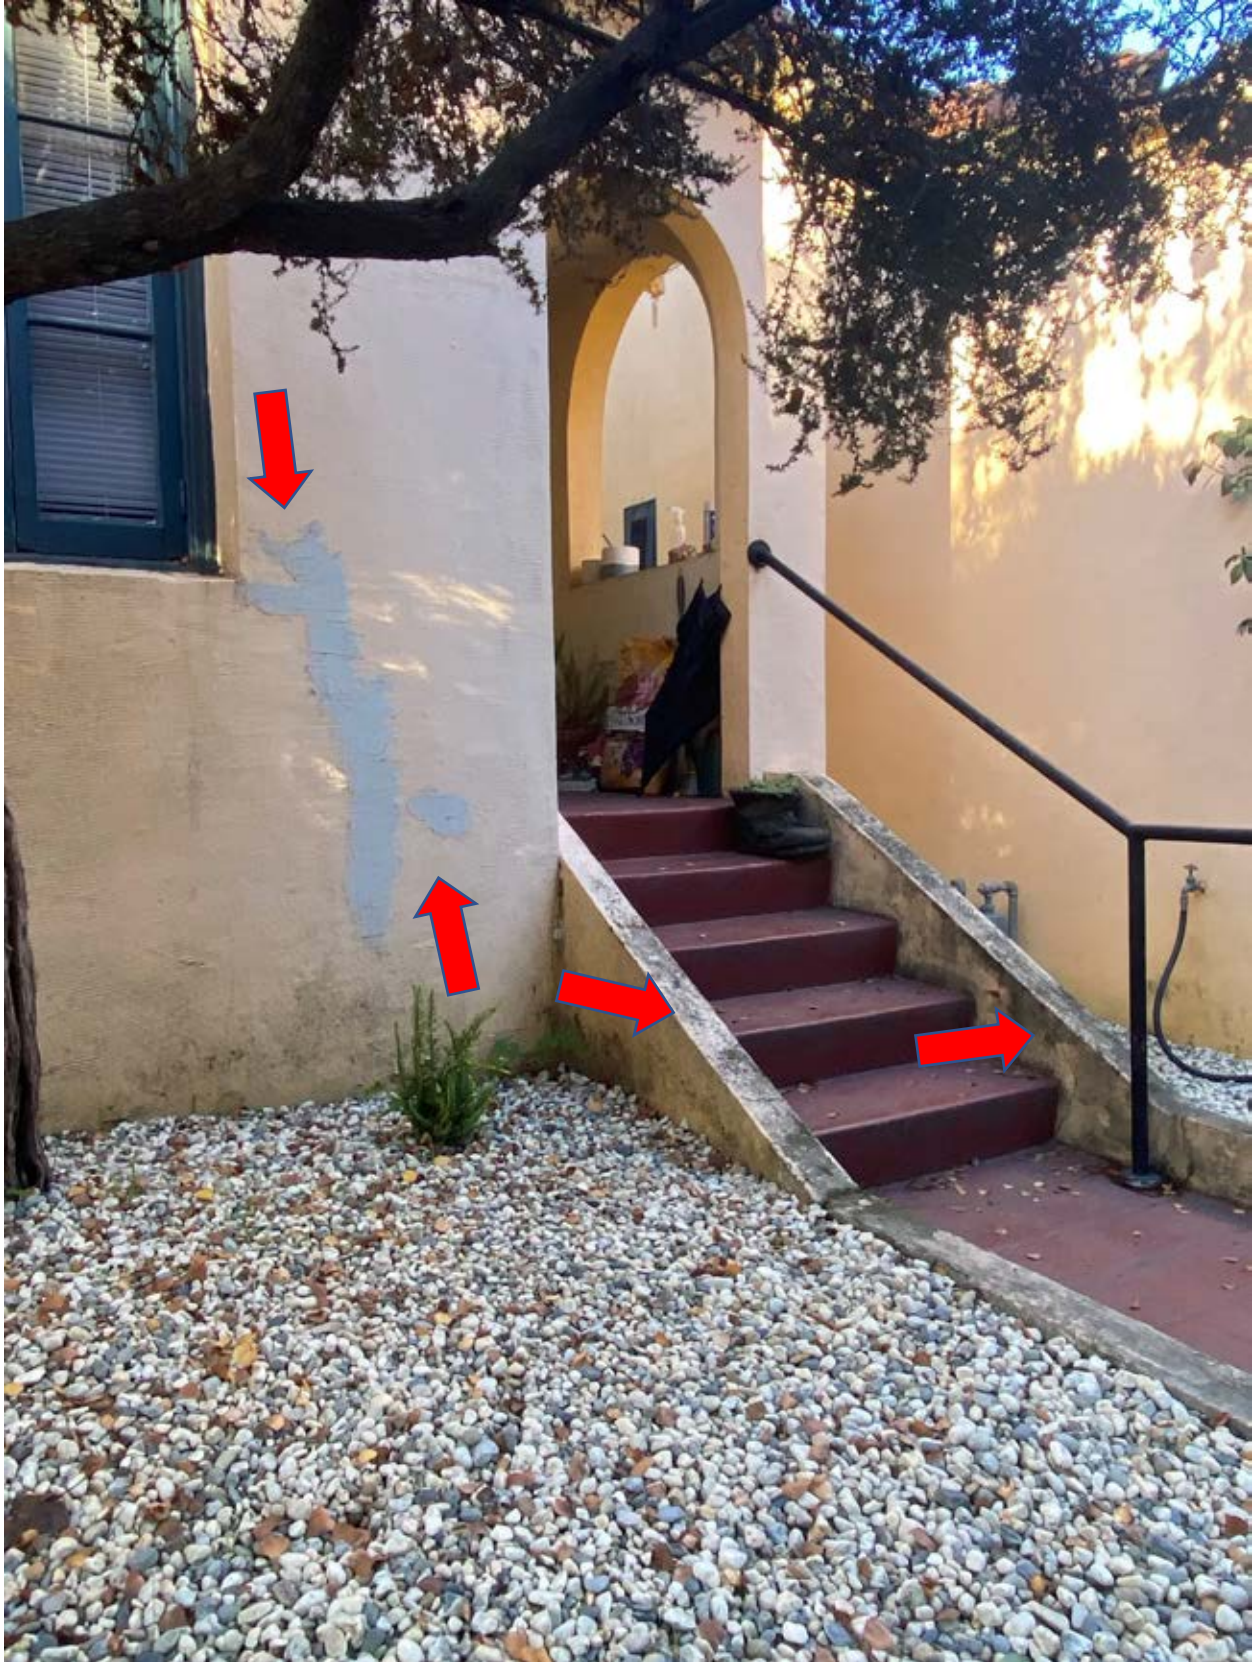
WORK ITEM: #4, #5

(Improper repairs to prior stucco damage. Retaining wall restoration needed)

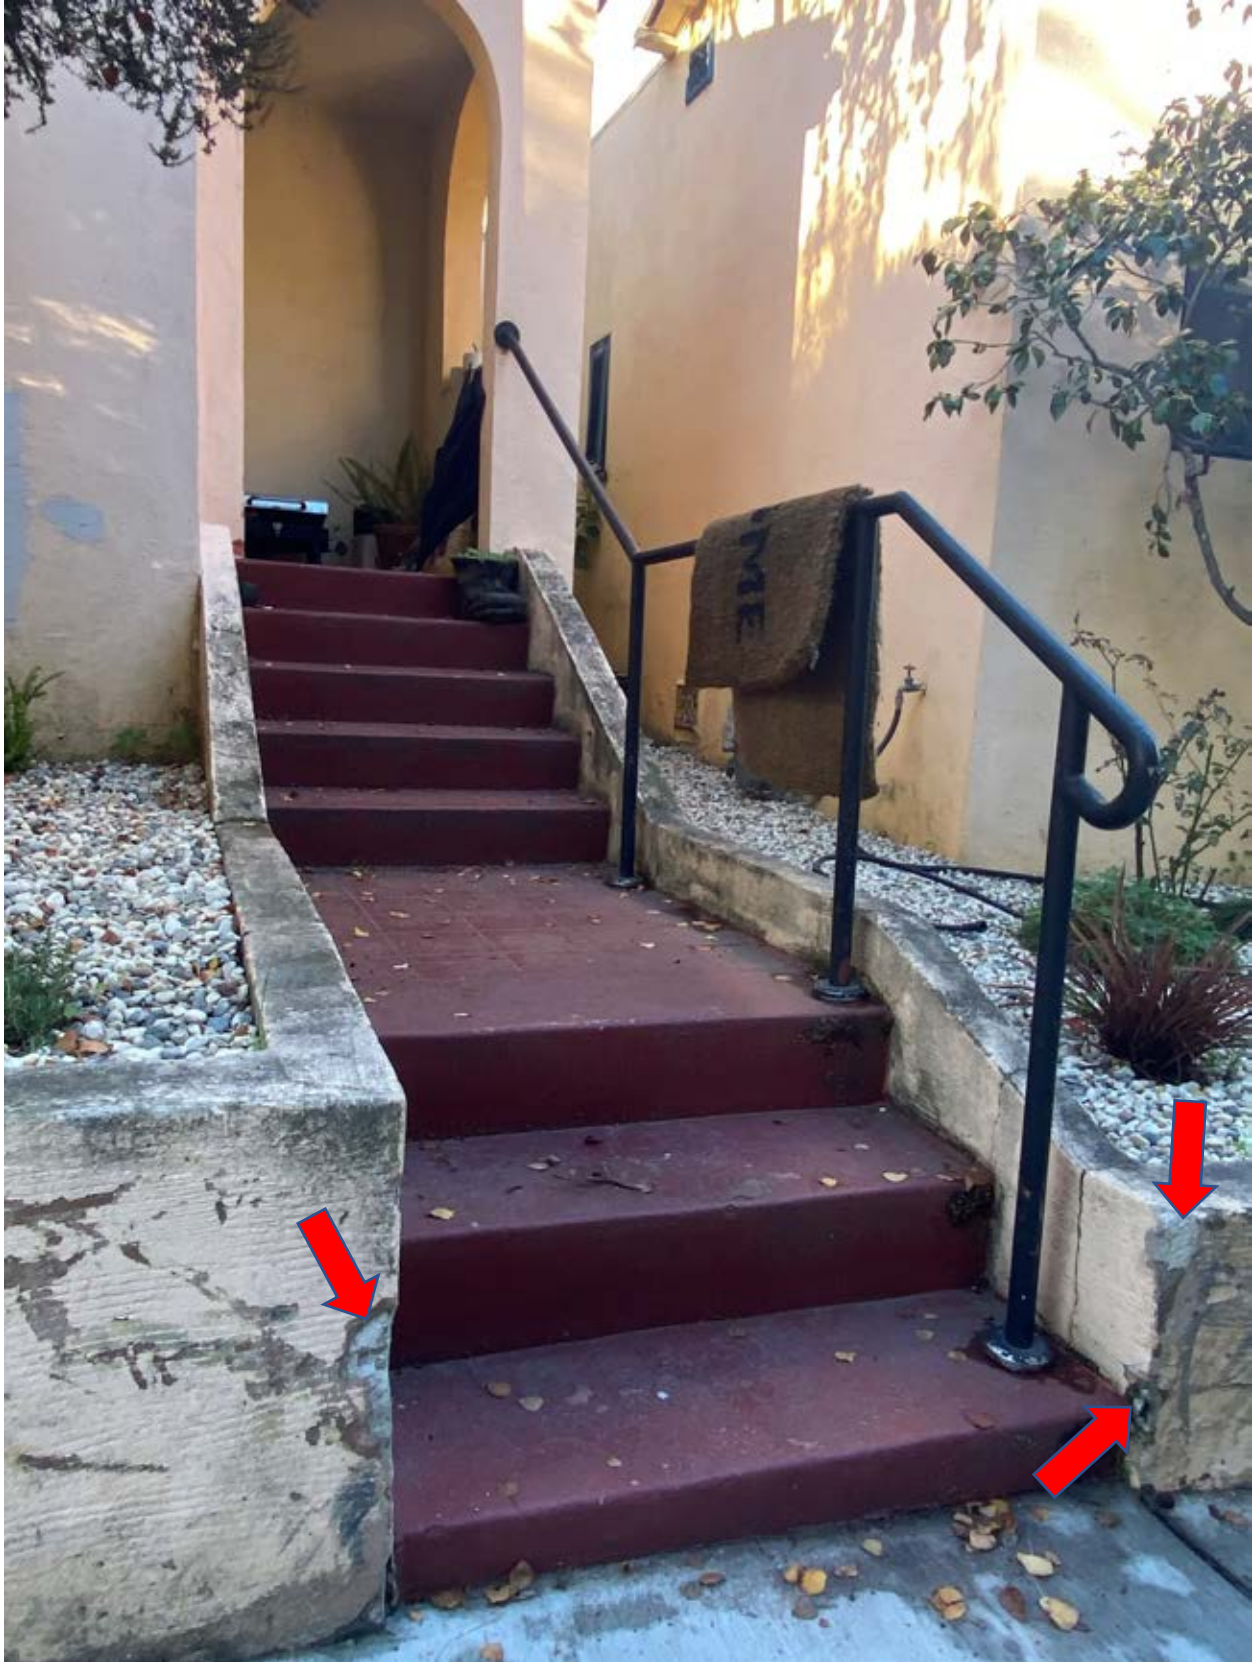
WORK ITEM: #4, #5

(Damage and cracking on bungalow entrance way)

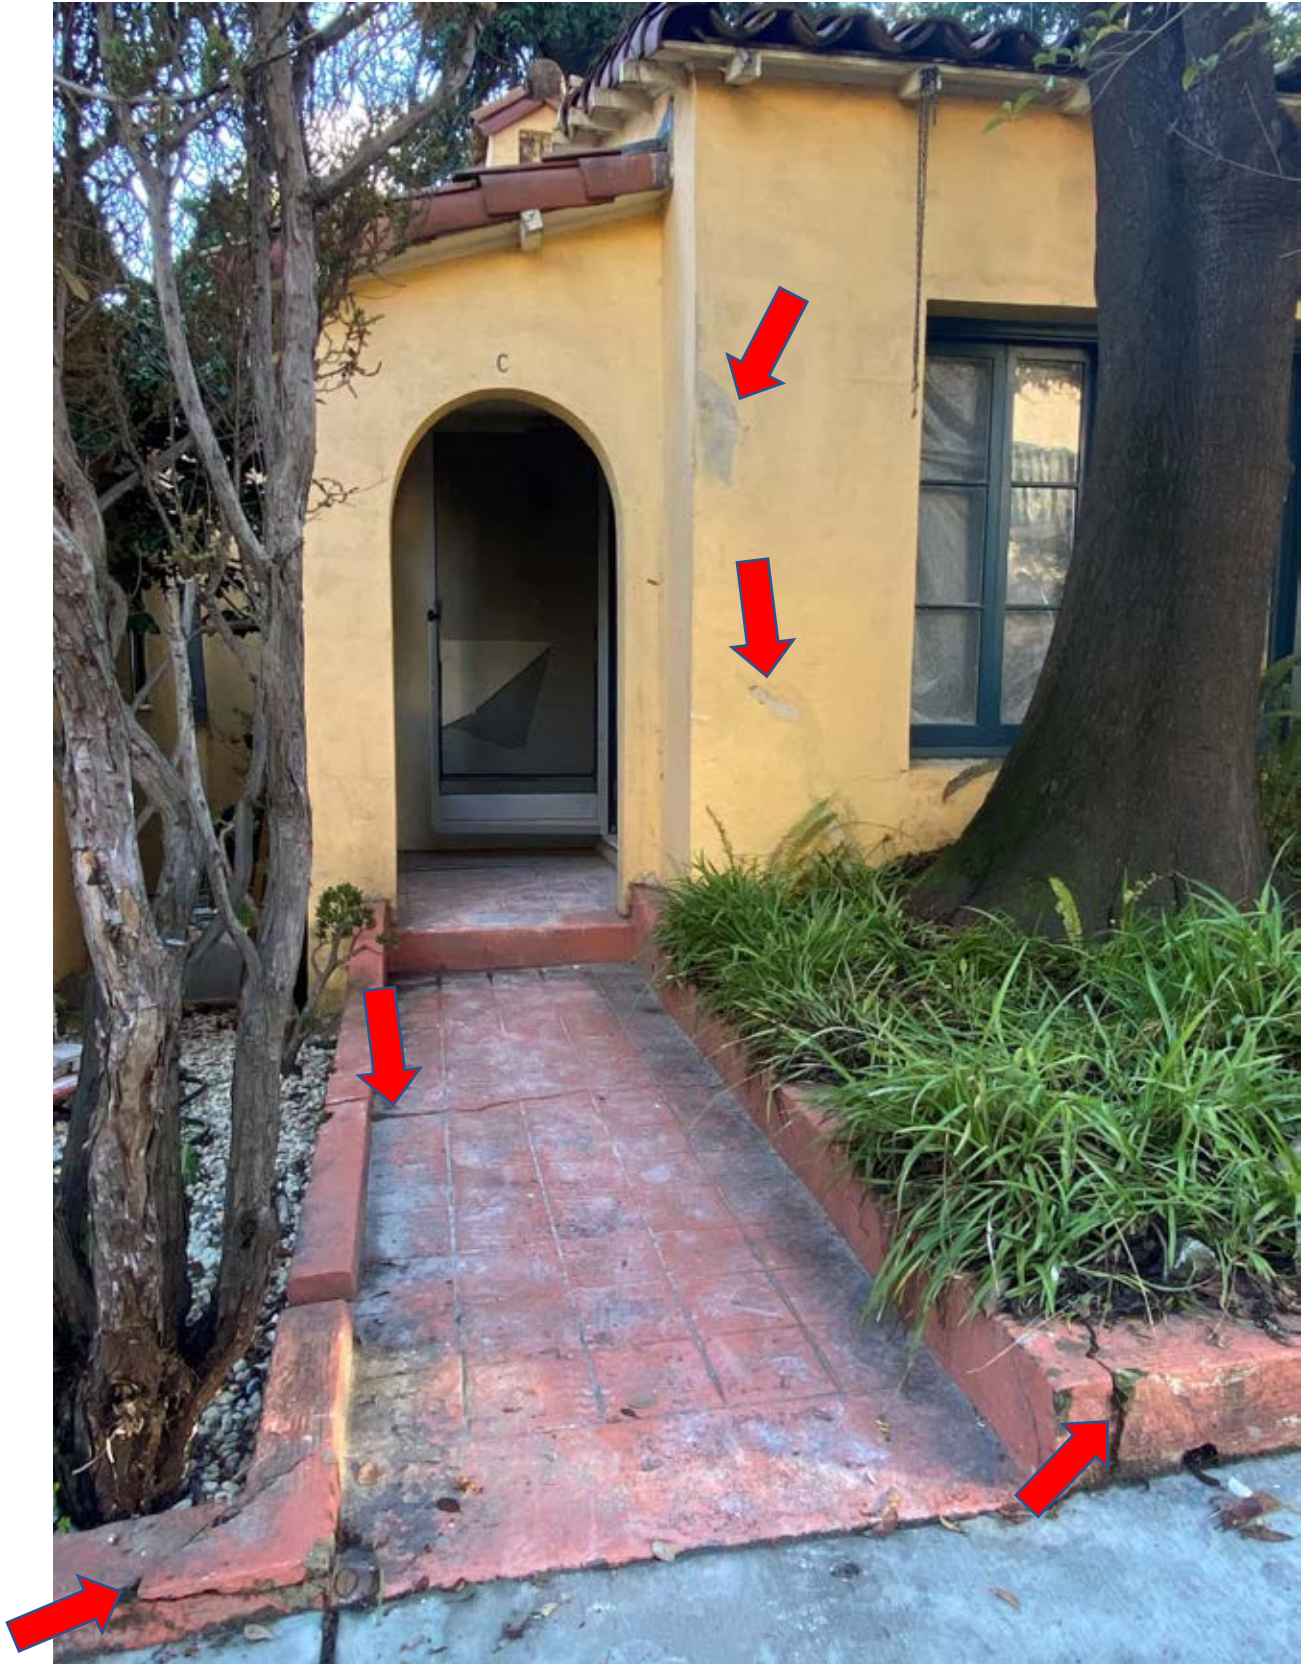
WORK ITEM: #4, #5

(Concrete damage on walkway entrance to bungalow)

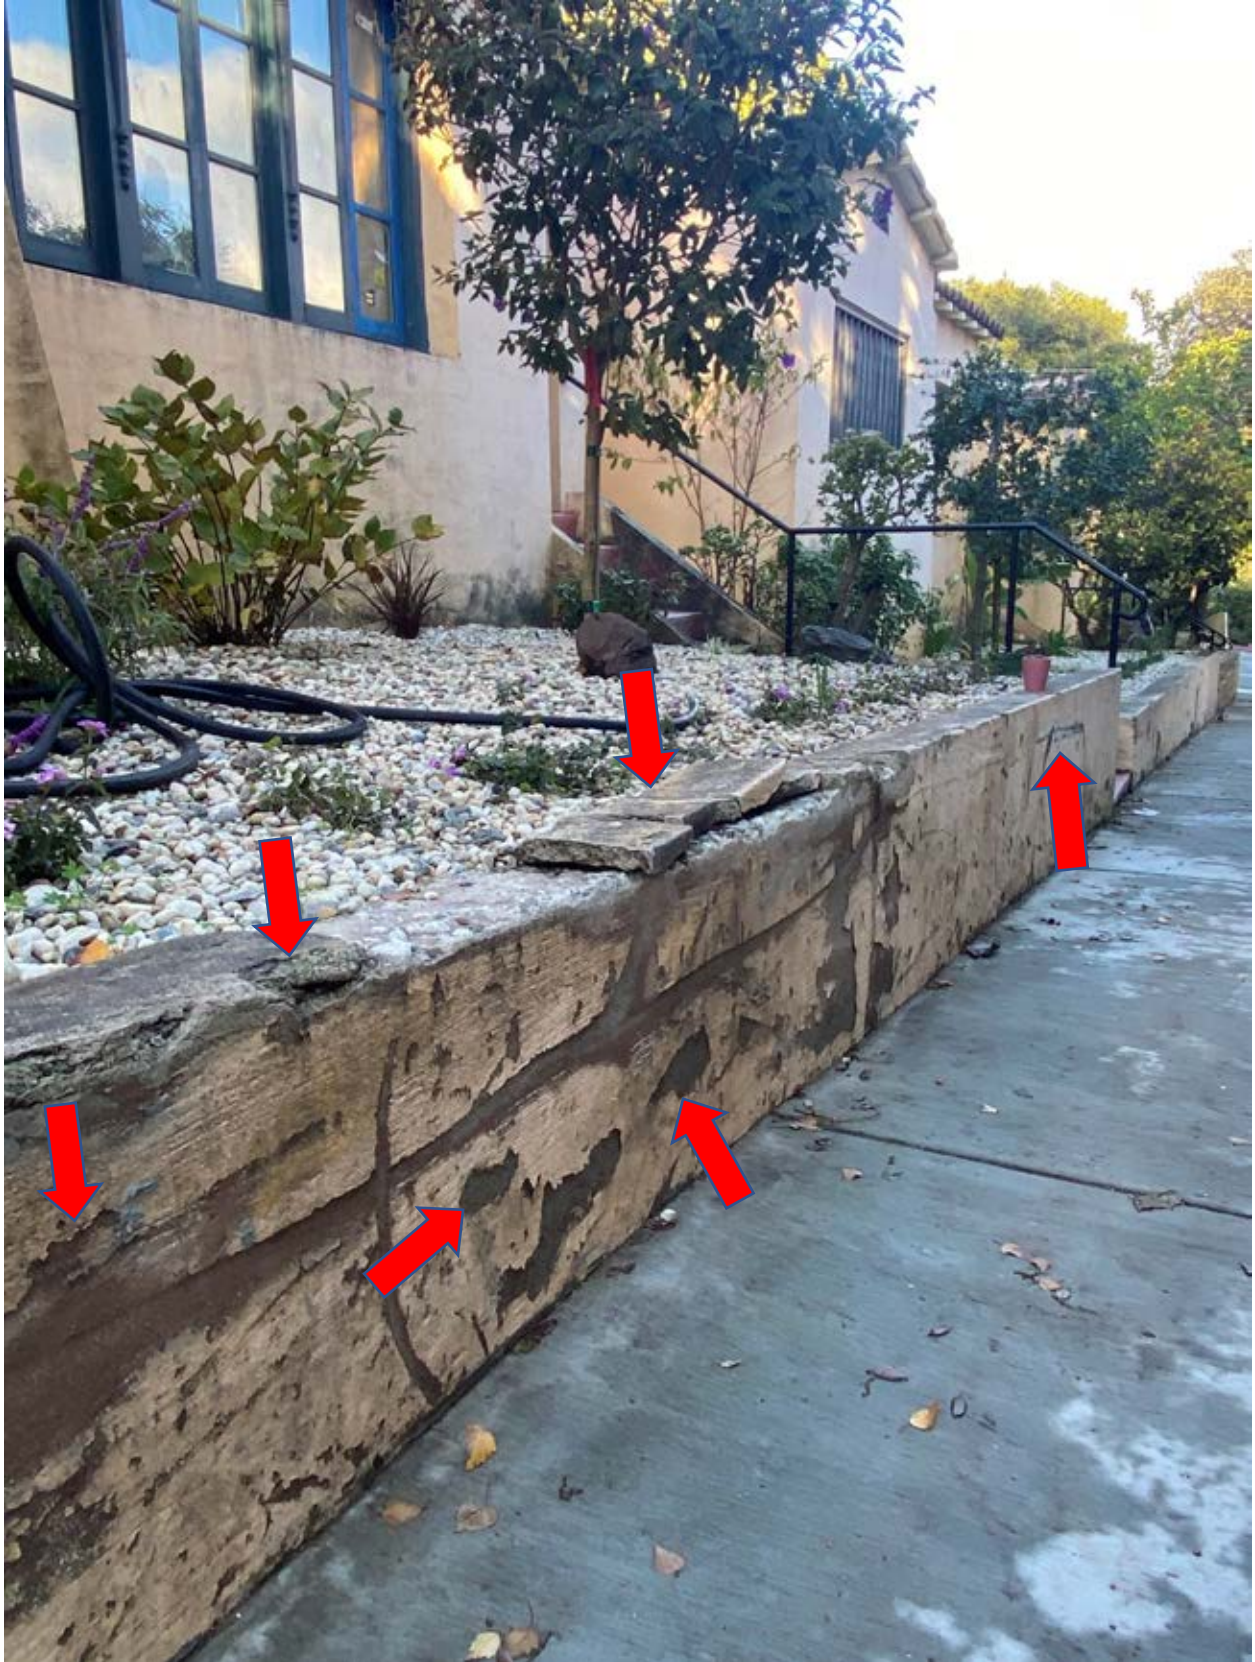
WORK ITEM: #6

(Major damage on portion of driveway retaining wall. Stucco damage and broken cement)

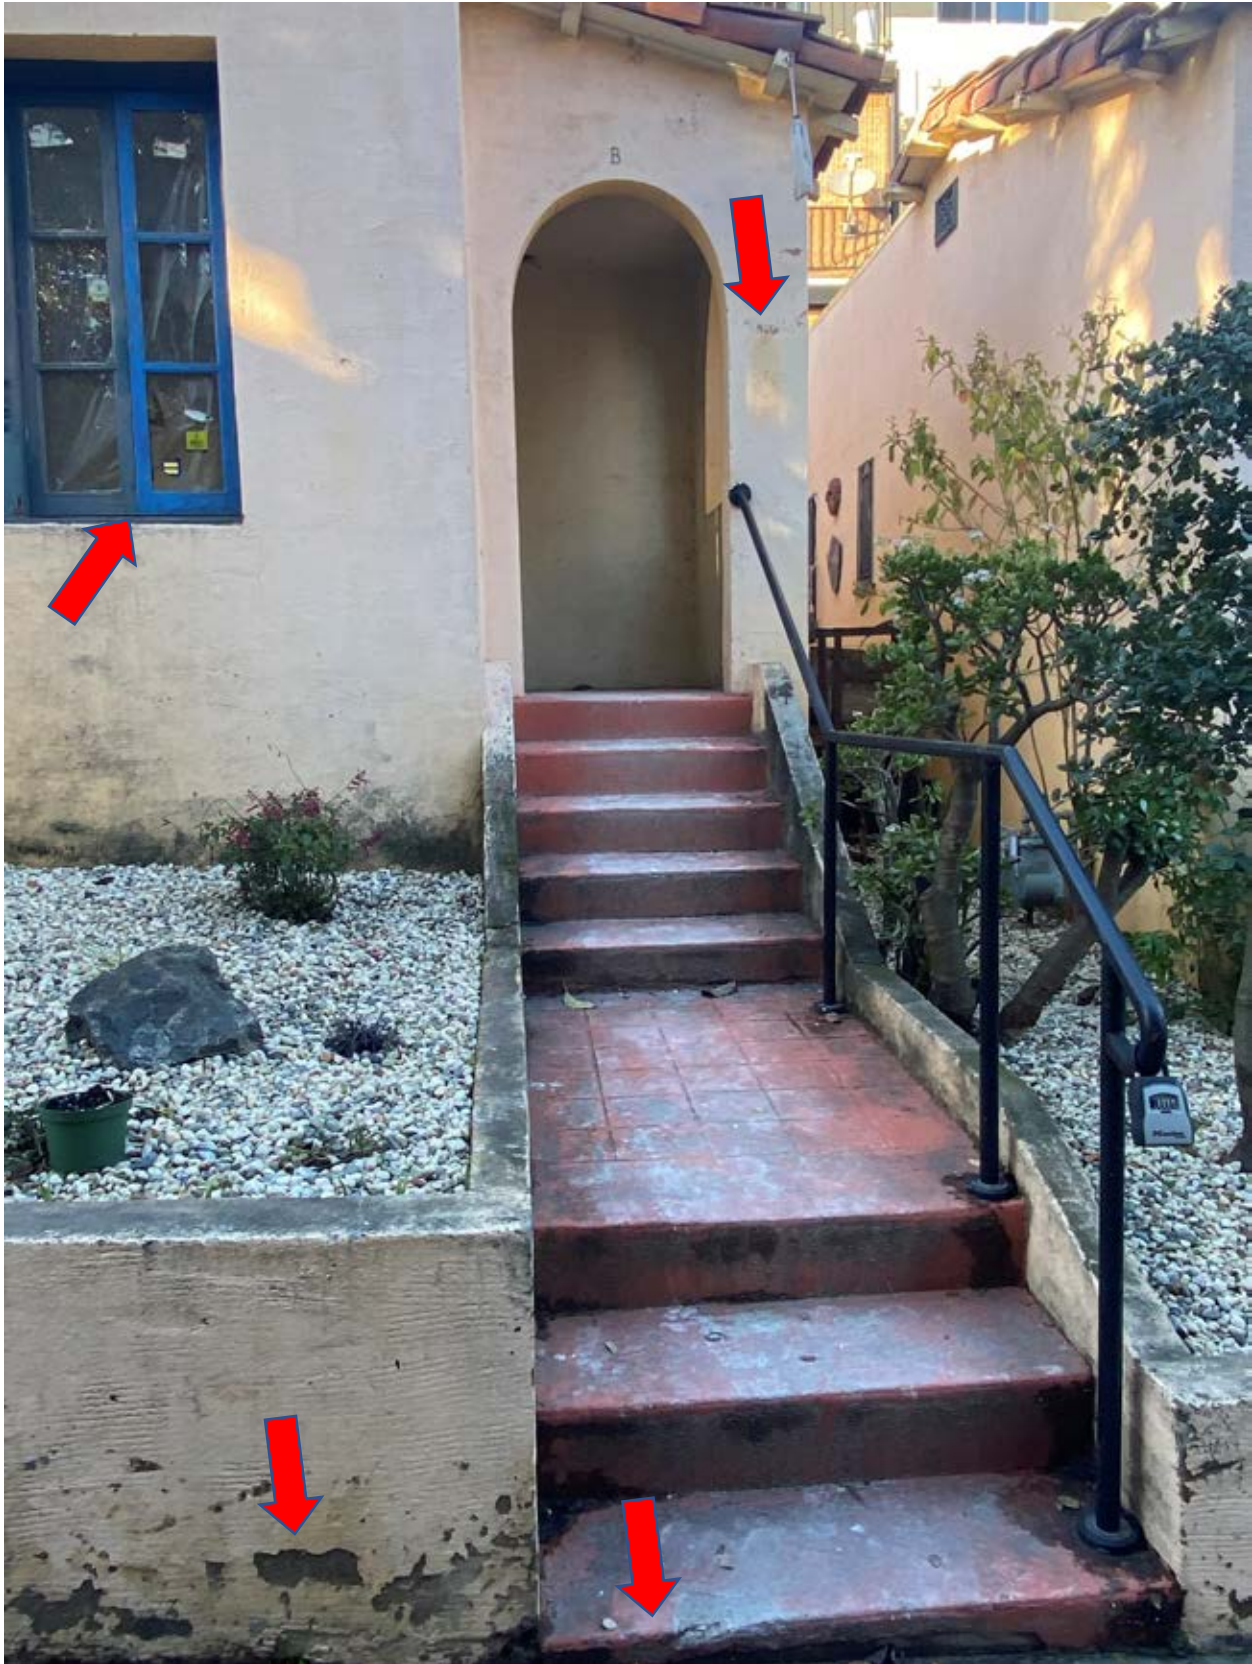
WORK ITEM: #4, #5

(Mismatch paint on windowsills, damage to stucco and concrete at bungalow entrance)

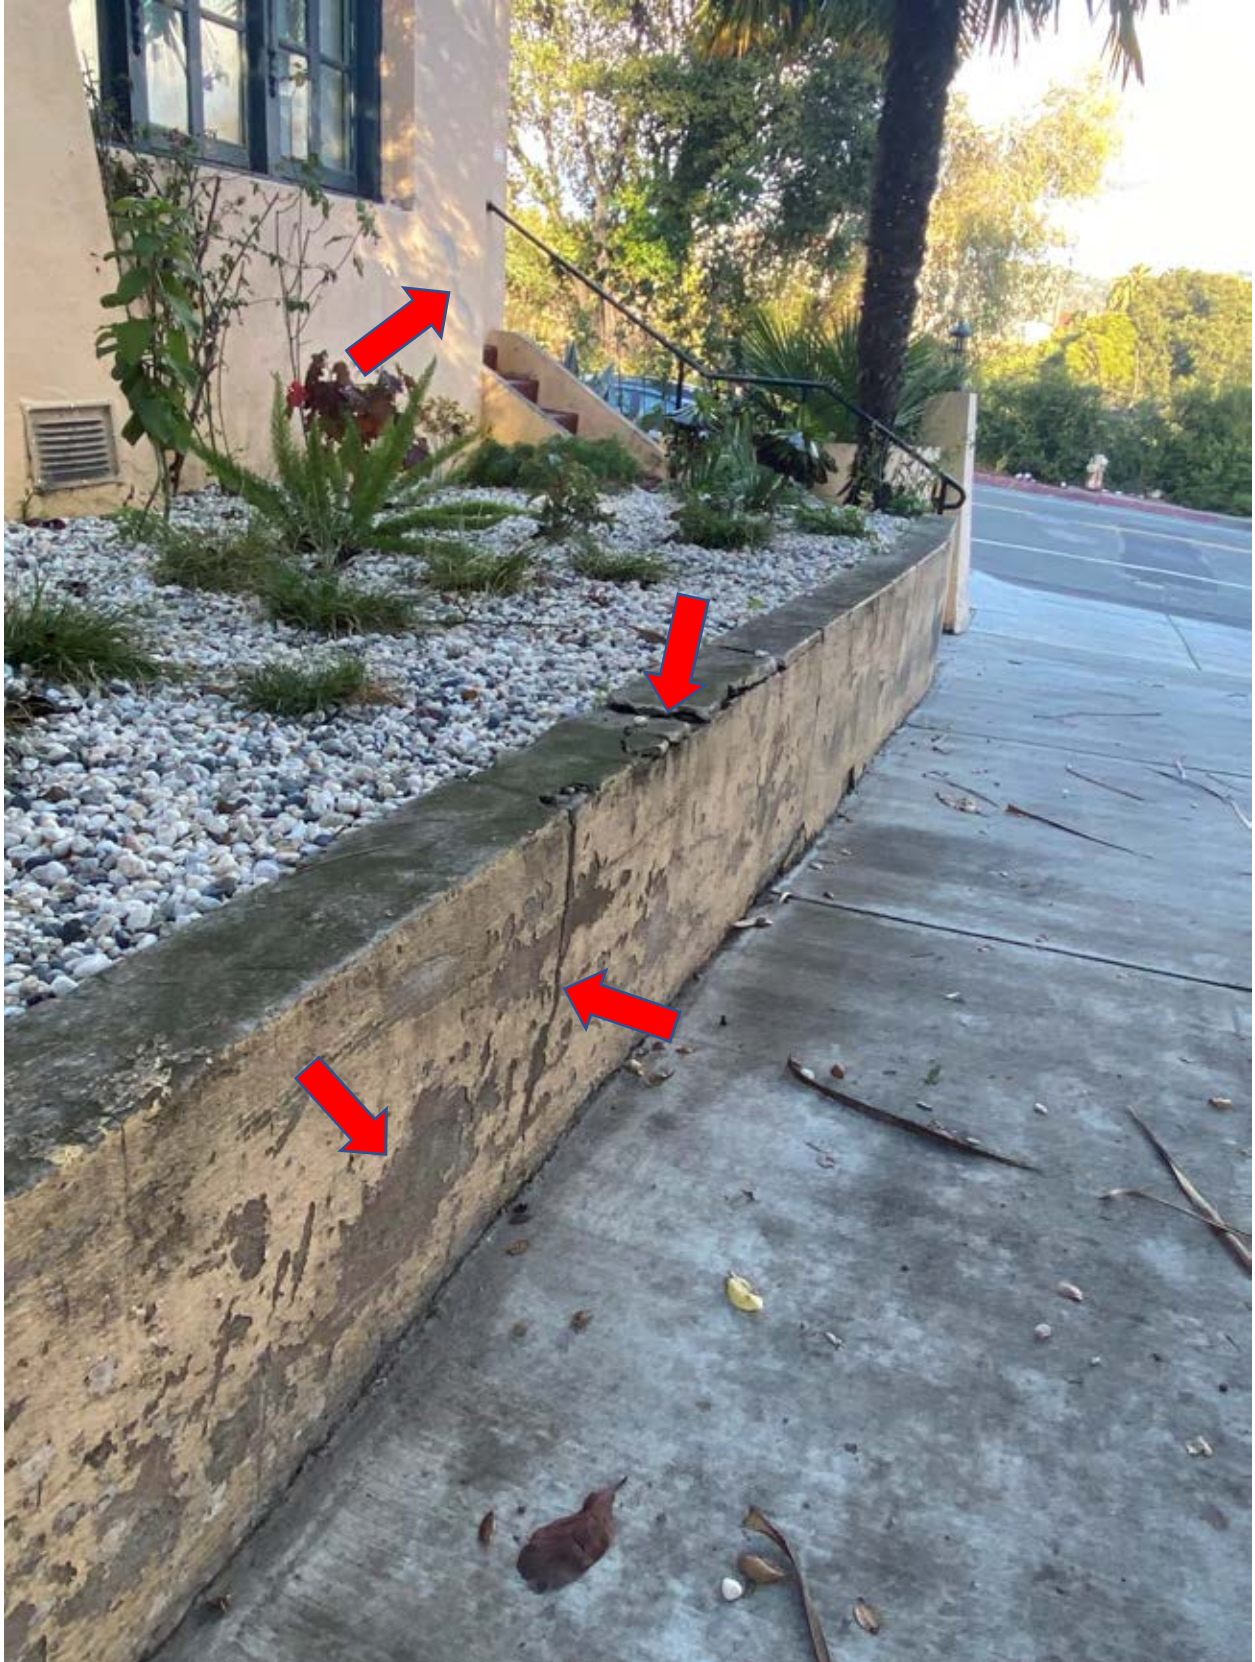
WORK ITEM: #6

(Stucco damage on driveway retaining wall)
