WORK PROGRAM 295 MACARTHUR BLVD, OAKLAND

Exterior Details and Work Program Summary:

RE: Structural Observation
295 MacArthur Blvd
Oakland, CA 94610

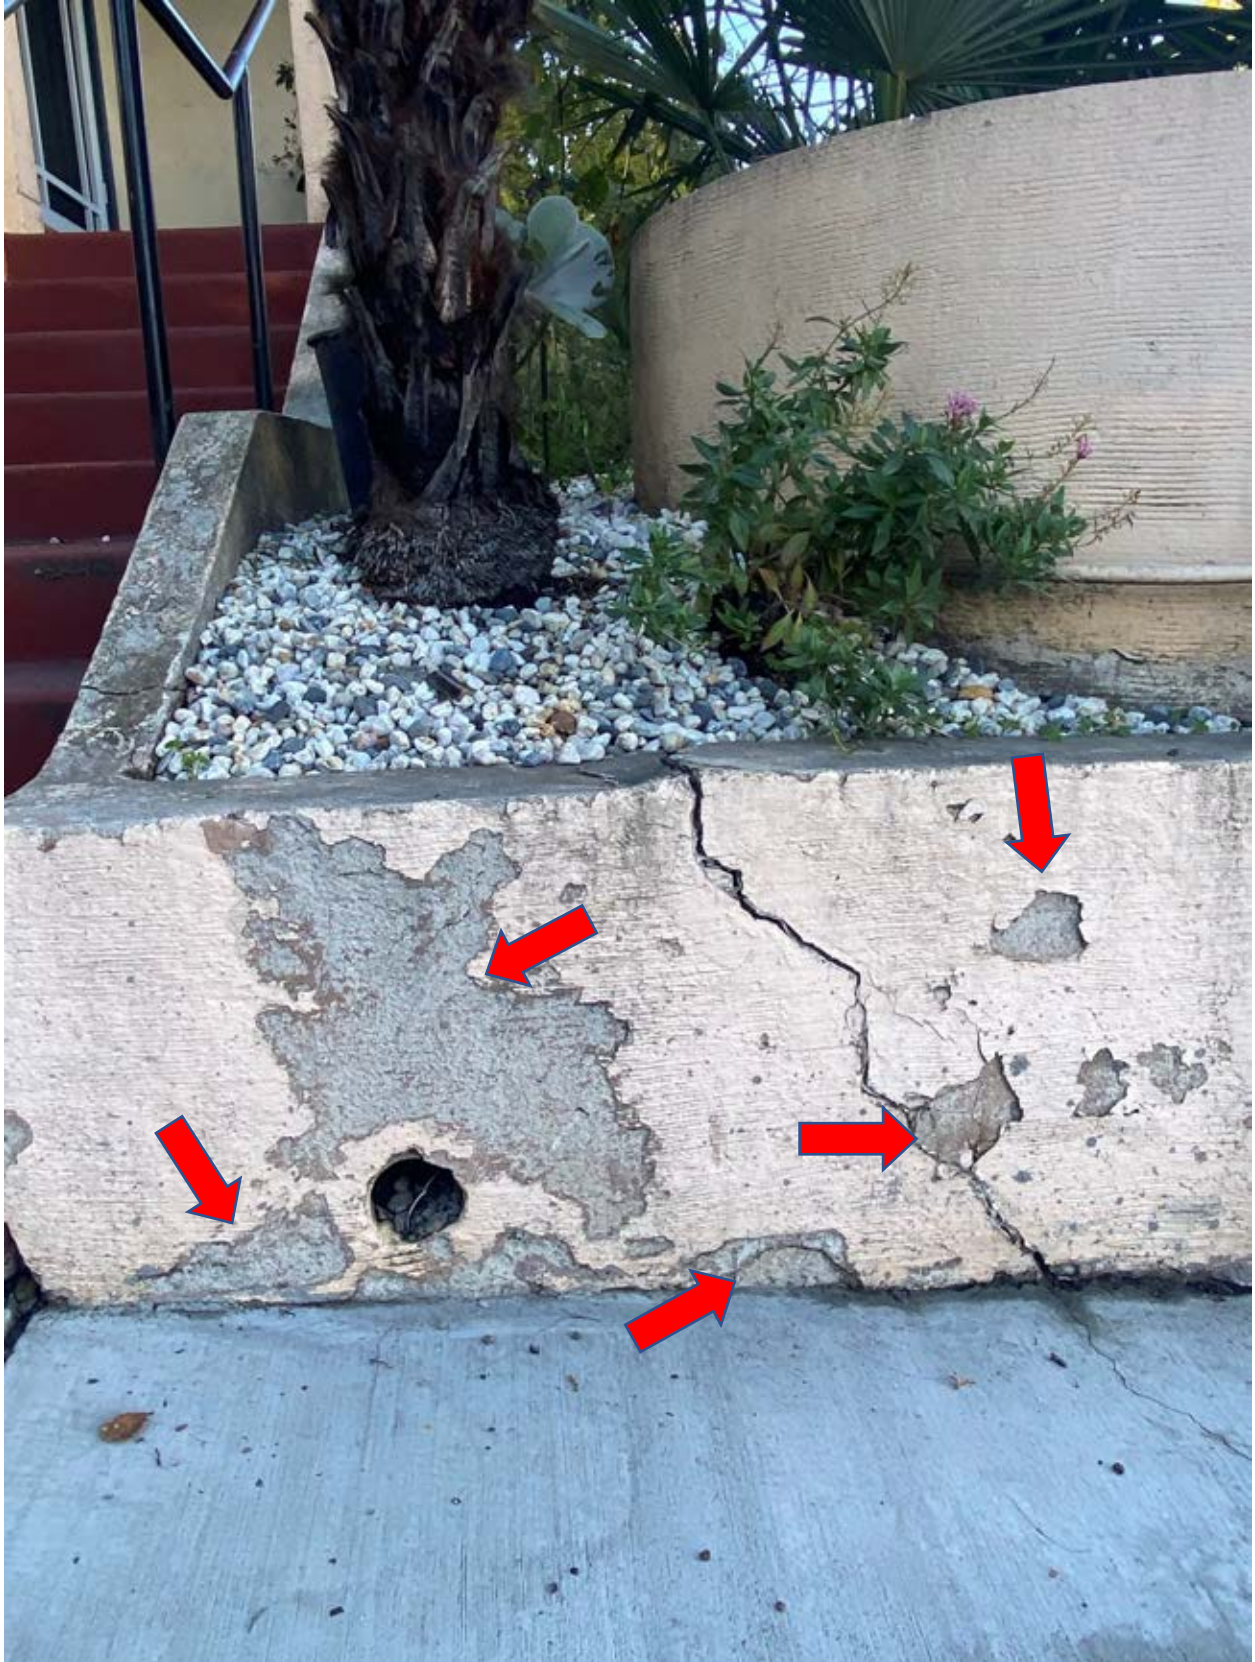
WORK ITEM: #6

(Major cracking and stucco damage on driveway retaining wall)

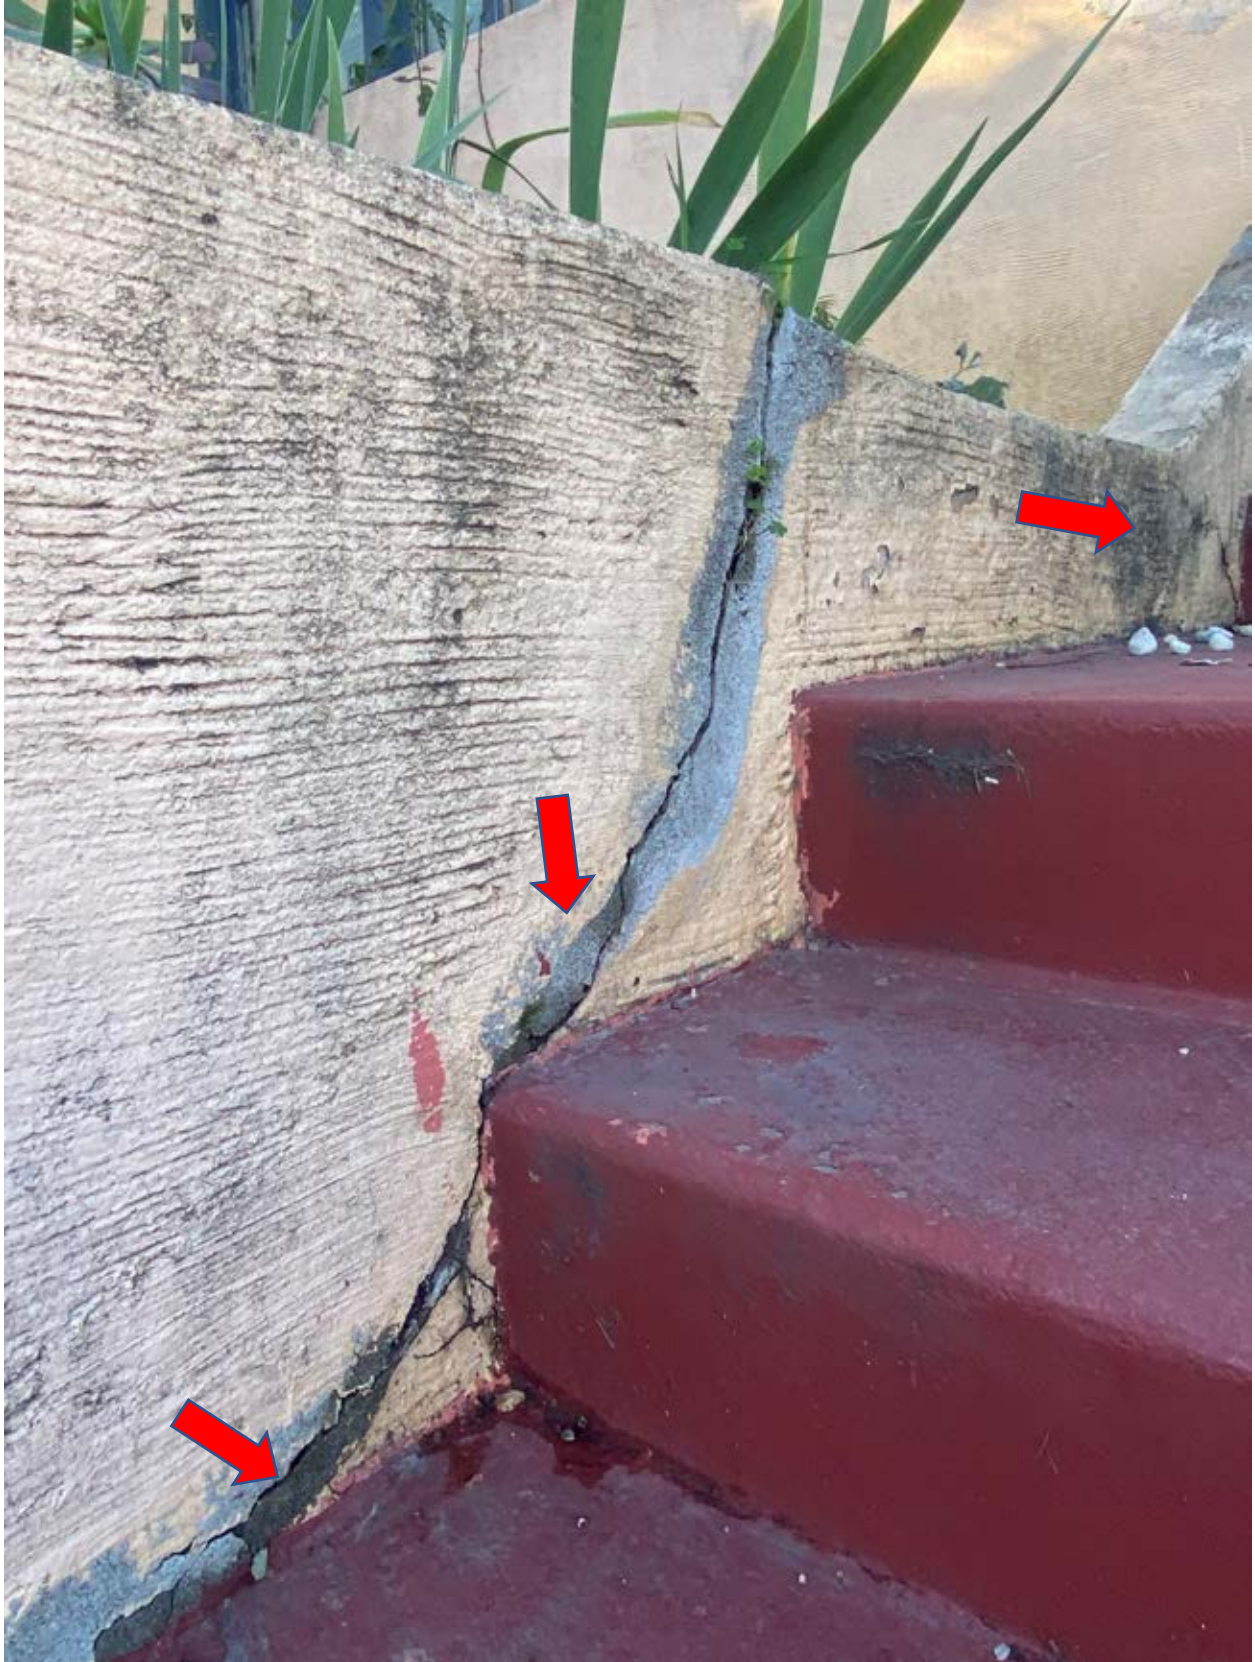
WORK ITEM: #4, #5

(Cracking and improper stucco repair on bungalow front entrance)

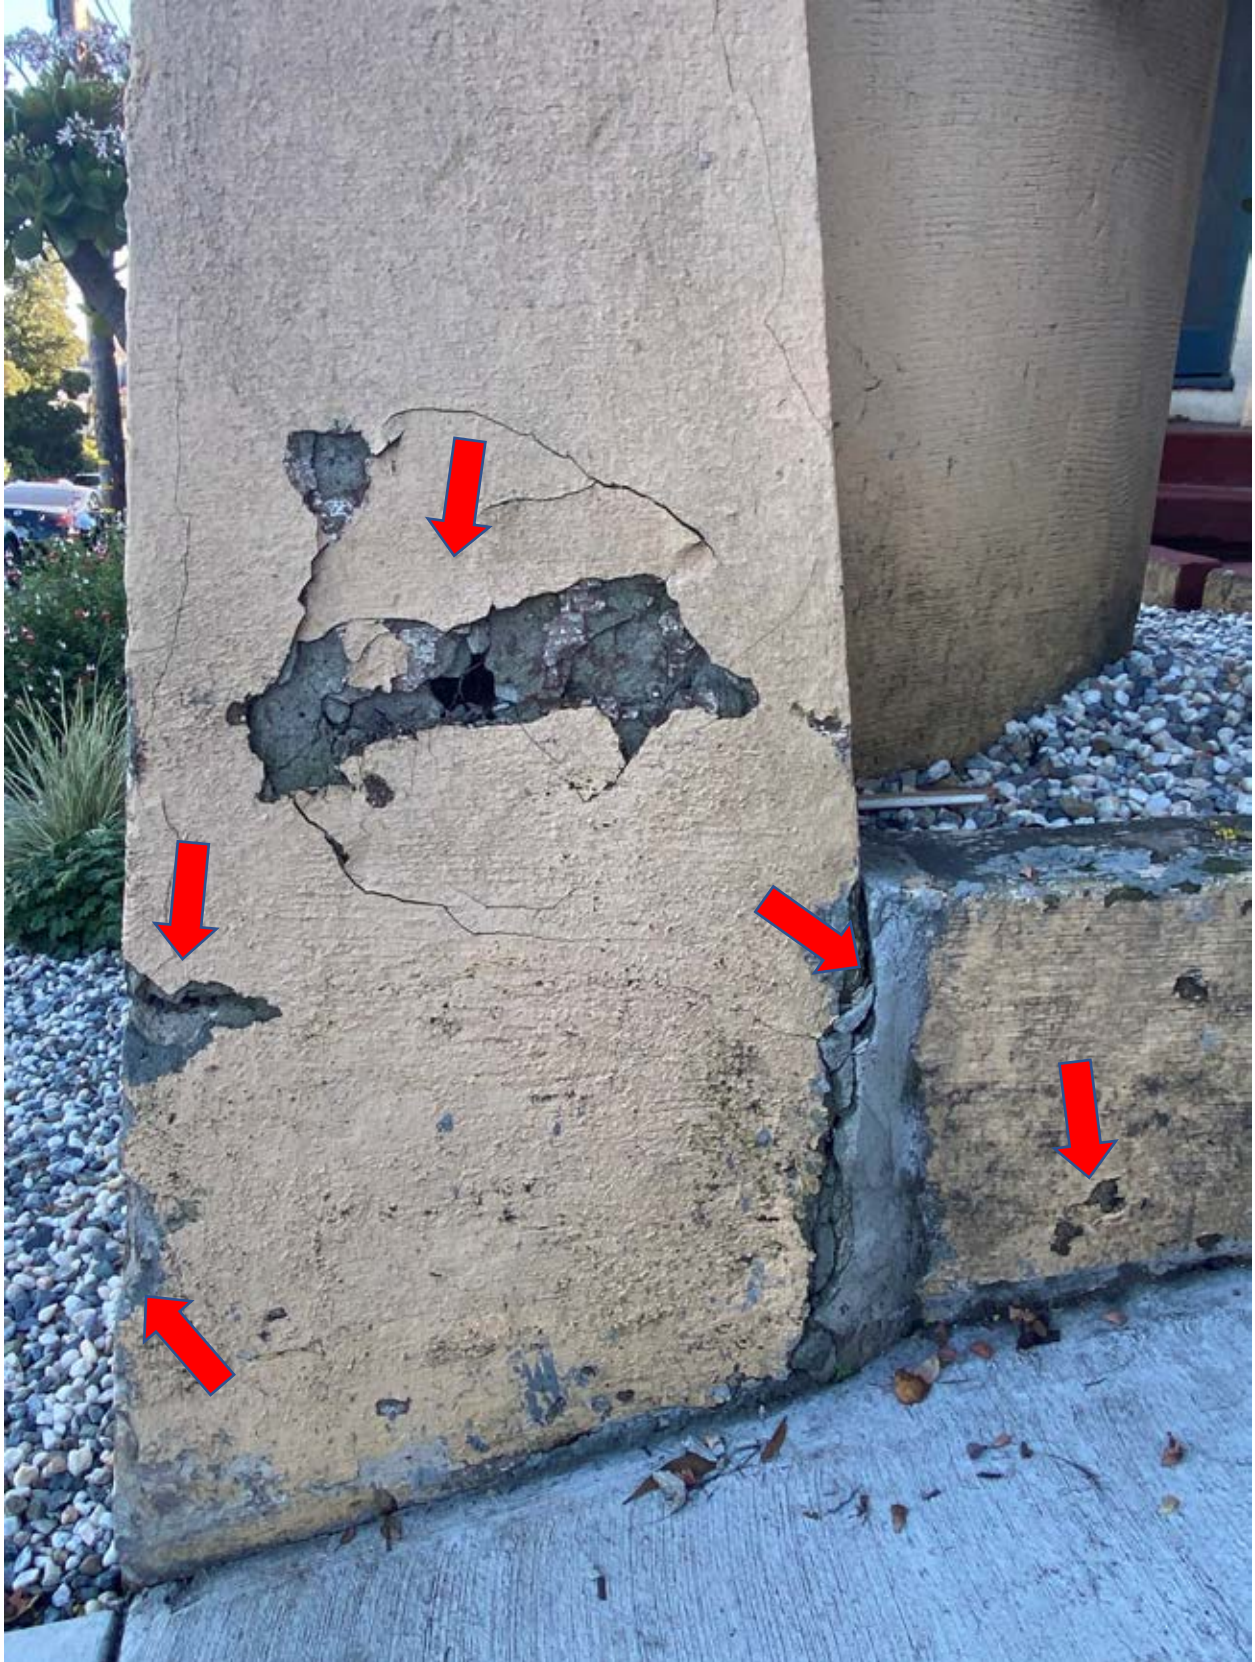
WORK ITEM: #7

(Major cracking on and stucco damage on street facing entrance posts)

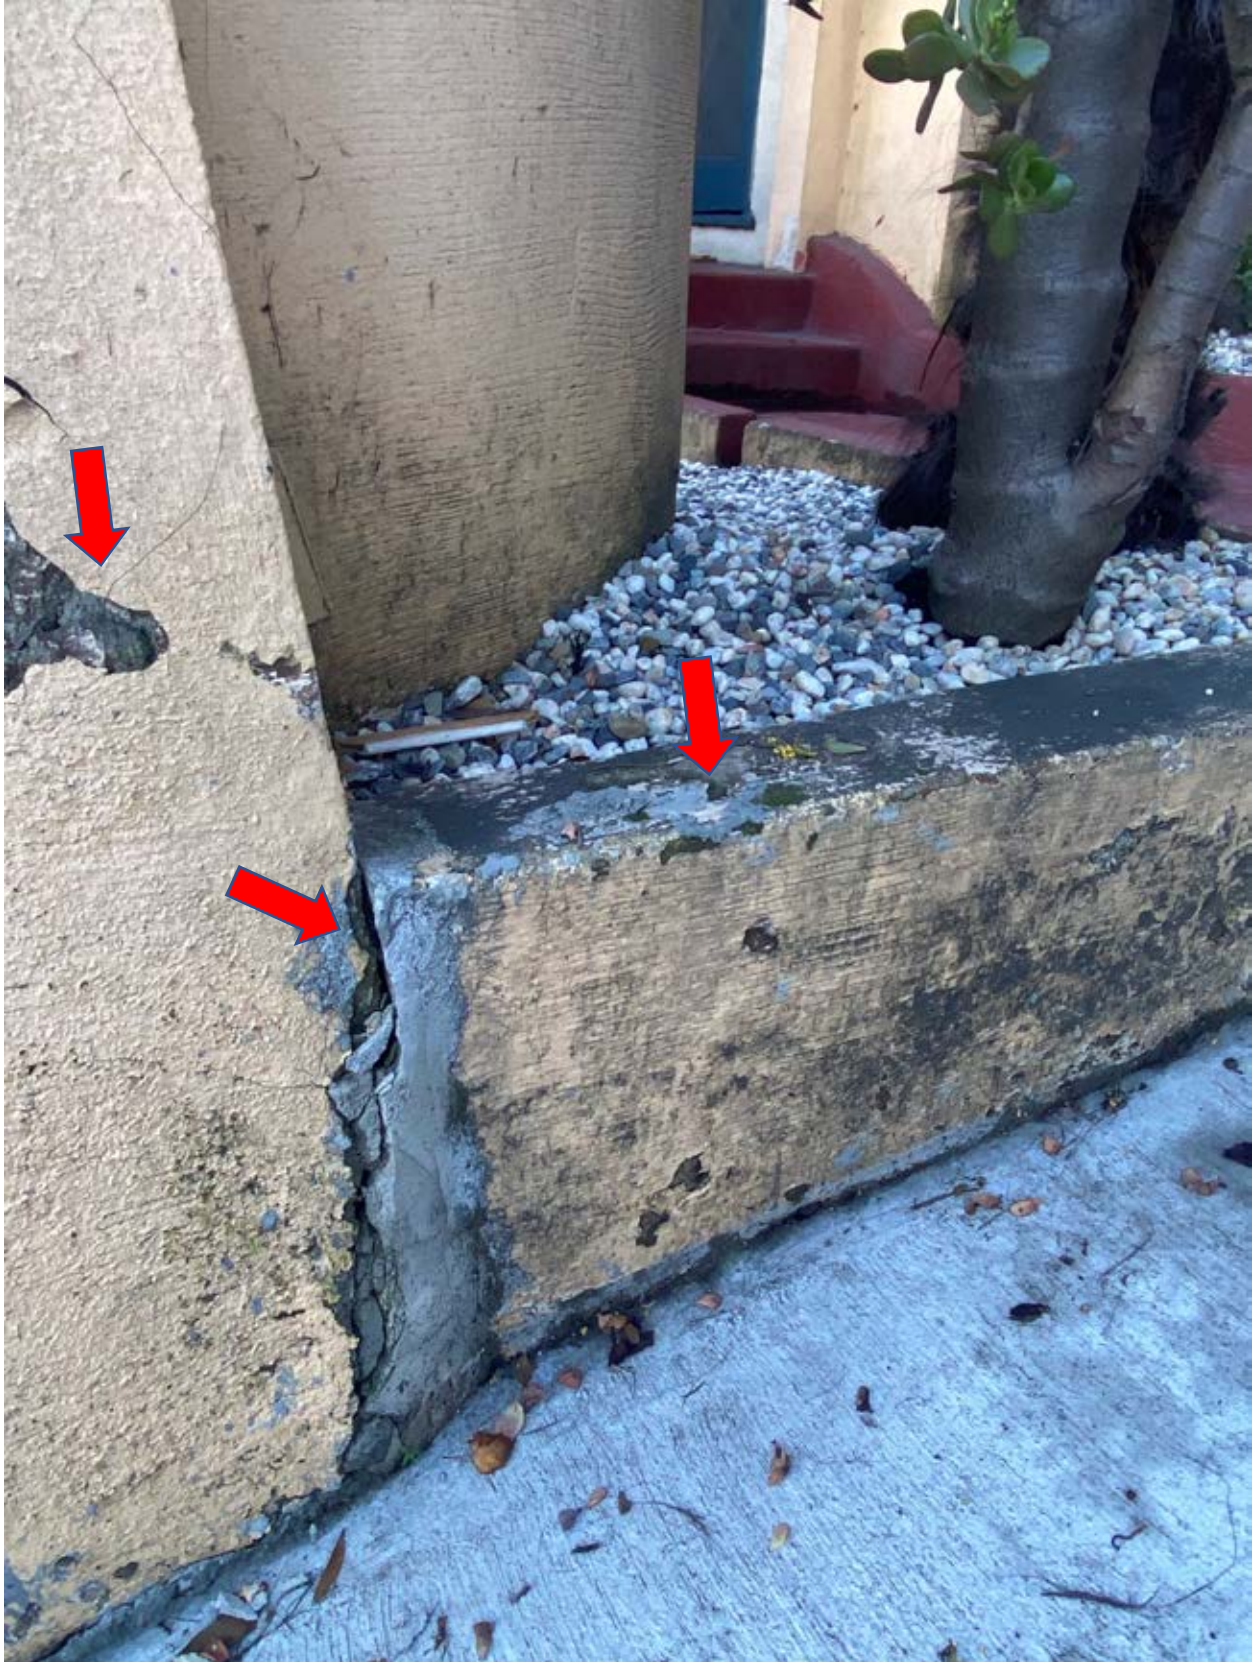
WORK ITEM: #6

(Major cracking and improper repairs on driveway portion of entrance post)

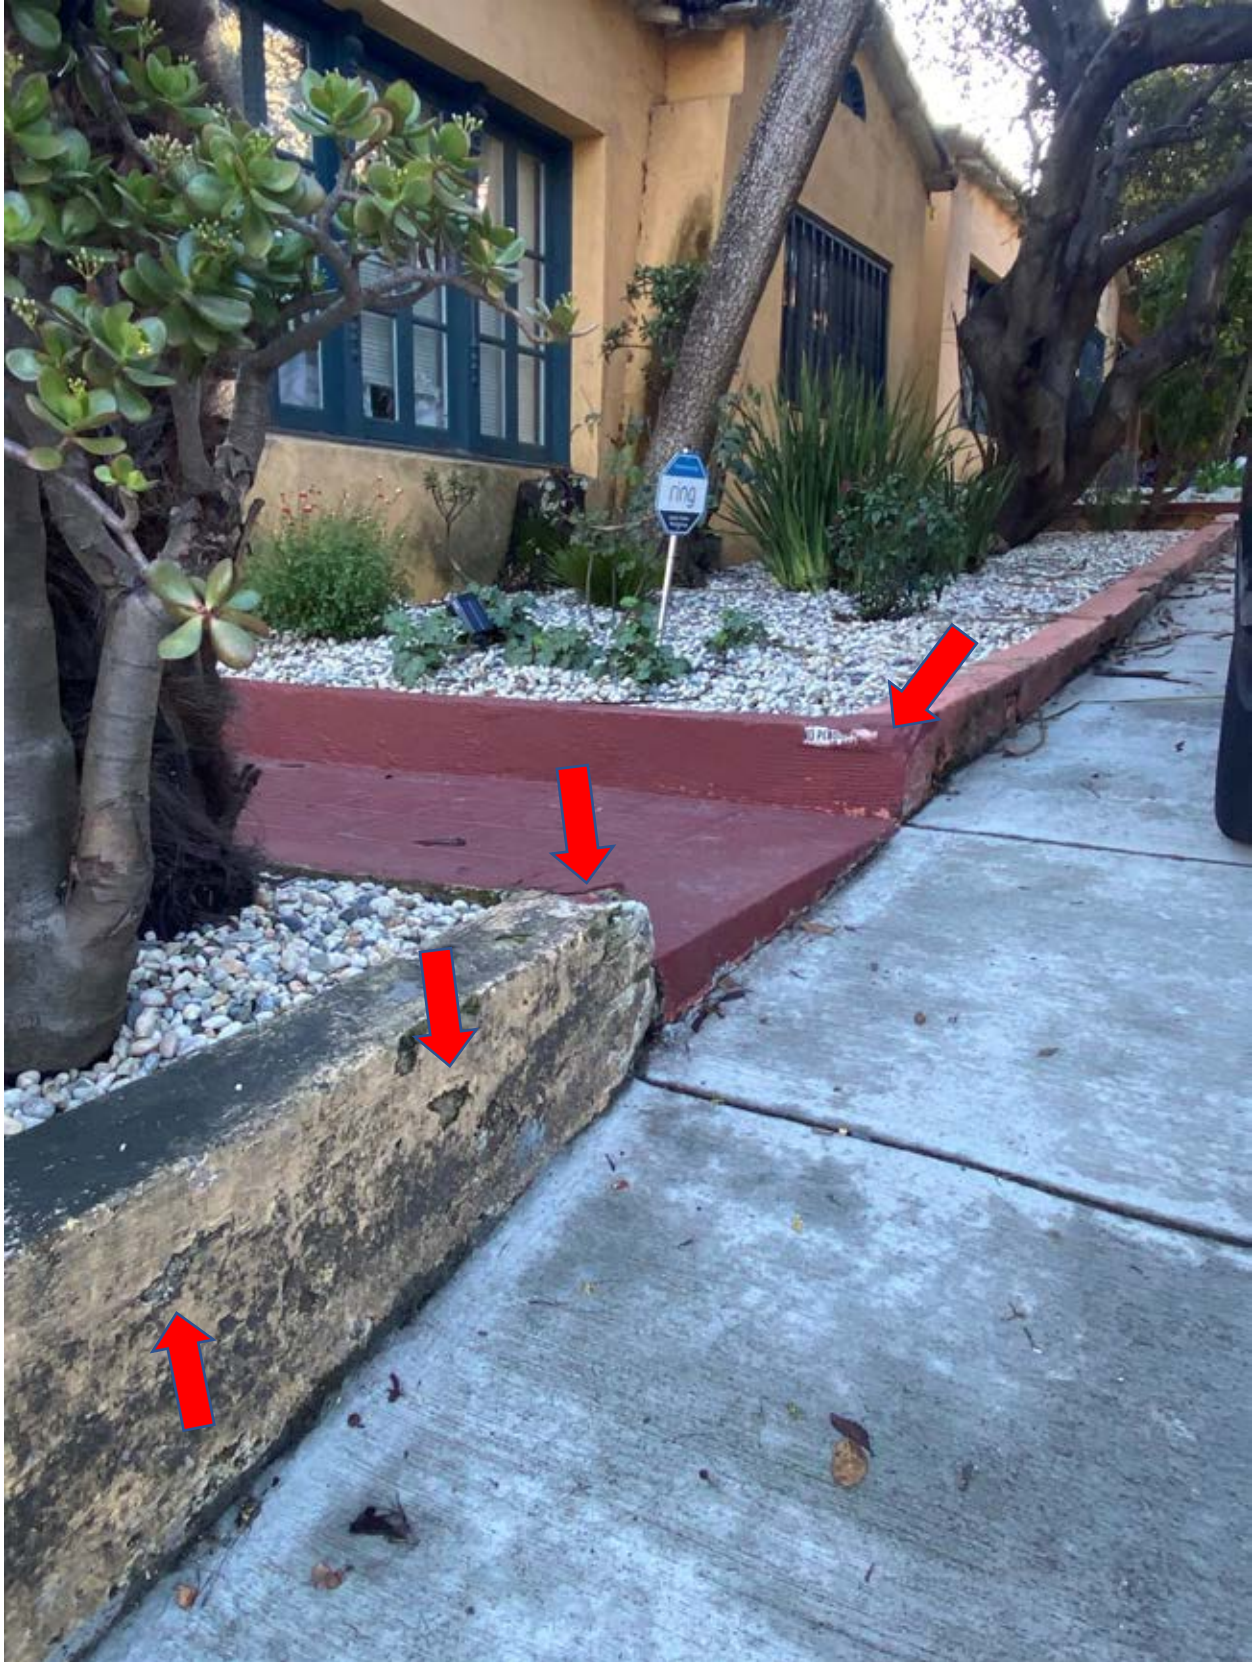
WORK ITEM: #4, #5

(Stucco damage and mismatched paint on walkway)

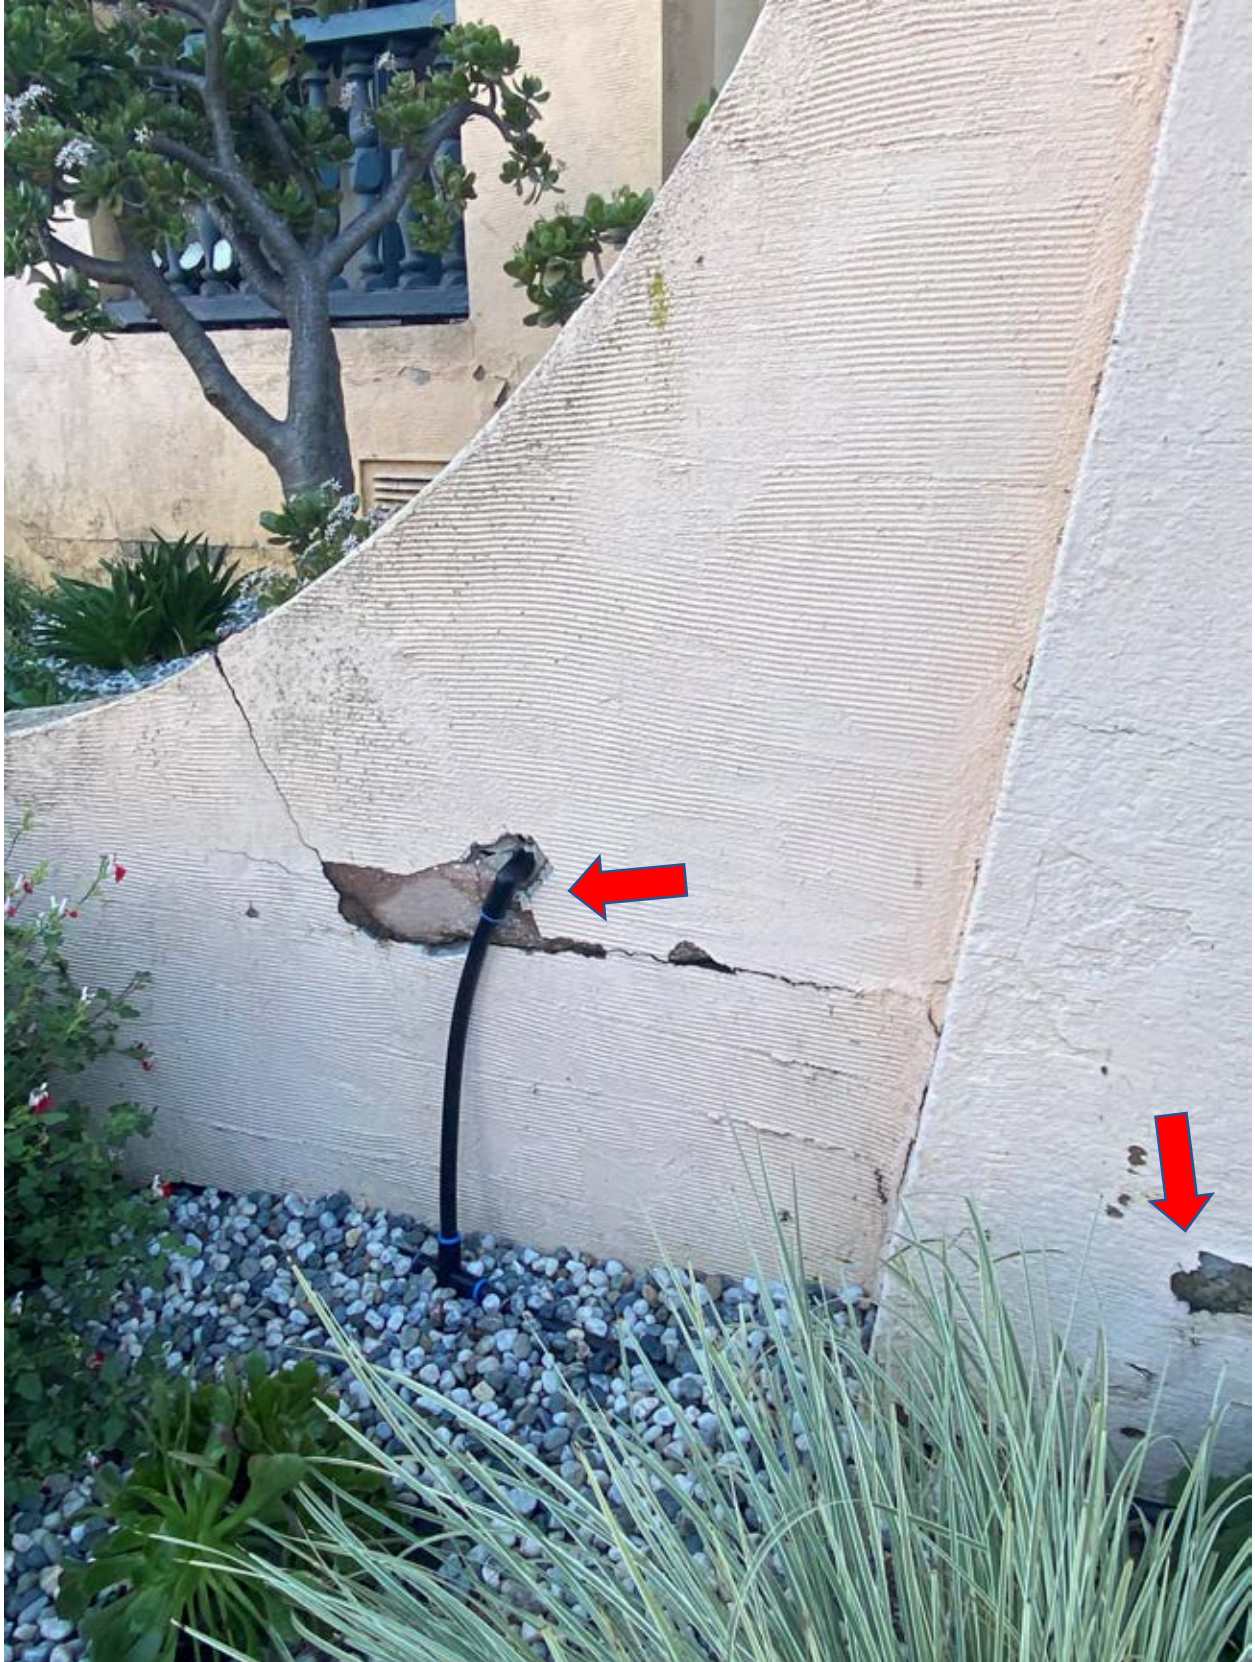
WORK ITEM: #7

(Improper repairs to street facing walls)

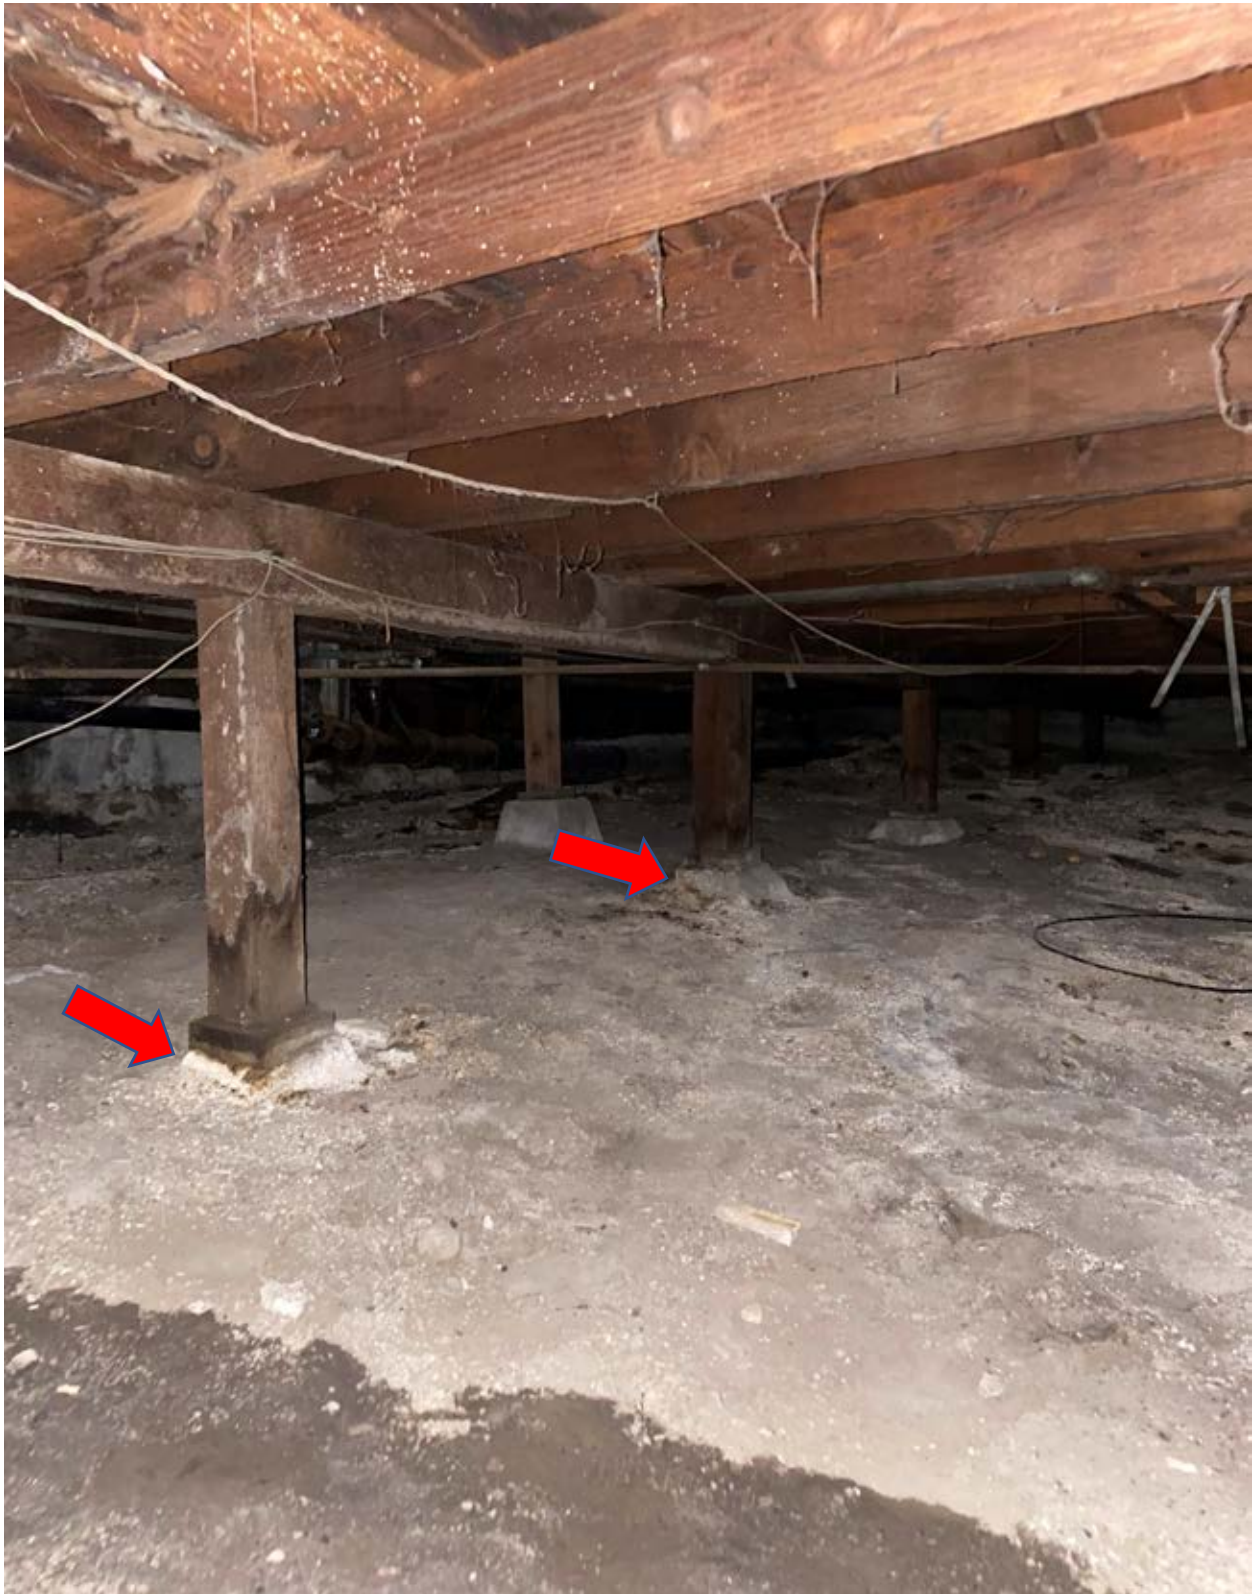
WORK ITEM: #8, #9, #10

(Soft-story structural/seismic issues that need to be reinforced)

- **Structural Framing.** Each of the ten buildings are wood-frame structures over crawl space. The ground floor framing of each building bears both on wood-frame cripple walls and directly on the concrete foundation. It is a soft-story condition where the buildings bear on wood-frame cripple wall, and it is not a soft-story condition where the building bear directly on the concrete foundation.
- **Recommendation.** The standard recommendation of the structural engineering community is to strengthen the unreinforced, wood-frame cripple walls with segments of wood-frame shear wall that anchor directly into the concrete foundation. These shear wall segments install from the inside of the crawl space, and they install only from within the crawl space, and not within the unit above.

- **Retrofit Scope.** To retrofit the subject buildings, wood-frame shear walls are installed into the existing concrete foundation. This is the most cost-effective retrofit technique. Work is only performed within the ground floor, and not above, within habitable units. Shear wall segments are installed on the interior side of existing walls, typically around the building perimeter and existing garage space. Their assembly involves adding framing, fasteners, hold-downs, and plywood to the existing typical stud framing like this:
