CORRECTIVE ACTION PLAN

County File # RO 0003347

820 W MacArthur Blvd.

Prepared By: P&D Environmental, Inc. 55 Santa Clara Avenue, Suite 240 Oakland, CA 94610

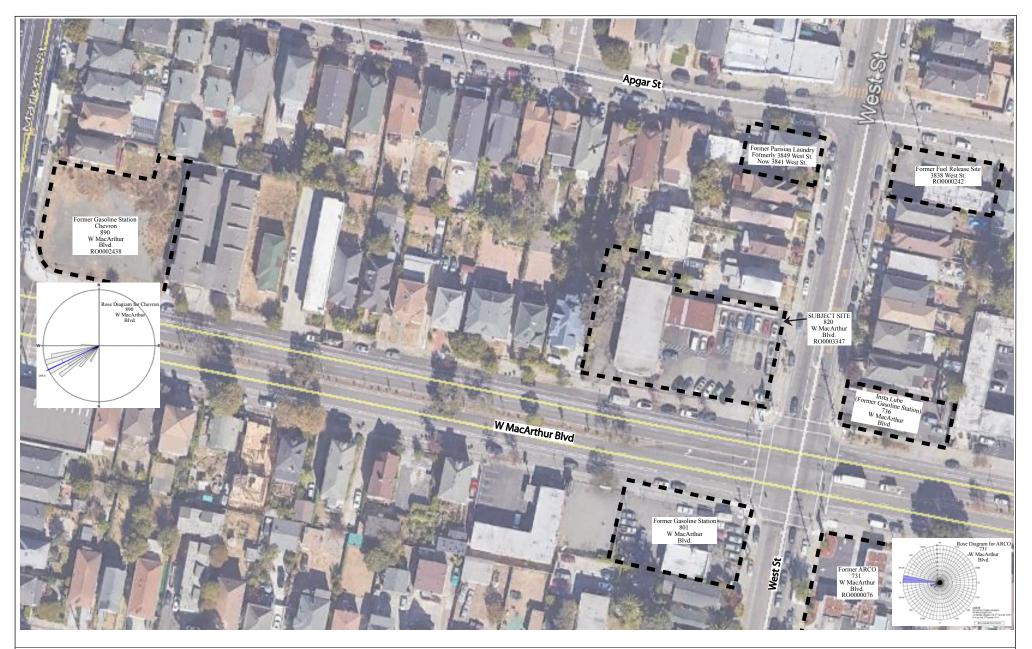
Figure 2
Site Vicinity Aerial Photograph Showing Nearby Site Locations
820 W MacArthur Boulevard
Oakland, California

Base Map from: Partner Engineering and Science, Inc. Additional Subsurace Investigation Report, October 31, 2018, and Google Earth, 2020

Review of *Figure 1* shows that the ground surface in the vicinity of the Site slopes to the southwest. Review of *Figure 2* shows groundwater flow directions obtained from water level measurements in groundwater monitoring wells during multiple events for two nearby sites. The southwesterly groundwater flow direction identified at the former Chevron gasoline station located at 890 W MacArthur Blvd is consistent with the regional ground surface slope, and is interpreted to be representative of the regional groundwater flow direction. Based on the variable nature of subsurface materials at and near the Site, local variations in groundwater flow direction may be encountered at the local scale and may be controlled locally by local geology, consistent with the more westerly groundwater flow direction observed at the former ARCO gasoline station located at 731 W MacArthur Blvd. San Francisco Bay is located approximately 7,700 feet to the west of the Site (see *Figure 1*).

Review of groundwater flow direction information obtained from groundwater monitoring wells at the former ARCO Station No. 4931 located at 731 W. MacArthur Blvd (approximately 200 feet southeast of the subject site at the southeast corner of the intersection of West Street and W MacArthur Blvd.) shows that the approximate depth to groundwater in groundwater monitoring wells as measured from the top of well casing typically ranged seasonally from approximately 5 to 10 feet and that the groundwater flow direction has historically been to the west with a gradient of 0.019. A rose diagram of historical groundwater flow directions at the 731 W. MacArthur Blvd ARCO station is shown on *Figure 2 of the April 27, 2020 CAP*.

Review of groundwater flow direction information obtained from groundwater monitoring wells at the former Chevron Station No. 9-2029 located at 880 W. MacArthur Blvd (approximately 450 feet west of the subject site at the northeast corner of the intersection of Market Street and W MacArthur Blvd.) shows that the approximate depth to groundwater in groundwater monitoring wells as measured from the top of well casing ranged seasonally from about 5 to 10 feet and that the groundwater flow direction has historically been to the southwest (see *Figure 2 of the April*

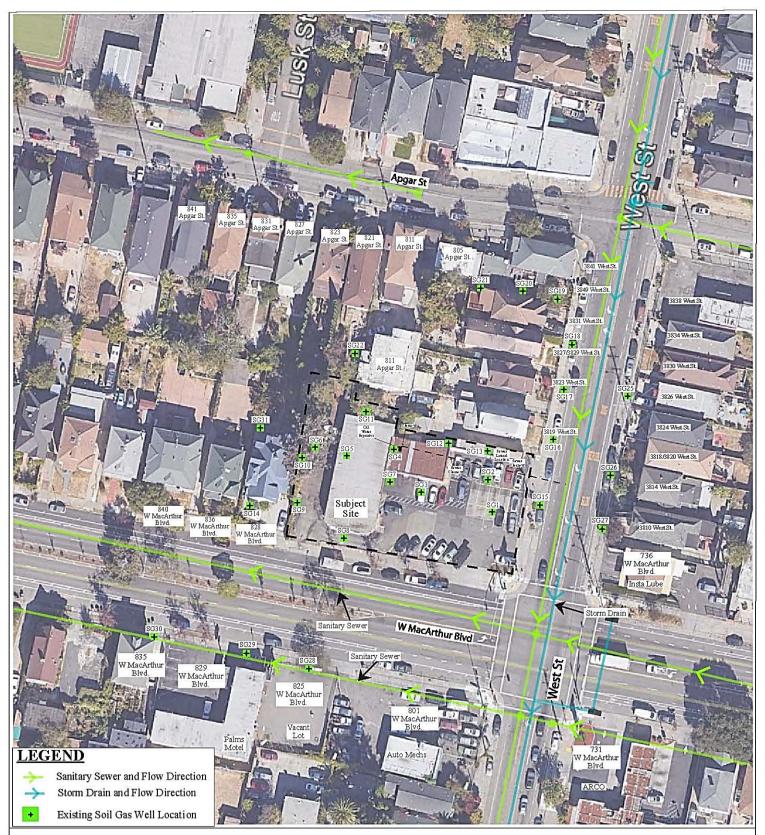
Figure 3 Site Vicinity Aerial Photograph Detail Showing Soil Gas Well Locations 820 W MacArthur Boulevard Oakland, California

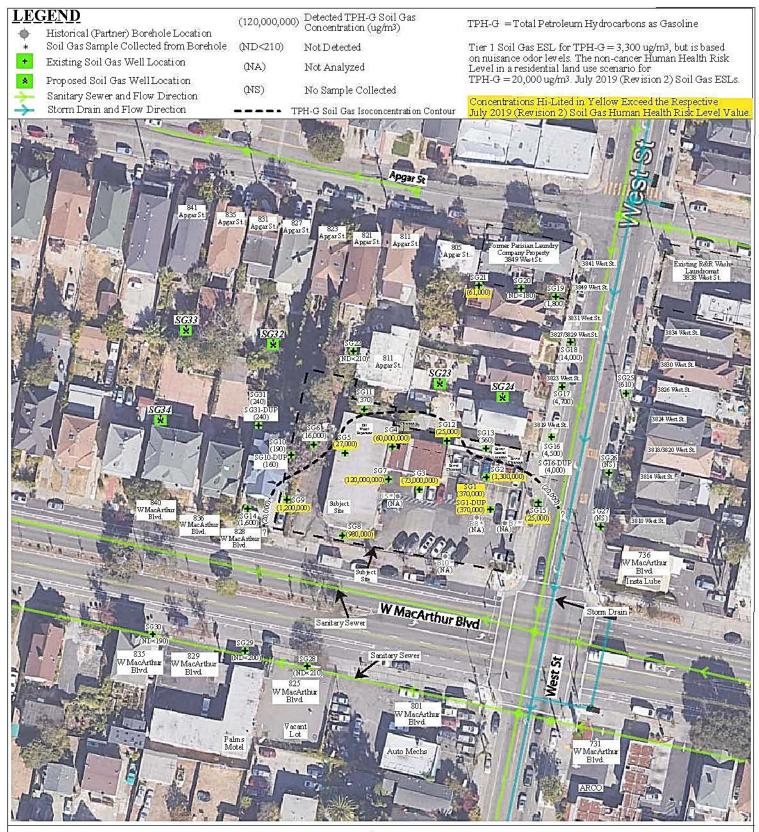
Figure 9 Site Vicinity Aerial Photograph Detail Showing TPH-G in Soil Gas 820 W MacArthur Boulevard Oakland, California

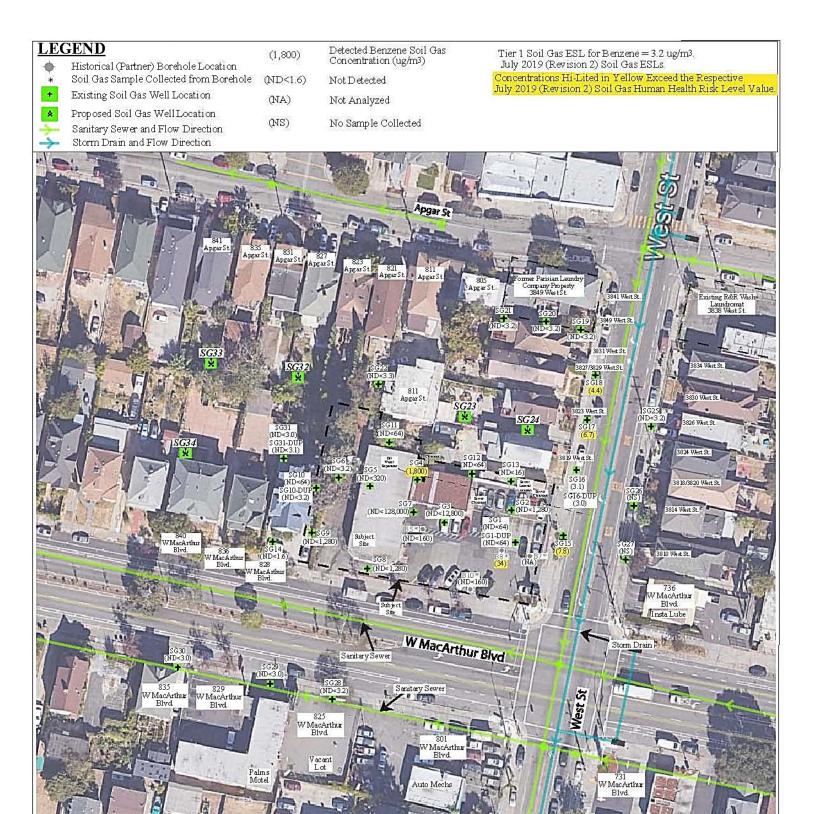
Figure 10 Site Vicinity Aerial Photograph Detail Showing Benzene in Soil Gas 820 W MacArthur Boulevard Oakland, California

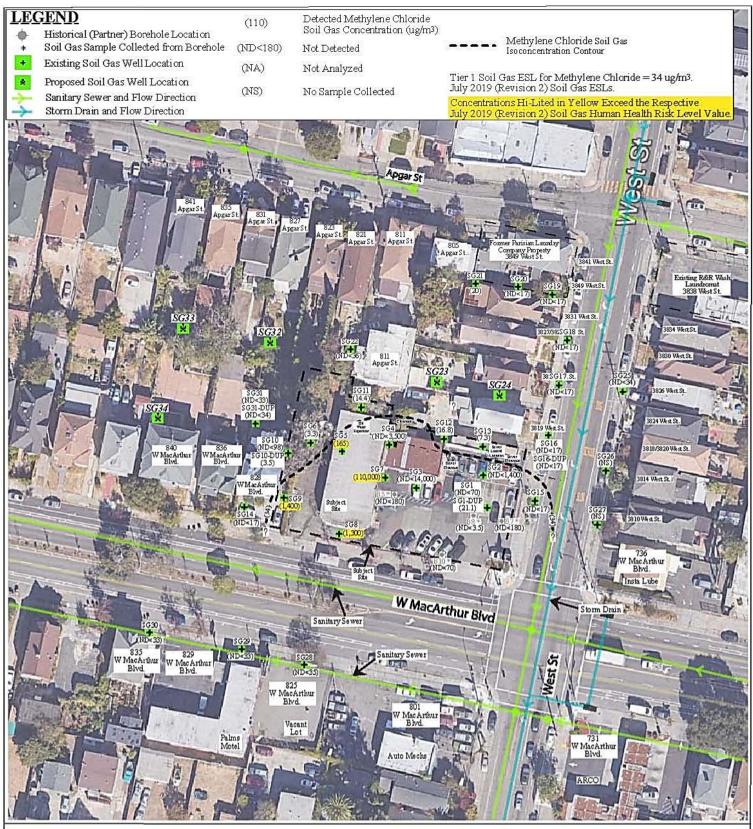
Figure 11 Site Vicinity Aerial Photograph Detail Showing Methylene Chloride in Soil Gas 820 W MacArthur Boulevard Oakland, California

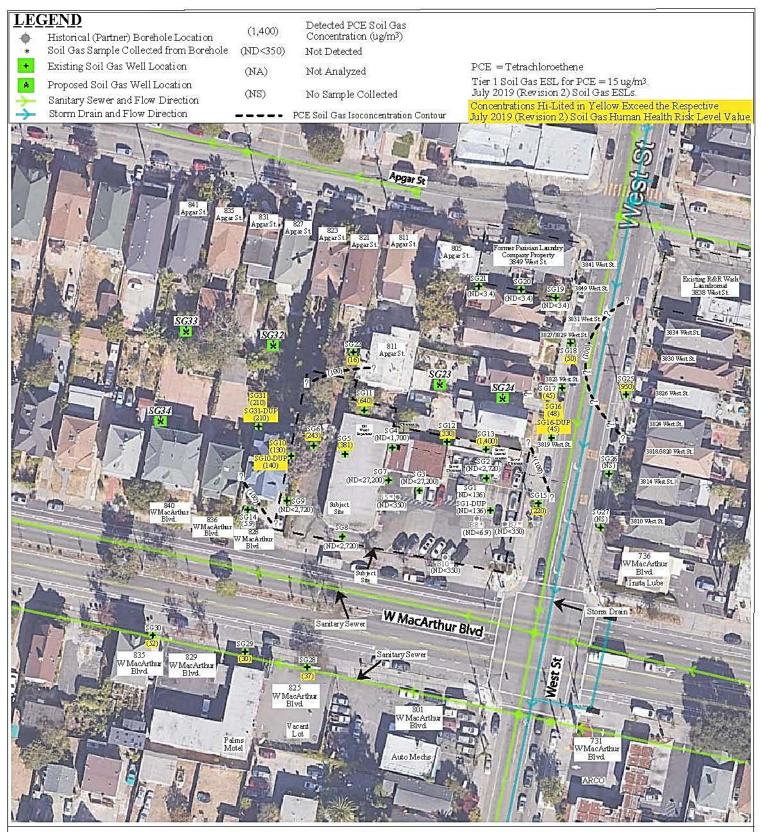
Figure 12 Site Vicinity Aerial Photograph Detail Showing PCE in Soil Gas 820 W MacArthur Boulevard Oakland, California

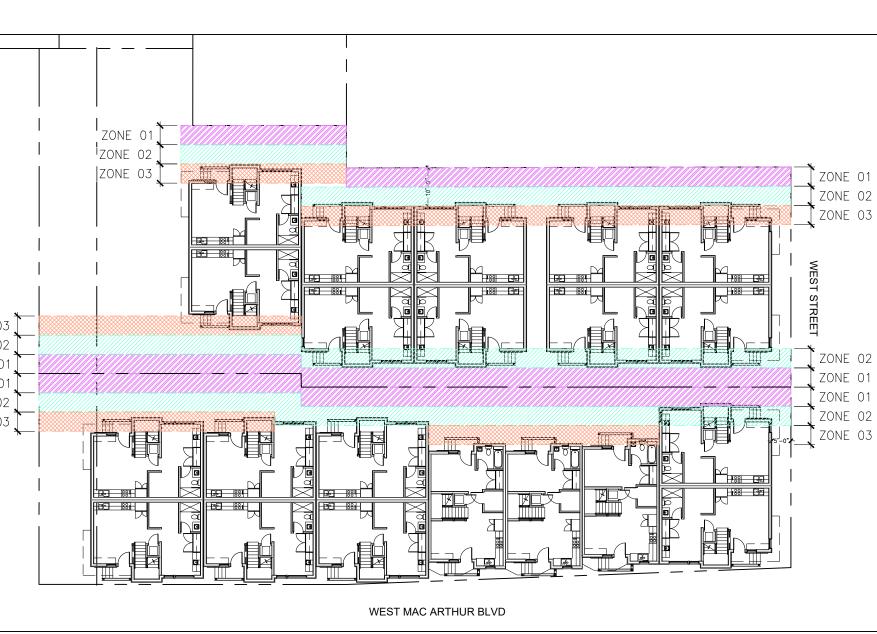
A0.5

AREA	ZONE	WALL AREA (SF)	OPENING AREA (SF)	OPENING PERCENTAGE	ALLOWED OPENING PERCENTAGE	MEET CODE
01	03	100	36	36.0%	45%	YES
02	03	119	35	29.4%	45%	YES
03	02	196	35	17.9%	25%	YES
04	03	204	70	34.3%	45%	YES
05	03	100	35	35.0%	45%	YES
06	02	238	35	14.7%	25%	YES
07	03	102	35	34.3%	45%	YES
08	03	196	35	17.9%	45%	YES
09	02	100	24	24.0%	25%	YES
10	02	119	25	21.0%	25%	YES
11	01	204	25	12.3%	15%	YES
12	02	102	23	22.5%	25%	YES
13	02	118	25	21.2%	25%	YES
14	03	79	4	5.1%	45%	YES
15	03	111	36	32.4%	45%	YES
16	03	79	12	15.2%	45%	YES
17	03	111	23	20.72%	45%	YES
18	03	771	105	13.62%	45%	YES
19	02	102	25	24.51%	25%	YES
20	02	100	25	25.00%	25%	YES
21	03	238	35	14.71%	45%	YES
22	02	204	50	24.51%	25%	YES

EXTERIOR WALL OPENING DISGRAMS

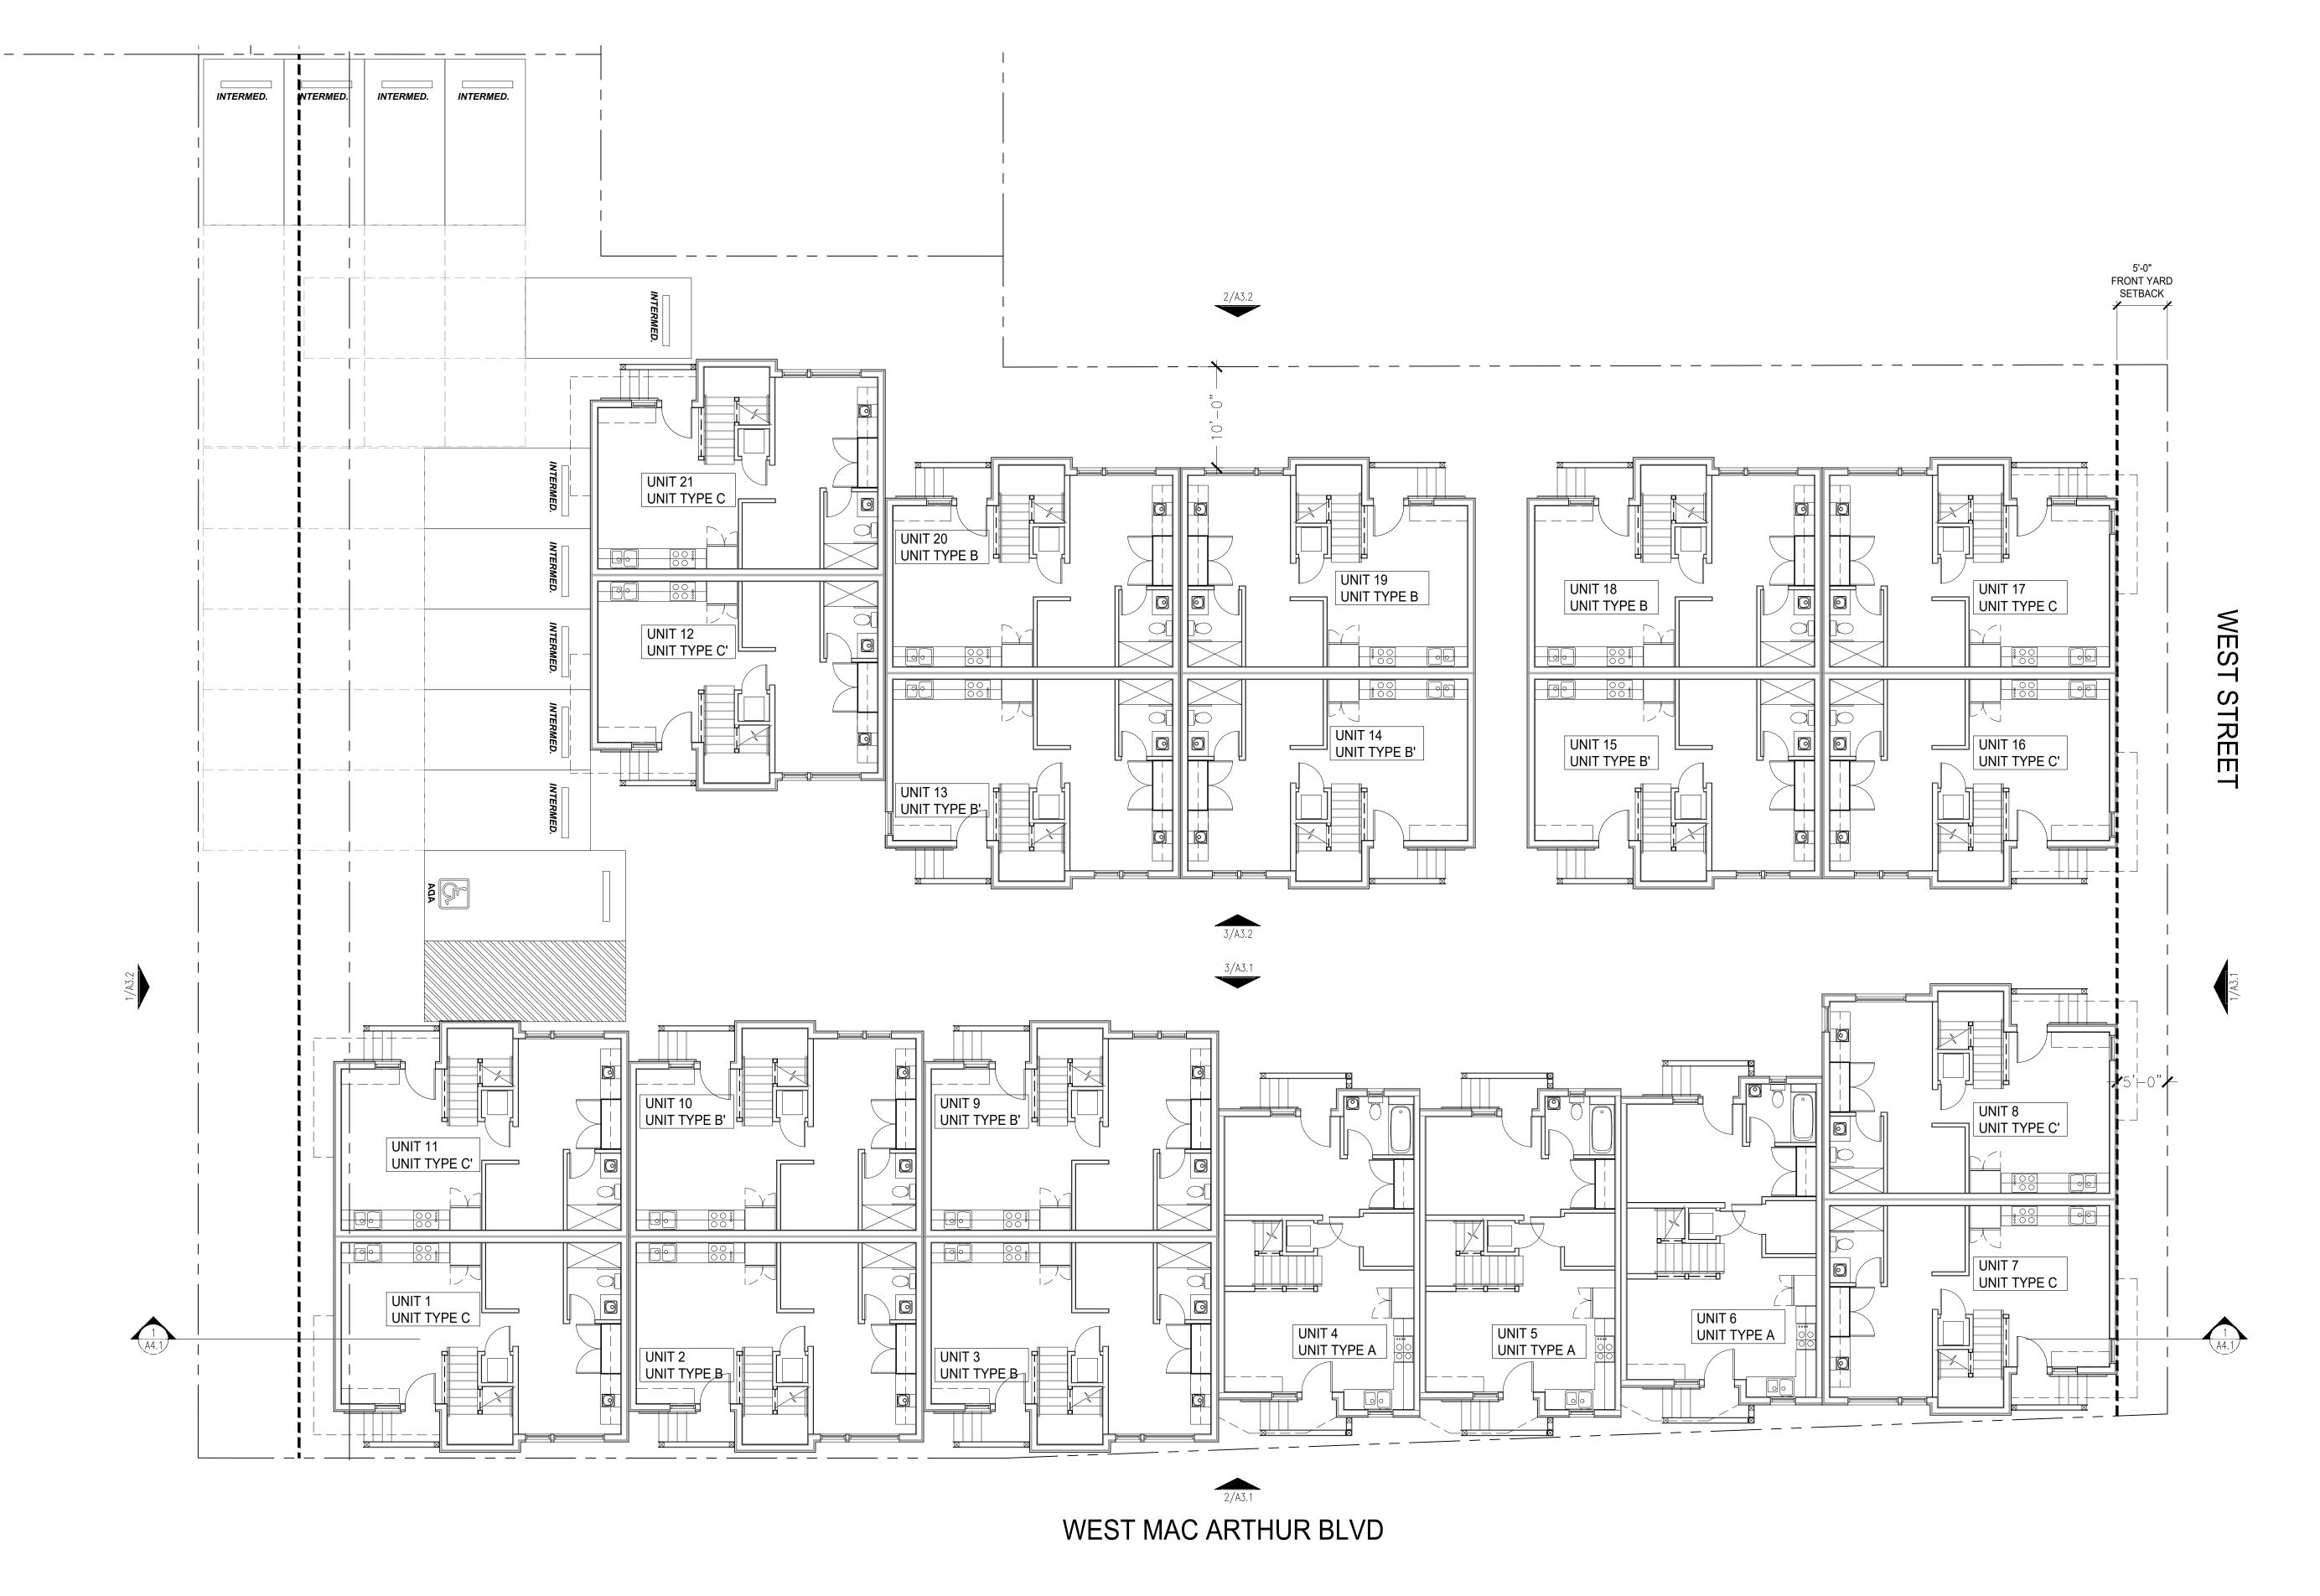
## PLAN: 1ST FLOOR

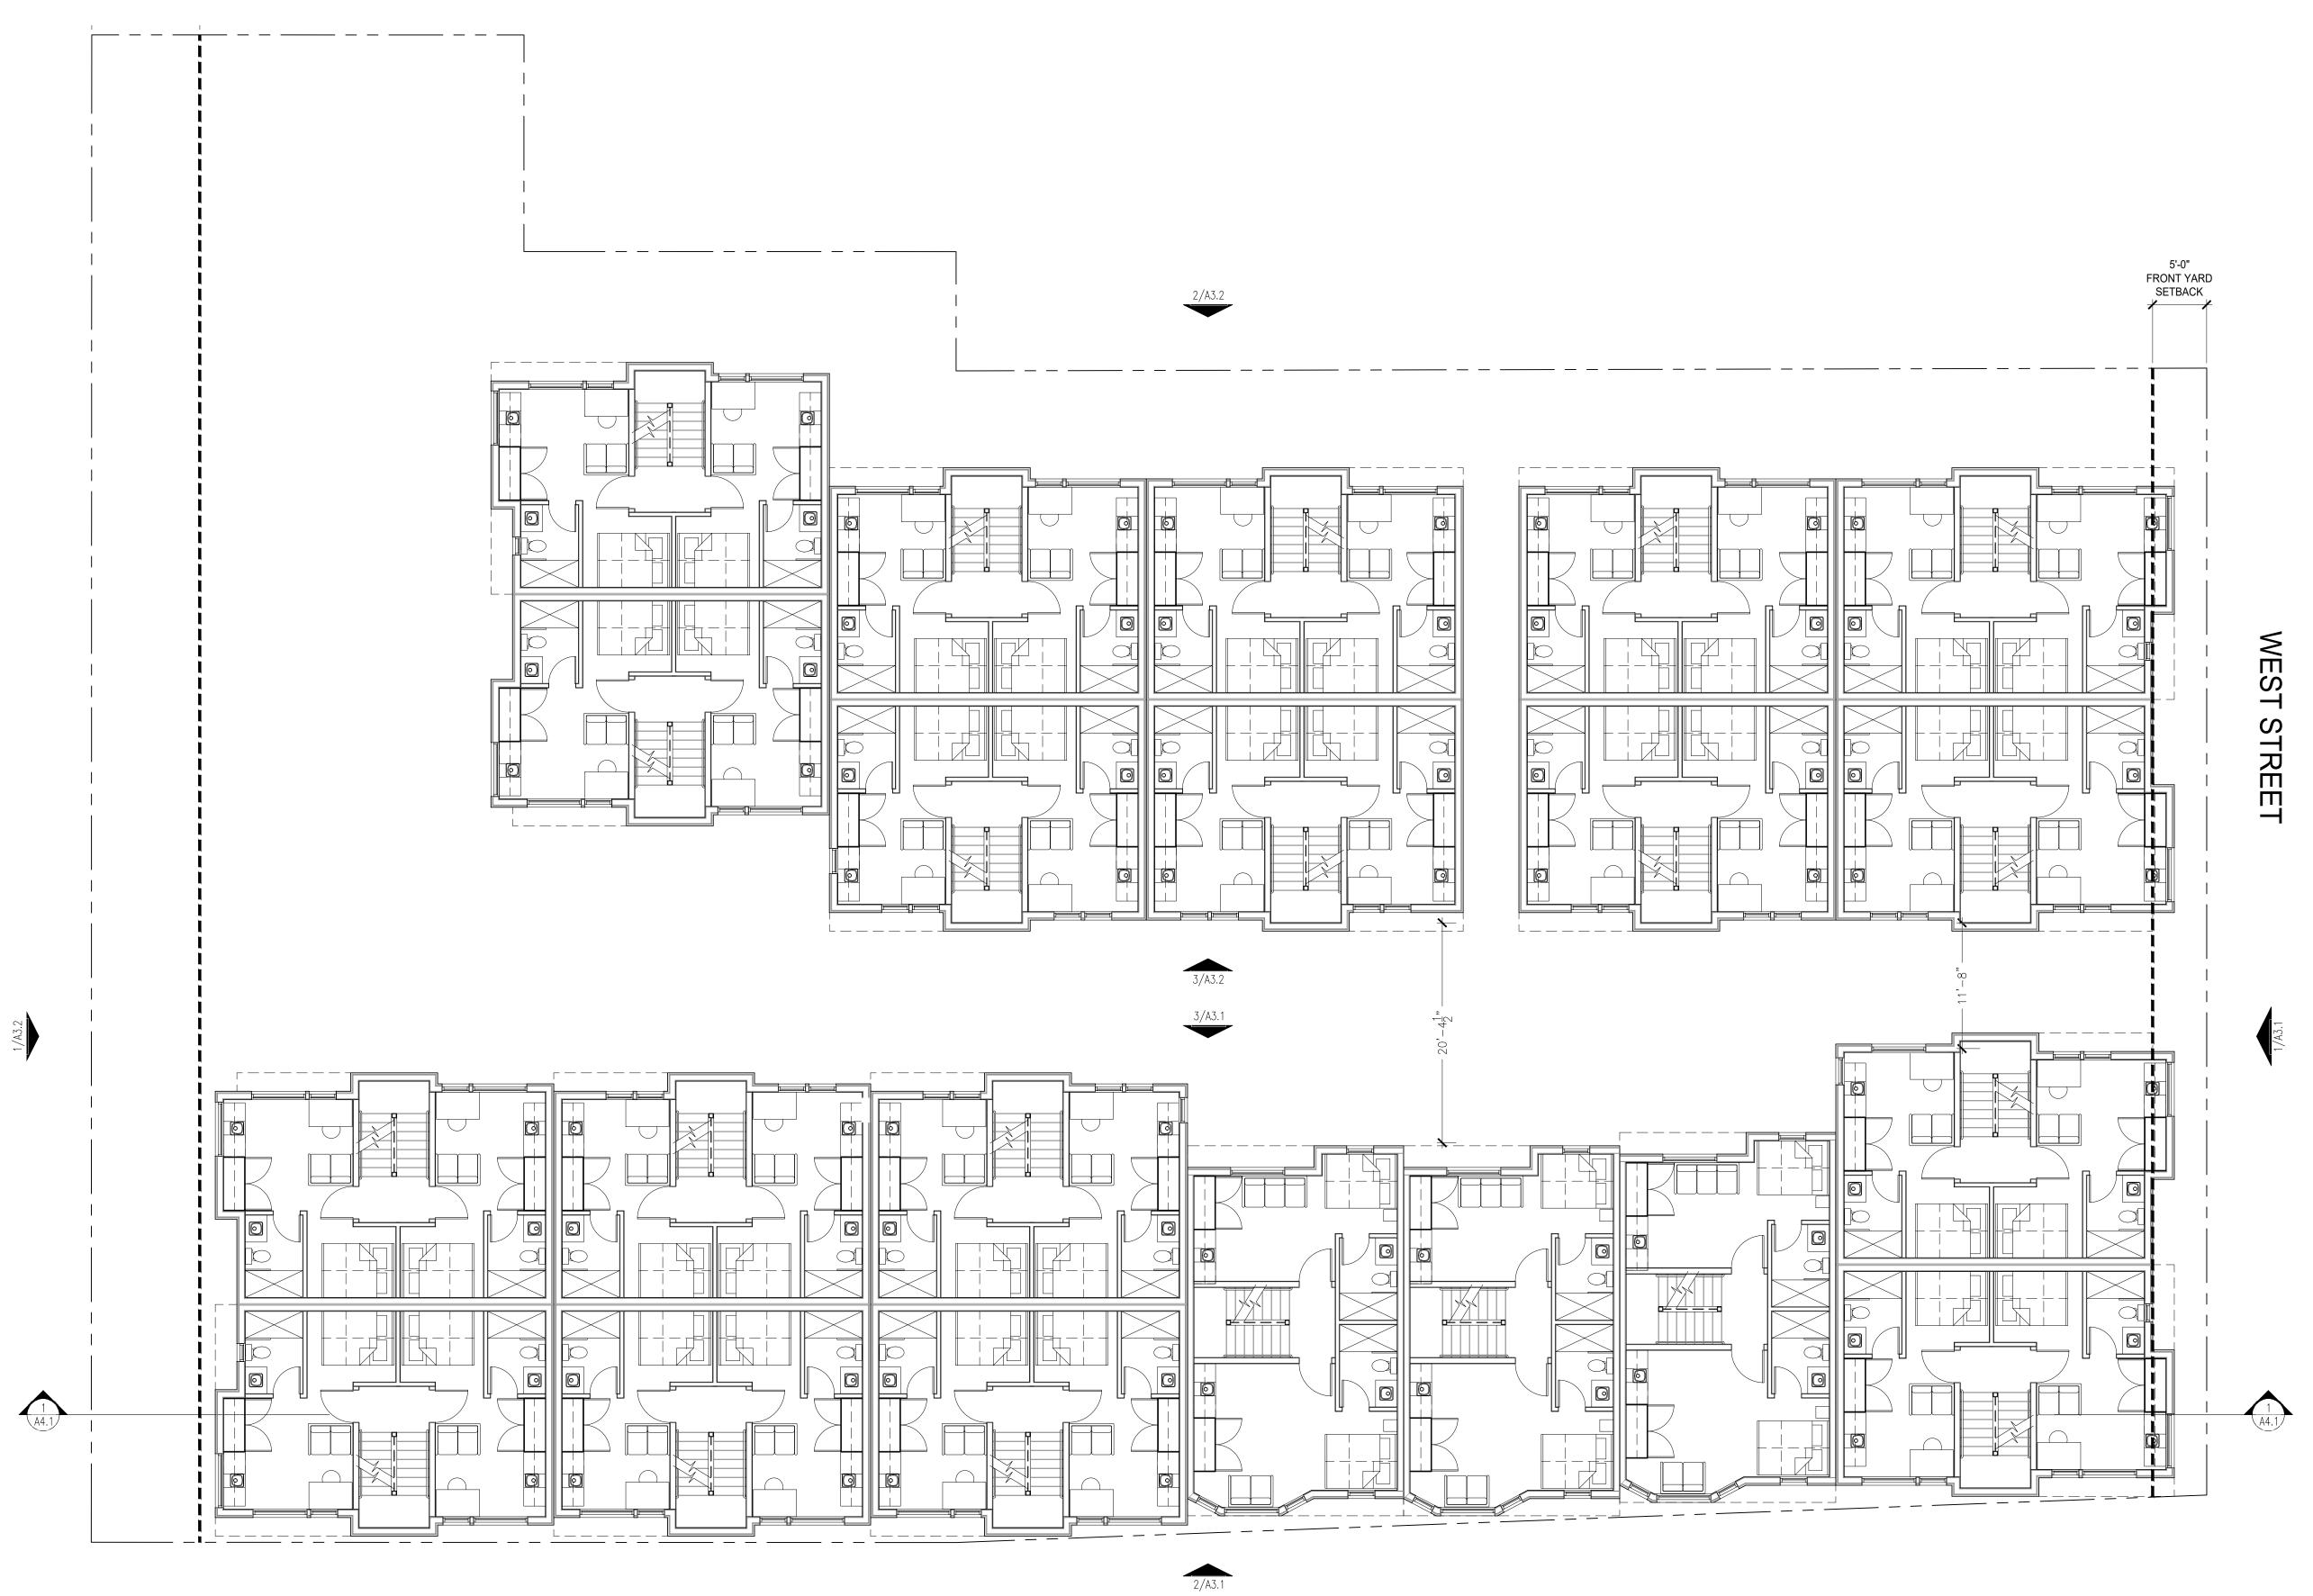
FLOOR PLAN: **GROUND FLOOR**

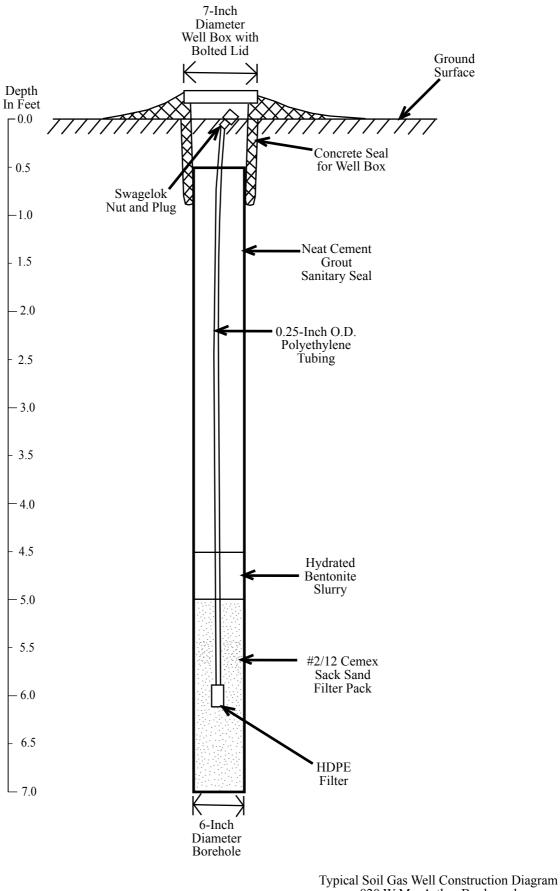
Soil Gas Well Construction Diagram

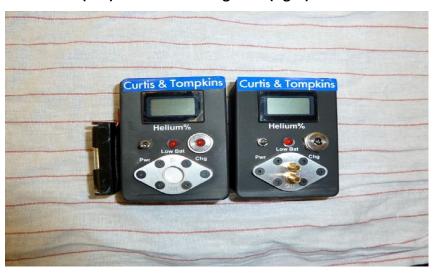
#### Figure 1: Diffusion Cell (left) and Flow-Through cell (right) Helium Detectors

When used properly, these diffusion cell He detectors provide real time measurement of Helium concentration in air from 1% to 99% Helium to accuracies of 0.1%. Prior to delivery, the He detectors are calibrated and performance verified. If, upon initial check, you discover the He gauge is apparently not working properly, call your C&T project manager immediately; repair and replacement costs will be assessed for all sensors returned damaged to the lab.

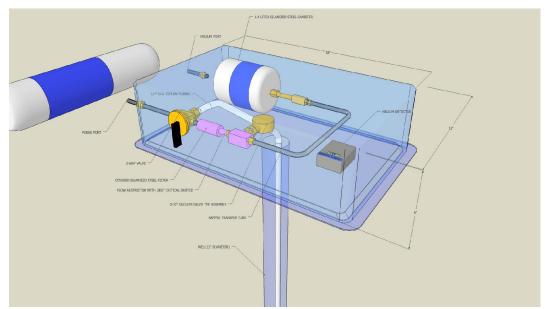
#### **Figure 2: Helium Tracer Shroud Components**

If you're using the lid, and we recommend you do, position the lid over the wellhead with the tubing arising through the hole in the lid. There is an audible snap when the lid is optimally attached.

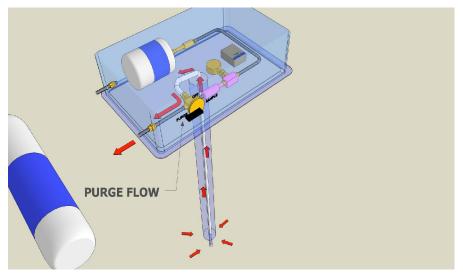
### Figure 3: Purge Flow Diagram

- 5.4. Monitor the Helium concentration displayed on the gauge in the shroud for about a minute in single shrouds, 90 seconds or longer in doubles. Under ideal conditions, 40 psi from the bottle will charge a single shroud to 25% helium concentration; double shrouds will require 80 psi. 25% Helium concentrations are maintained in the lab (zero wind) for 6-10 minutes. You may add more helium while purging and sampling. We suggest 10 psi increments for singles and 20 psi for doubles by opening the lecture bottle valve ¼ turn. We suggest users record/document the Helium concentration in the shroud at a minimum of 2 minute intervals during sampling.
