## Memorandum

**Subject:** Oak Knoll Mixed Use Development Project Tree Removal Impact Mitigation Plan

## Historic Resource Inventory

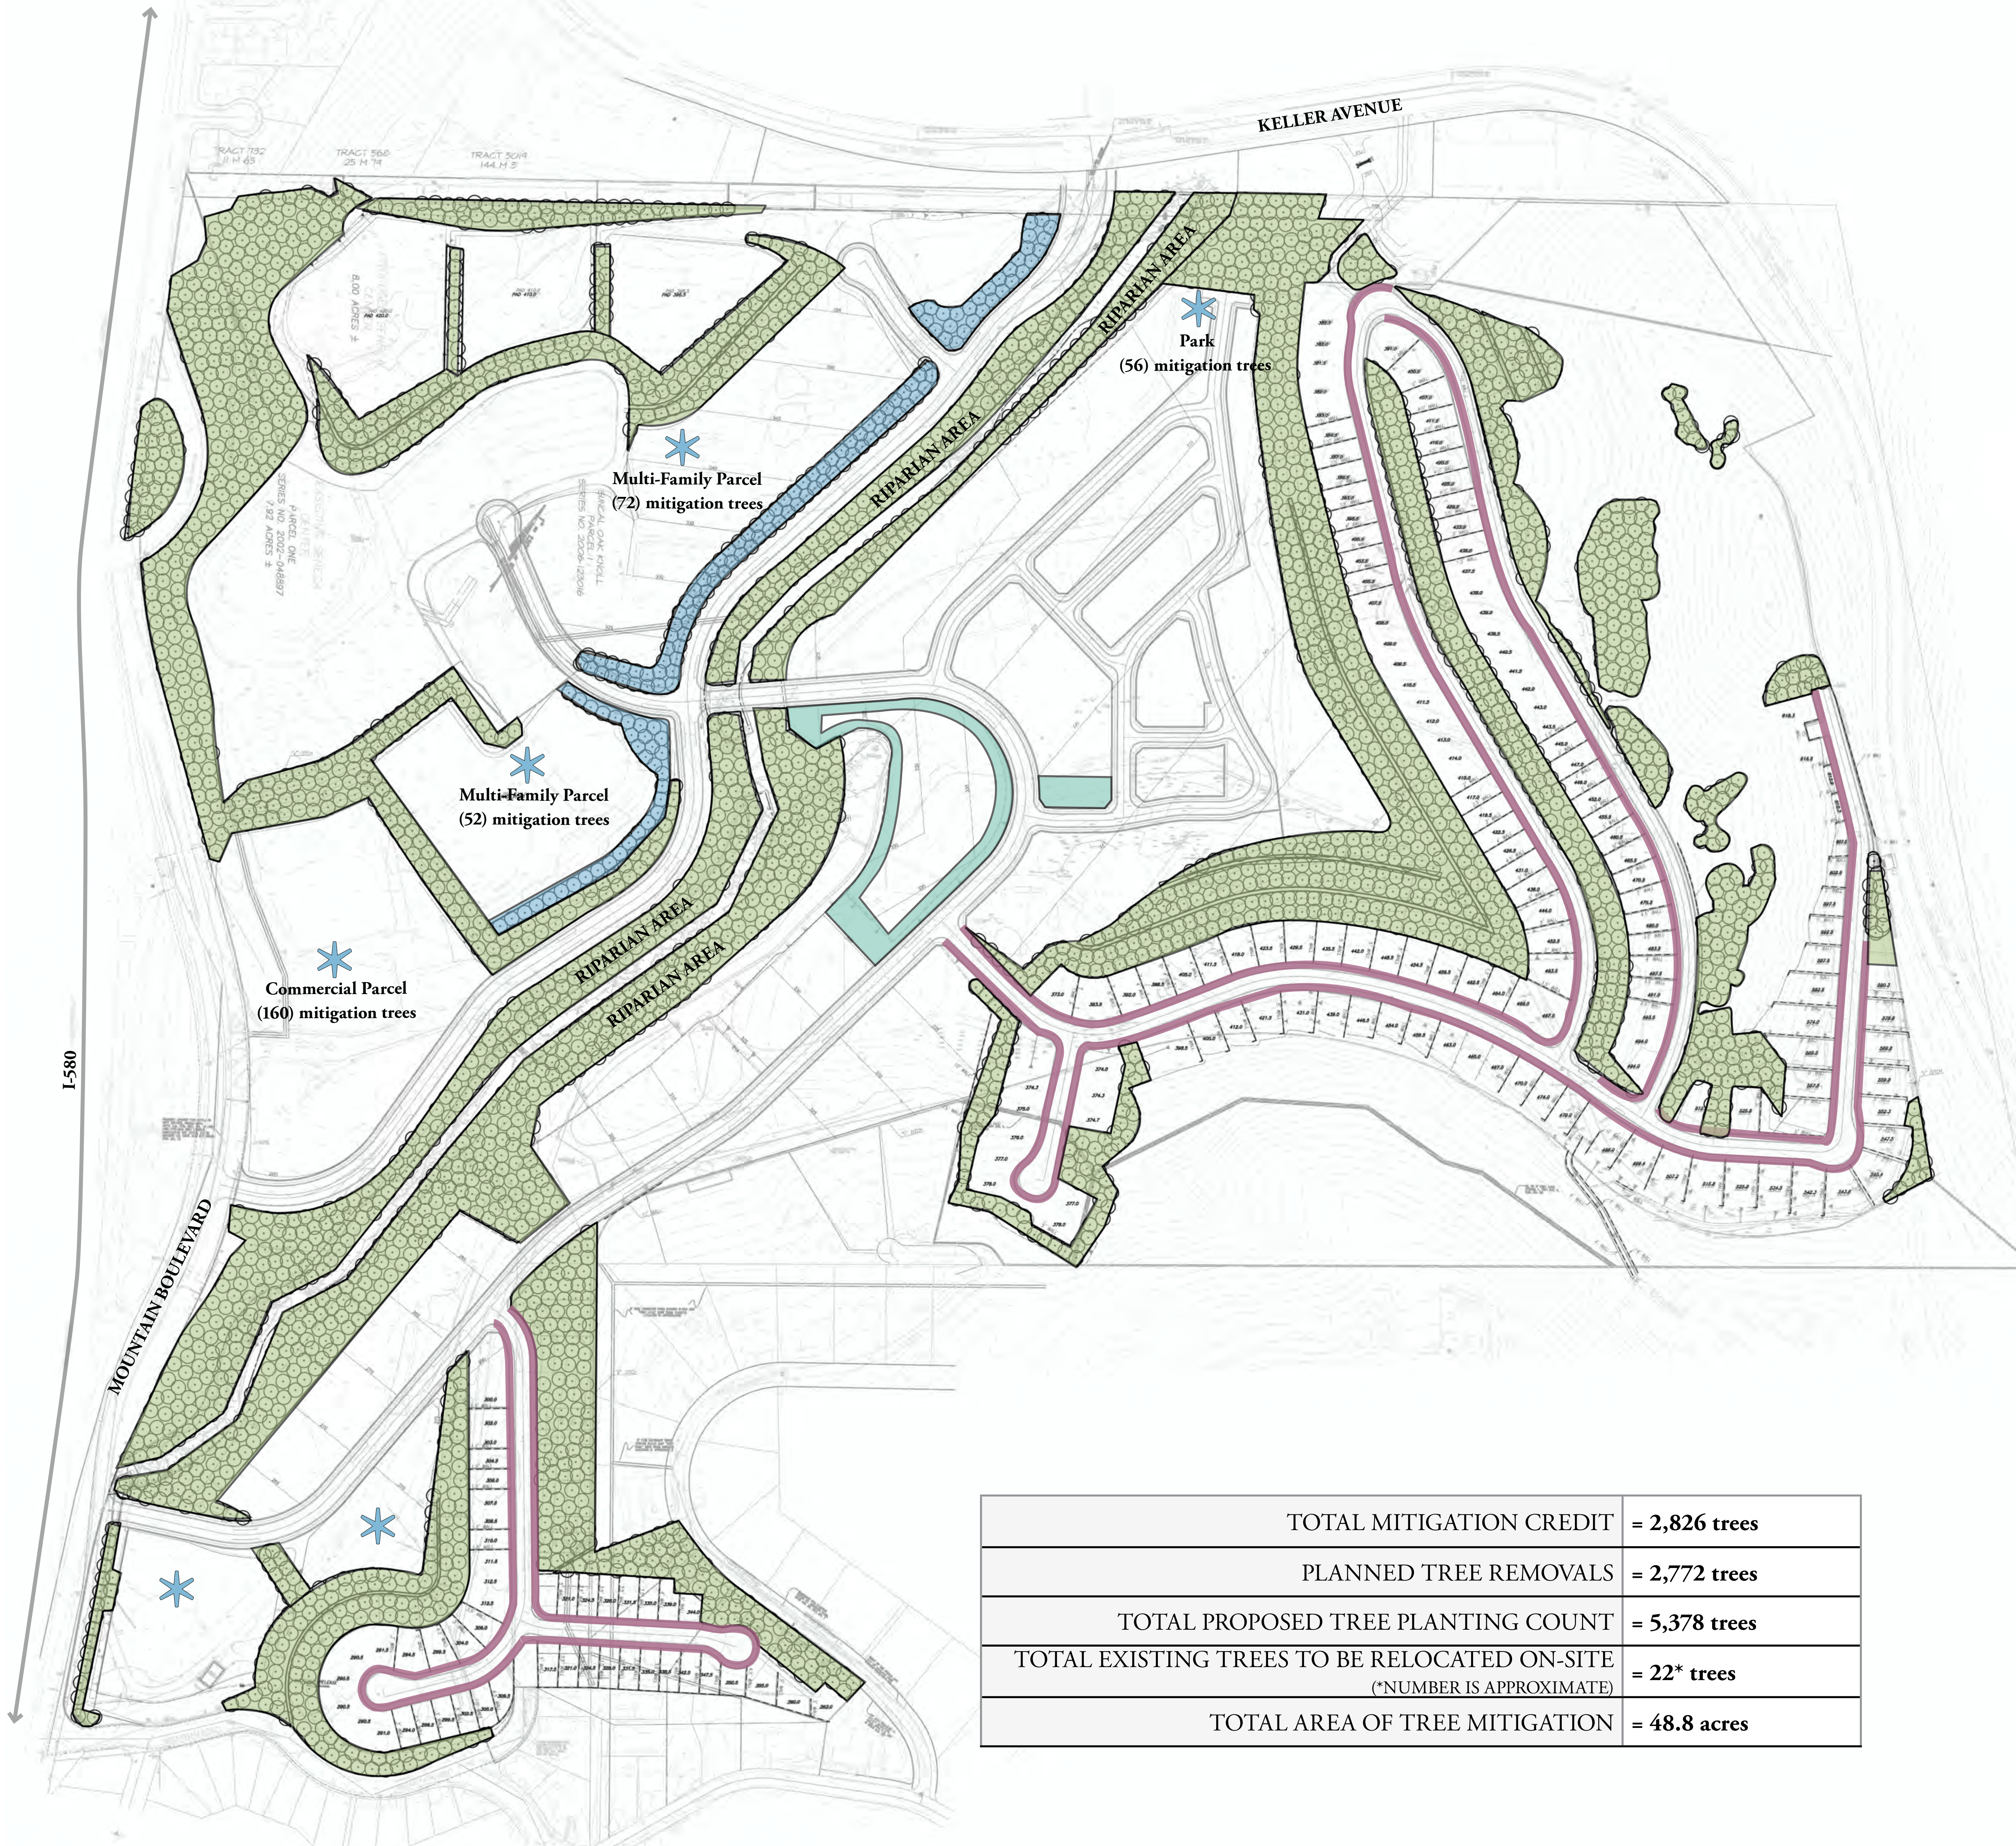
Note: Location of proposed trees shown is approximate and may vary based on site conditions.

The preliminary tree mitigation map (Appendix B) includes four conceptual planting areas including: open space/woodland slope areas, street tree planting areas, community center, and in-tract areas. In addition, the mitigation areas would include a proposed riparian planting palette in accordance with the proposed Rifle Range Creek Riparian Restoration Plan (WRA 2015b). Replacement trees sizes will vary from five-gallon pot size up to 60" box trees, with most replacement trees being 15-gallon pot size. Proposed spacing for replacement trees will range from grouped plantings 10 to 14 feet on center per 700 square feet for small 5- to 15-gallon pot sizes, to 23 to 26 feet on center for larger box trees. The final spacing of replacement

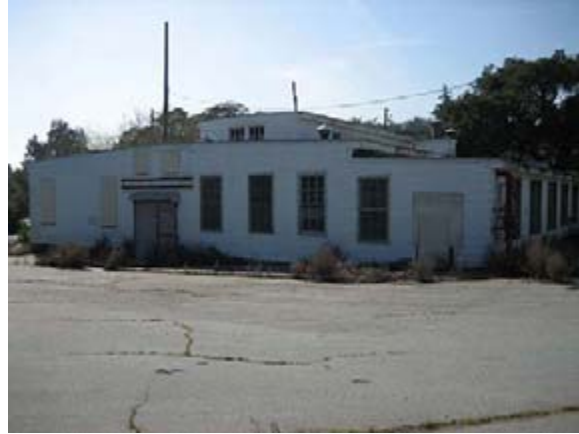
**Building No./Identifier: 9**

*Date of Construction (if known):* 1942  
*1994 Survey (Y/N):* Y  
*Type (I, II, or III.):* I  
*Evaluation:* Not Historic  
*Height (in stories):* 1  
*1949 Use:* Storehouse  
*1989 Use:* General Storage Shed  
*Notes:*

Building No. 9 has a gable-roof and cement asbestos siding. It is located adjacent to Building No. 8, along the nearby creek.

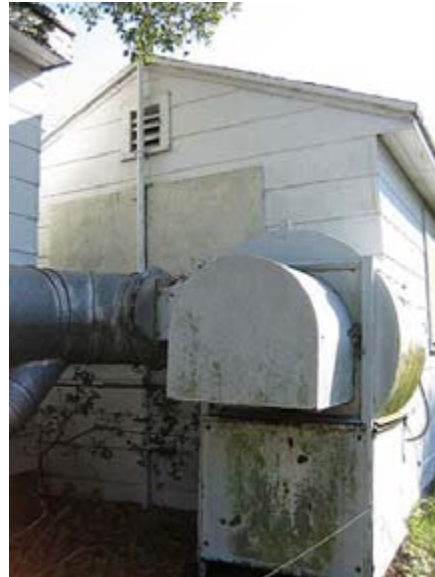
**Building No./Identifier: 10**

*Date of Construction (if known):* 1942  
*1994 Survey (Y/N):* Y  
*Type (I, II, or III.):* I  
*Evaluation:* Not Historic  
*Height (in stories):* 1  
*1949 Use:* Public Works Shop  
*1989 Use:* Industrial (Shop)  
*Notes:*

Original features include the wood sash windows and paneled doors.

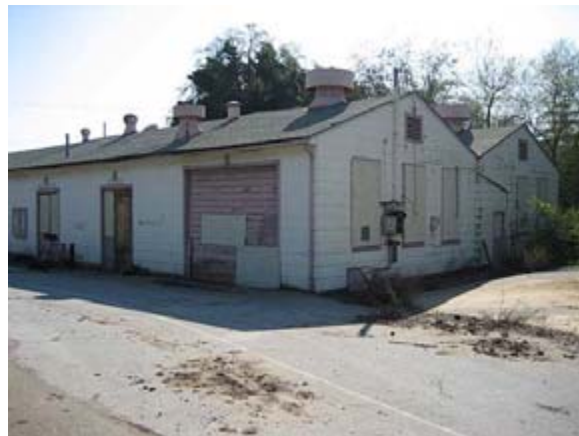
**Building No./Identifier: 11**

Original features include wood panel doors and windows.

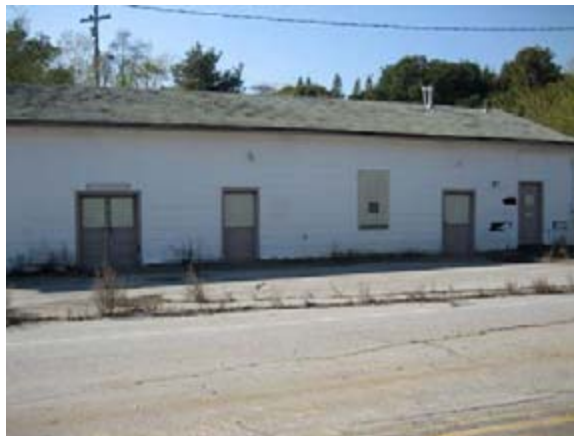
**Building No./Identifier: 13**

Attached to the building is a shed roof addition, clad with cement asbestos shingles. Original features include the original sliding doors and double-hung windows.

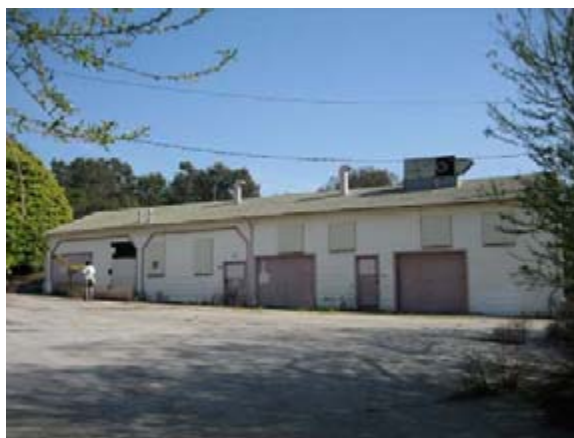
**Building No./Identifier: 14**

Building No. 14 has a gable-roof with a flat-roof addition, and a shed overhang/cage storage area clad with corrugated metal and featuring a steel-frame structural system.

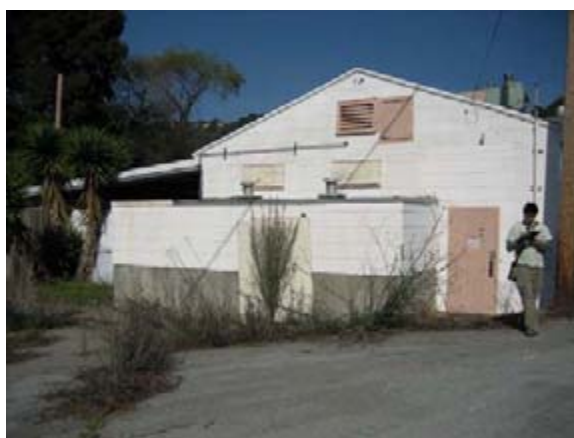
**Building No./Identifier: 17**

Building No. 17 is a concrete structure with a flat roof. It is built in two parts and is surrounded by a concrete retaining wall and gully. The building is utilitarian in design.

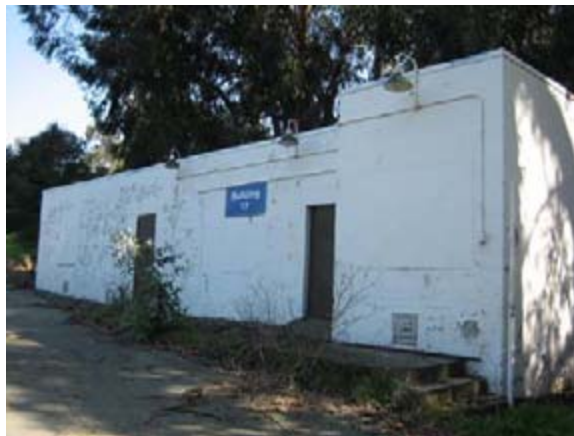
**Building No./Identifier: 18**

Building No. 18 is the only property on the site that has been determined to be individually eligible for listing in the National Register of Historic Places by the 1994 Historic Resources Inventory. As noted in the nomination forms prepared by Page & Turnbull, the building is significant in the areas of architecture, military and entertainment/recreation for its association with the former U.S. Naval Hospital in Oakland, the Oak Knoll Country Club and golf professional Mary Fry. Later correspondence with the CA-OHP determined this building to be ineligible for listing in the National Register of Historic Places.

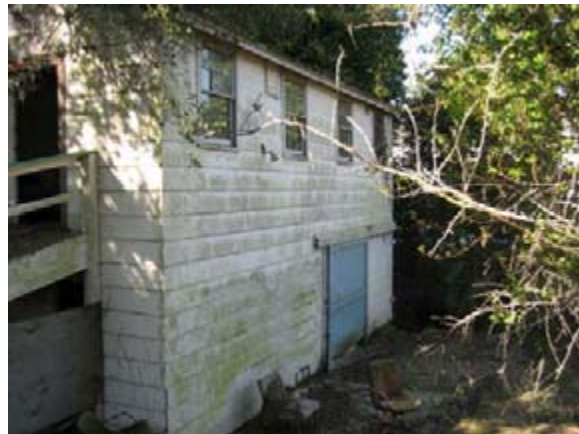
**Building No./Identifier: 22**

*Notes:* Building No. 22 features wood trusses, metal panels over redwood siding, and wood and steel-sash windows.

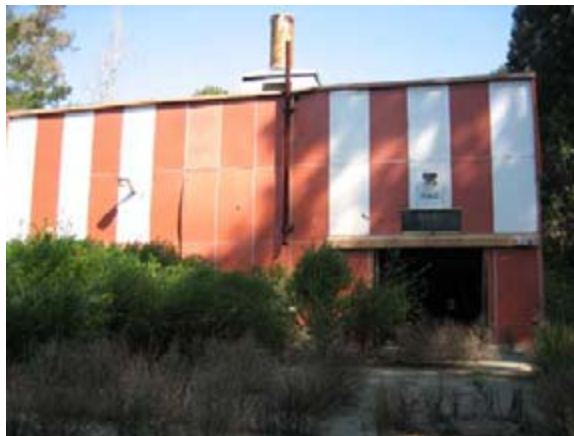
**Building No./Identifier: 36**

Architectural features include portions of original exposed redwood siding and a back porch canopy/shed.

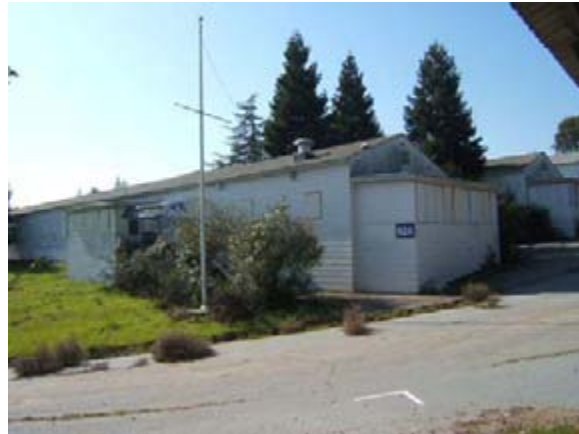
**Building No./Identifier: 63**

*Date of Construction (if known):* 1942  
*1994 Survey (Y/N):* Y  
*Type (I, II, or III.):* II  
*Evaluation:* Requires Further Research  
*Height (in stories):* 1  
*1949 Use:* Medical Ward  
*1989 Use:* Administrative Office  
*Notes:* Building No. 63 has a typical H-shaped floor plan. It features a metal garage door, wood-paneled doors, and six-over-six double-hung wood sash windows.

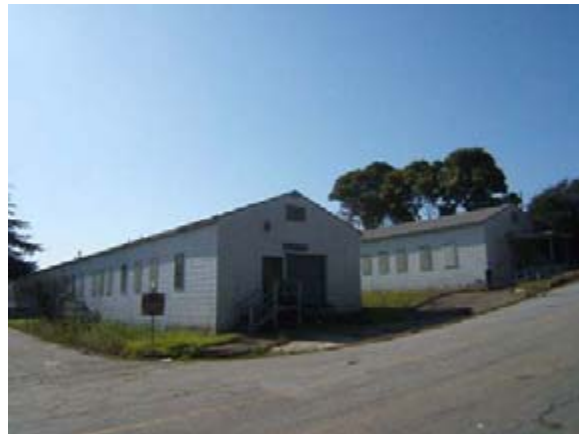
**Building No./Identifier: 65**

*Date of Construction (if known):* 1942  
*1994 Survey (Y/N):* Y  
*Type (I, II, or III.):* II  
*Evaluation:* Requires Further Research  
*Height (in stories):* 1  
*1949 Use:* Ward  
*1989 Use:* Laboratory  
*Notes:* This building has a typical H-shaped floor plan. It contains large exposed mechanical equipment on metal frames within its courtyard.

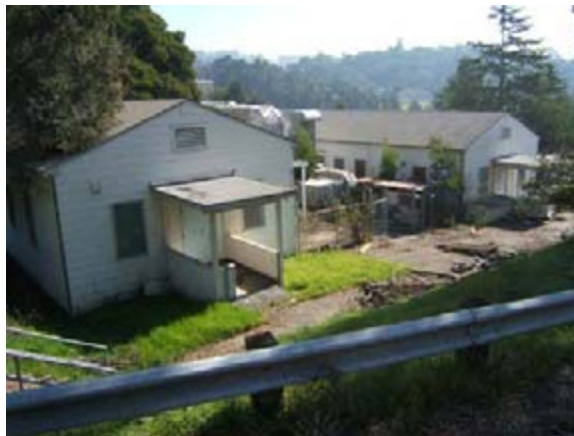
**Building No./Identifier: 66**

*Date of Construction (if known):* 1942  
*1994 Survey (Y/N):* Y  
*Type (I, II, or III.):* II  
*Evaluation:* Requires Further Research  
*Height (in stories):* 1  
*1949 Use:* Sick Officer's Quarters  
*1989 Use:* Medical Ward  
*Notes:* Building No. 66 features a typical H-shaped plan and is located on a sloping site. The building is accessed from wood ramps.

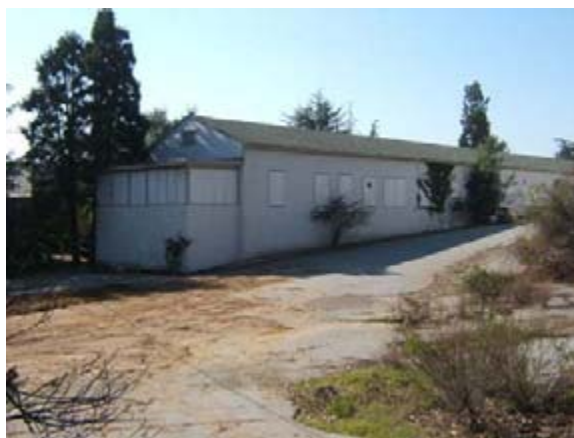
**Building No./Identifier: 67**

*Date of Construction (if known):* 1942  
*1994 Survey (Y/N):* Y  
*Type (I, II, or III.):* II  
*Evaluation:* Requires Further Research  
*Height (in stories):* 1  
*1949 Use:* Sick Officer's Quarters  
*1989 Use:* Dental Clinic and Office  
*Notes:* Building No. 67 is H-shaped in plan and is located on a sloping site. The building features double-hung, six-over-six wood-sash windows and paneled wood doors. Enclosed porches are located on the west façades of the wings.

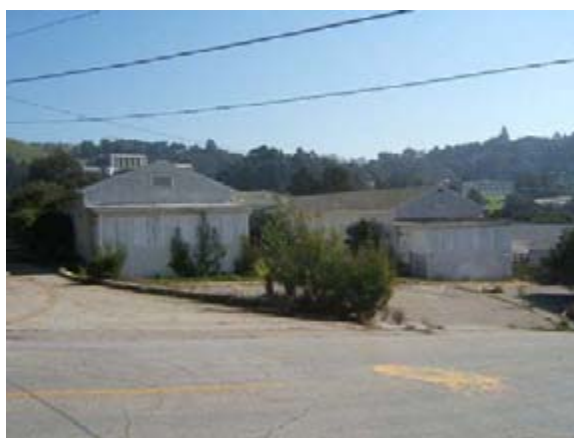
**Building No./Identifier: 69**

Building No. 69 has a typical H-shaped plan and a two-story south wall due to the slope of the site. This building is currently occupied, and has been altered; the original wood-sash windows and wood doors have been replaced with double-hung, one-over-one, aluminum windows and aluminum doors.

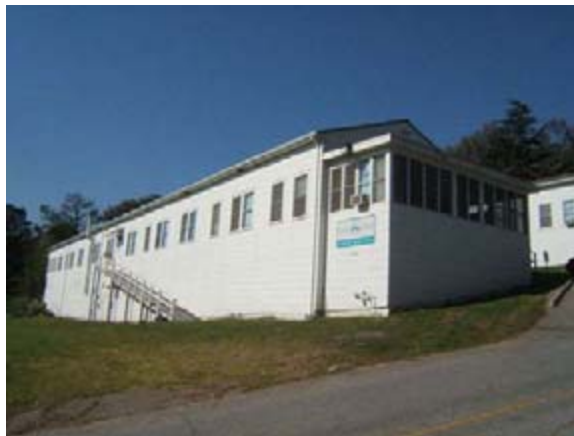
**Building No./Identifier: 70**

As with many of the surrounding buildings, Building No. 70 has an H-shaped plan. Architectural features include enclosed porches on the north side of the building and a two-story stair tower with metal stairs on the east side of the building.

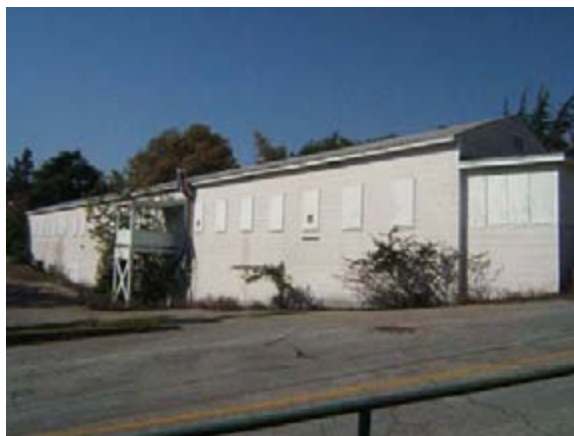
**Building No./Identifier: 75**

Building No. 75 has a typical H-shaped plan. Architectural features include a flat-roofed entry porches on the north side and enclosed hipp-roof porches on the south.

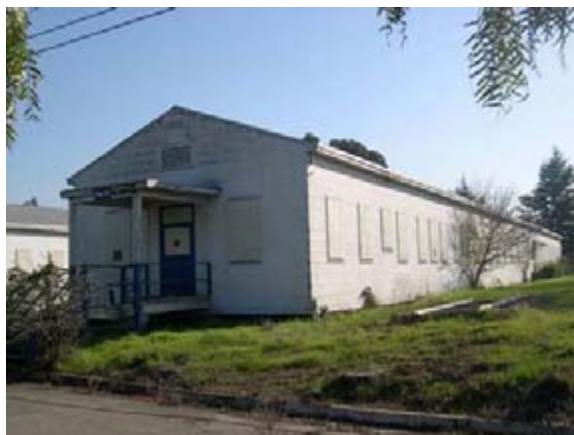
**Building No./Identifier: 89**

Architectural features include the original full-length loading dock with concrete stairs. The building is raised off the ground and has a gable roof.

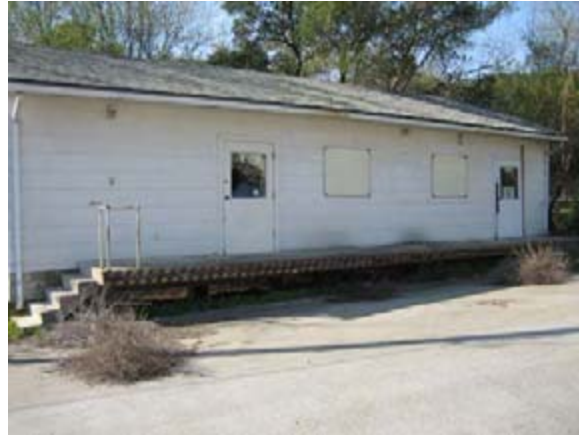
**Building No./Identifier: 90**

Building No. 90 is a small concrete structure with a corrugated metal shed roof. Original features include six-light windows.

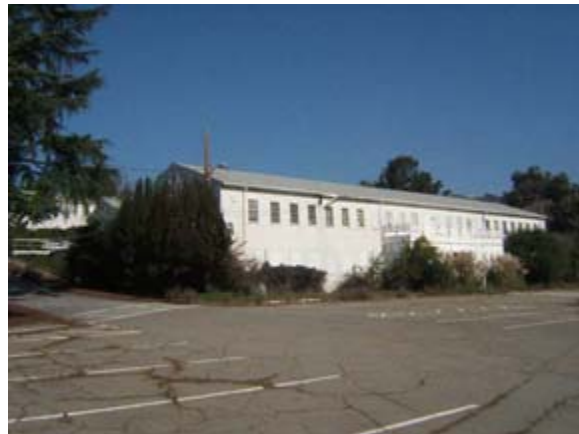
**Building No./Identifier: 102**

This building is two-stories in height with minimal fenestration on the first floor. Architectural elements include concrete bunkers and a shed-roof addition.

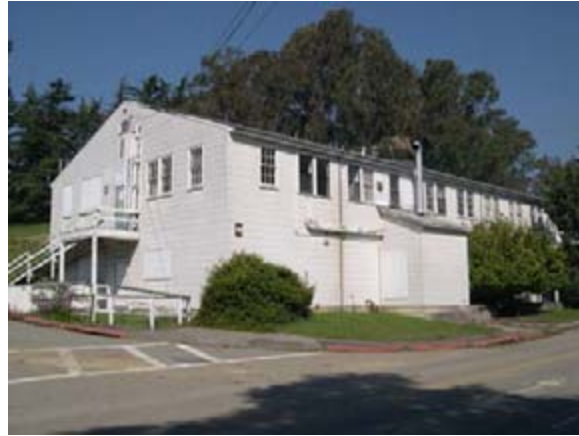
**Building No./Identifier: 103**

Architectural features include a double gable roof, louvred gable openings, and a raised entry porch. Handmade wood signs reading “Oak Knoll’s Bowl Cue recreation center” are still extant on the north and east façades.

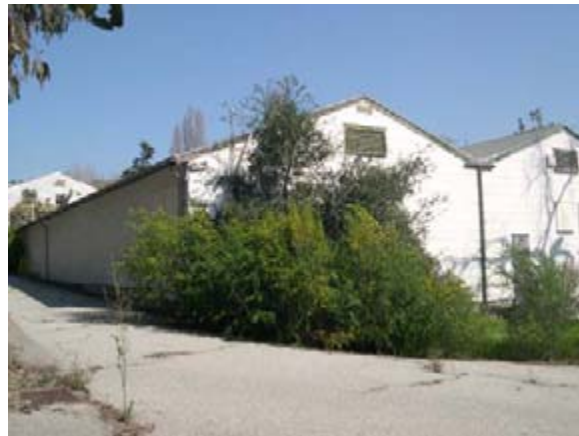
**Building No./Identifier: 108**

Building No. 108 appears to have been heavily altered over its lifetime, as seen by the concrete exterior and large metal doors.

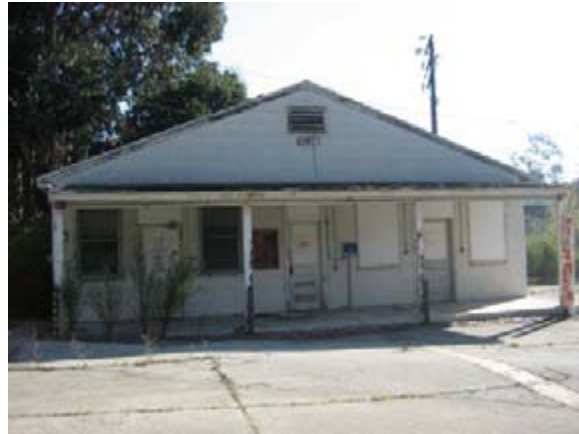
**Building No./Identifier: 112**

*Date of Construction (if known):* 1945  
*1994 Survey (Y/N):* Y  
*Type (I, II, or III.):* I  
*Evaluation:* Not Historic  
*Height (in stories):* 1  
*1949 Use:* Public Works Garage  
*1989 Use:* Auto Shop/Rentals  
*Notes:*  
Notable features include a sliding track garage door, exposed rafters, and glazed wood panel doors.

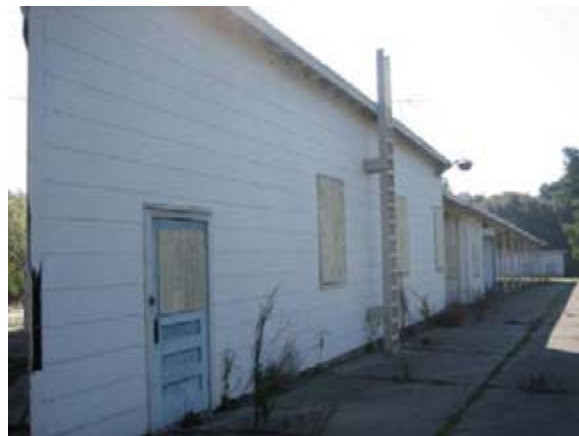
**Building No./Identifier: 113**

Building No. 113 is part of the 112, 113, 113A, and 116 auto rental and repair complex.

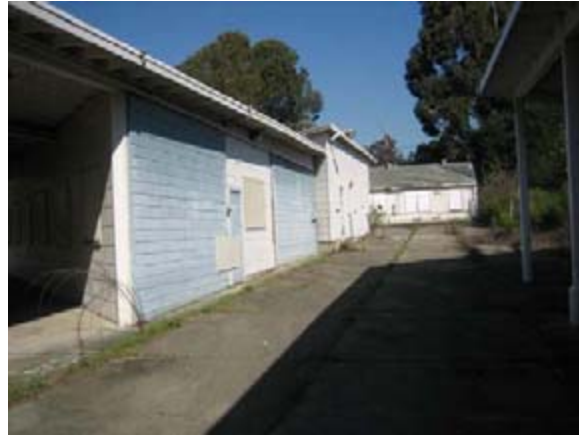
**Building No./Identifier: 113A**

Building No. 113 is part of the 112, 113, 113A, and 116 auto rental and repair complex.

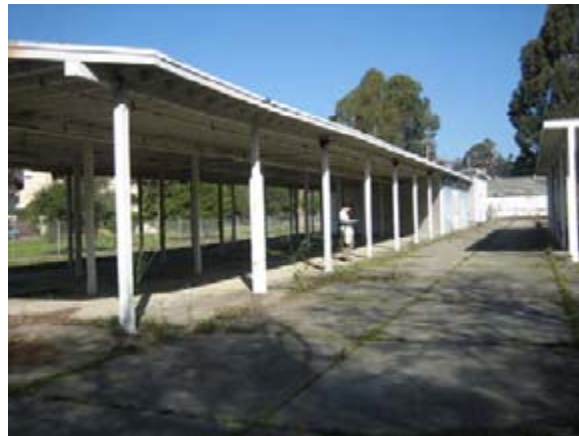
**Building No./Identifier: 114**

Building 114 features a carport, original redwood doors, and a gas pump.

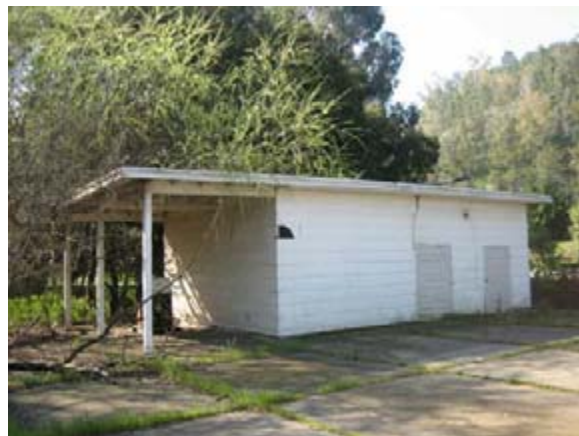
**Building No./Identifier: 115**

*Date of Construction (if known):* 1943  
*1994 Survey (Y/N):* Y  
*Type (I, II, or III.):* I  
*Evaluation:* Not Historic  
*Height (in stories):* 1  
*1949 Use:* Animal House & P.W. Storehouse  
*1989 Use:* Animal Hospital  
*Notes:* This building is L-shaped in plan and has been altered. Architectural elements include a roll-up metal utility door and a hip-roof addition.

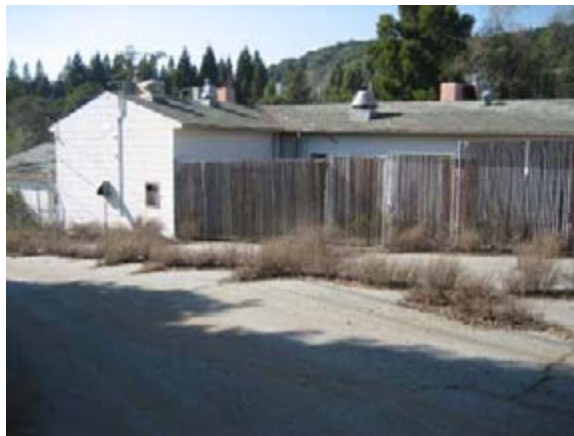
**Building No./Identifier: 116**

*Date of Construction (if known):* 1943  
*1994 Survey (Y/N):* Y  
*Type (I, II, or III.):* I  
*Evaluation:* Not Historic  
*Height (in stories):* 1  
*1949 Use:* Garage Storage Shelter  
*1989 Use:* Emergency Vehicle Shelter  
*Notes:*  
Building No. 113 is part of the 112, 113, 113A, and 116 auto rental and repair complex.

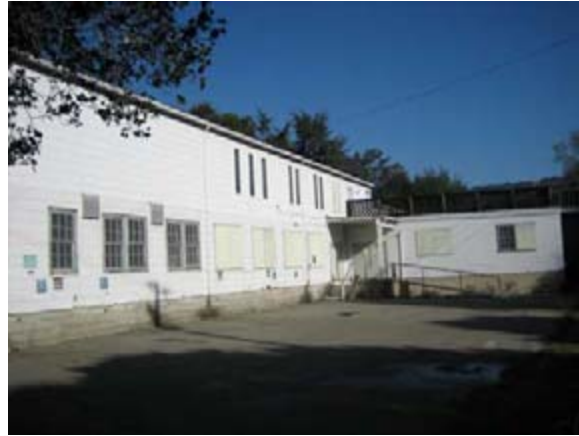
**Building No./Identifier: 138**

*Date of Construction (if known):* 1944  
*1994 Survey (Y/N):* Y  
*Type (I, II, or III.):* II  
*Evaluation:* Not Historic  
*Height (in stories):* 2  
*1949 Use:* Swimming Pool Bath House  
*1989 Use:* Pool  
*Notes:*  
This building has a shed-roof addition, redwood siding (partially obscured by cement-asbestos shingles), a concrete bunker, and an interior pool.

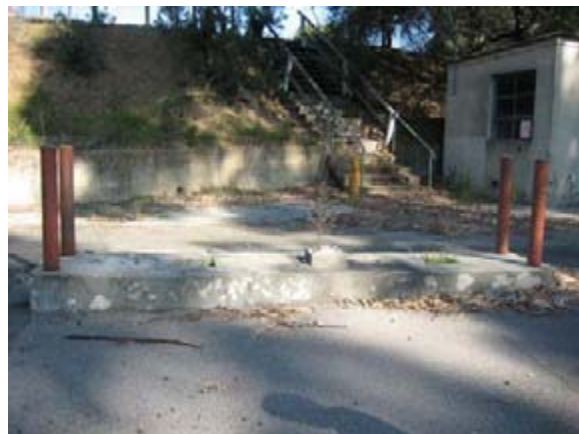
**Building No./Identifier: 141**

*Date of Construction (if known):* 1953  
*1994 Survey (Y/N):* N  
*Type (I, II, or III.):* n/a  
*Evaluation:* Not Historic  
*Height (in stories):* n/a  
*1949 Use:* n/a  
*1989 Use:* Filling Station  
*Notes:*  
Only the concrete slab remains from the filling station.

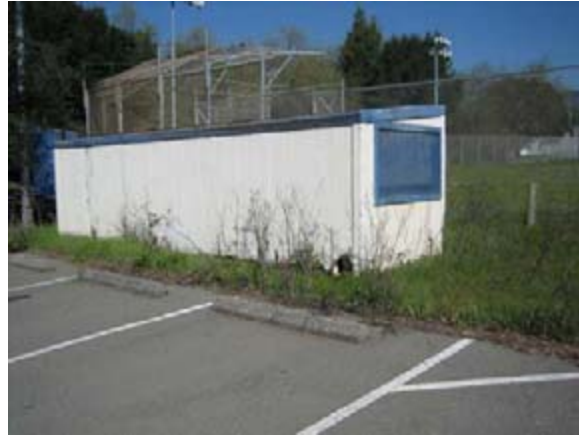
**Building No./Identifier: 143**

*Notes:* This building is a baseball dugout with redwood siding. The dugout contains a snack shack and wood bleachers with steel supports.

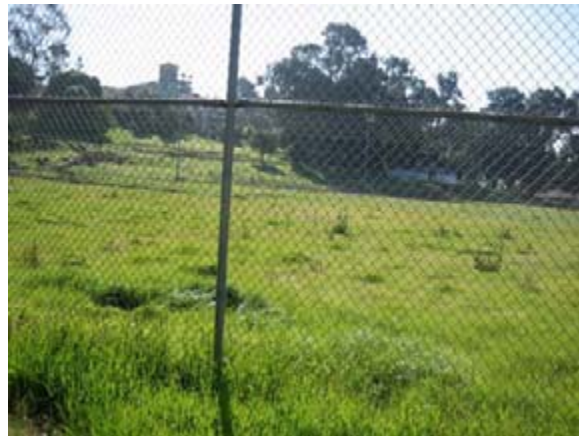
**Building No./Identifier: 144**

Building No. 144 is a baseball field surrounded by a chain link fence. It is located adjacent to the handball court and tennis court.

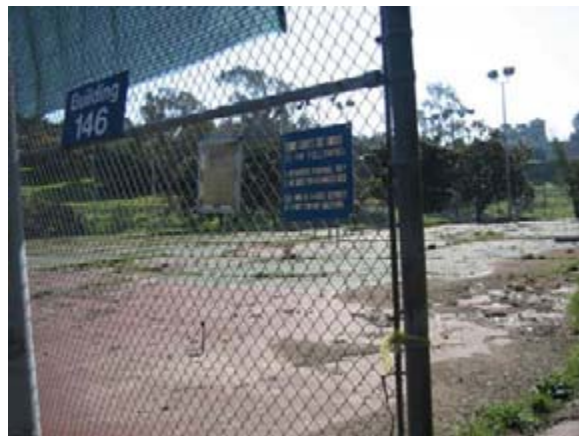
**Building No./Identifier: 146**

Building No. 146 consists of heavily altered tennis courts bounded by a chain link fence.

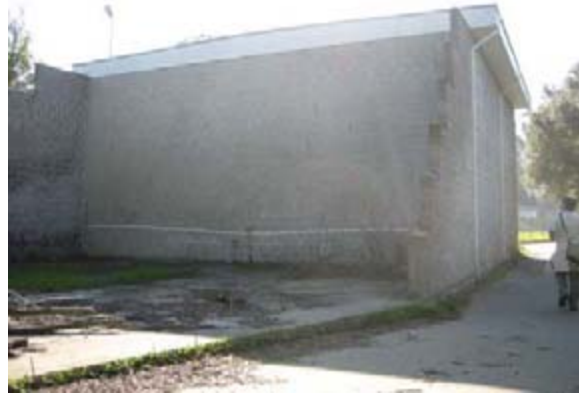
**Building No./Identifier: 147**

Building No. 147 is a handball court with four large windowless walls that have perpendicular sides tapering to the ground. Exterior courts are built off the large wall, as seen in the photograph.

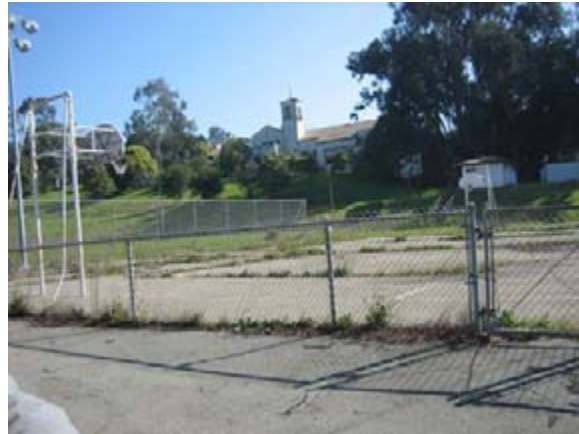
**Building No./Identifier: 148**

Building No. 148 is a basketball court. It consists of a flat asphalt slab with two basketball hoops.

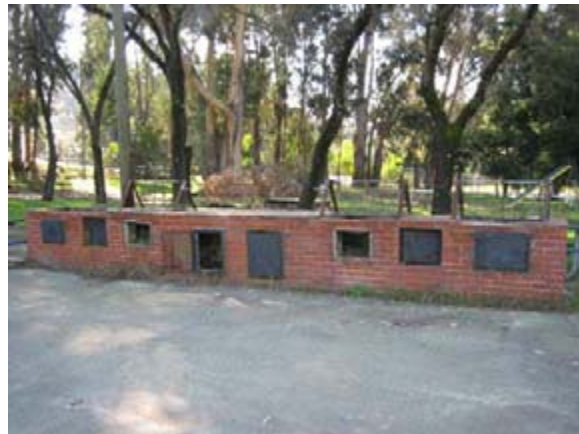
**Building No./Identifier: 149**

Predominantly a landscape feature, Building No. 149 is a BBQ adjacent to a playground and swing set. It is composed of brick masonry with metal doors.

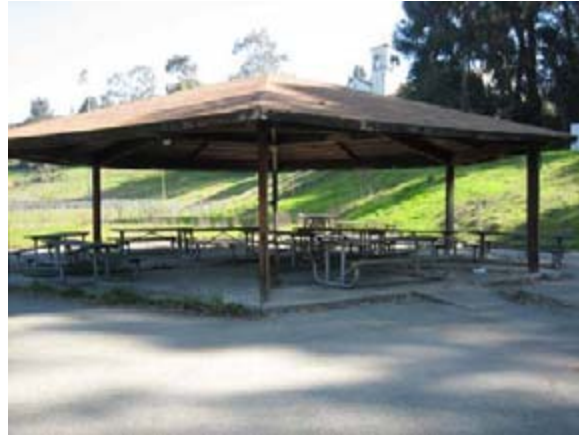
**Building No./Identifier: 150**

*Date of Construction (if known):* 1959  
*1994 Survey (Y/N):* N  
*Type (I, II, or III.):* n/a  
*Evaluation:* Not Historic  
*Height (in stories):* 1  
*1949 Use:* n/a  
*1989 Use:* Recreation Grounds  
*Notes:* Building No. 150 has a hip-roof gazebo with open sides, and contains picnic tables.

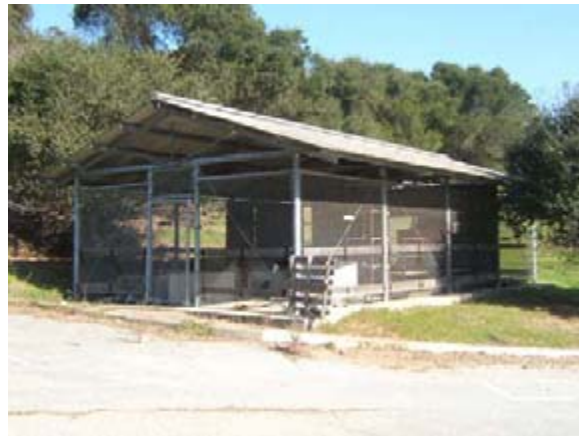
**Building No./Identifier: 215**

*Date of Construction (if known):* 1976  
*1994 Survey (Y/N):* N  
*Type (I, II, or III.):* n/a  
*Evaluation:* Not Historic  
*Height (in stories):* 1  
*1949 Use:* n/a  
*1989 Use:* Storage  
*Notes:*  
Building No. 215 is a shed supported on a metal frame with a corrugated metal hip roof. The walls are composed of chain link fencing.

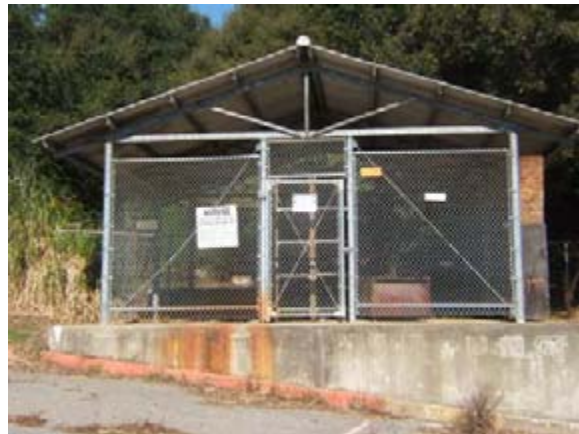
**Building No./Identifier: 216**

*Date of Construction (if known):* 1976  
*1994 Survey (Y/N):* N  
*Type (I, II, or III.):* n/a  
*Evaluation:* Not Historic  
*Height (in stories):* 1  
*1949 Use:* n/a  
*1989 Use:* Storage  
*Notes:*  
Building No. 216 is a shed supported on a metal frame with a corrugated metal hip roof. The walls are composed of chain link fencing.

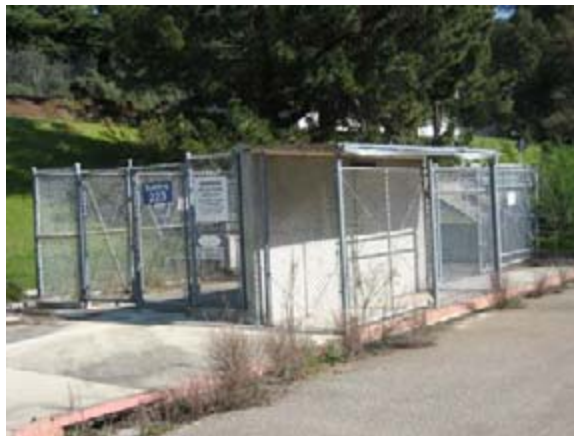
**Building No./Identifier: 223**

This is an open-air paved area enclosed by chain link fence.

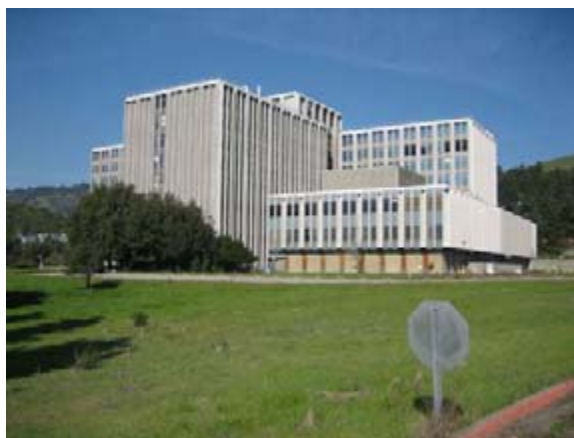
**Building No./Identifier: 500**

Building No. 500 is a Modernist structure with multiple projecting wings of varying heights. The design is attributed to San Francisco architect Milton Pflueger.

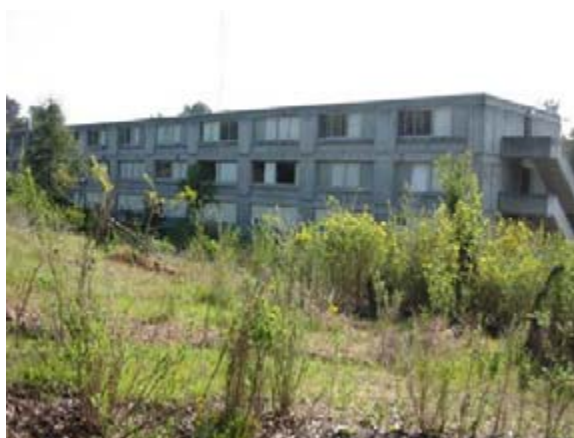
**Building No./Identifier: 501**

This reinforced concrete structure has an H-shaped plan with exterior stairways. The building is rendered in an International Modern style and was utilized as an residence hall/dormitory.

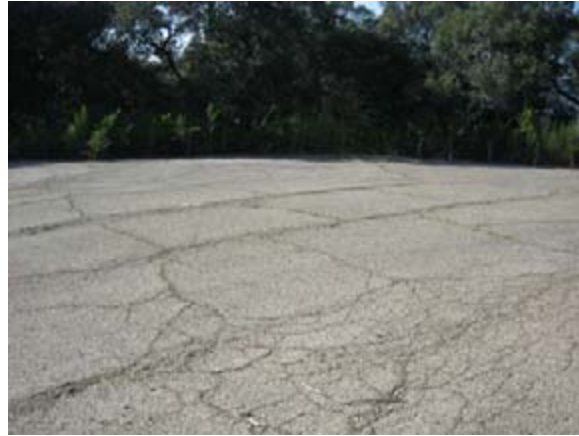
**Building No./Identifier: 502**

*Date of Construction (if known):* 1972  
*1994 Survey (Y/N):* N  
*Type (I, II, or III.):* n/a  
*Evaluation:* Not Historic  
*Height (in stories):* n/a  
*1949 Use:* n/a  
*1989 Use:* helicopter landing pad  
*Notes:* This is a flat asphalt slab previously used as a landing pad for helicopters.

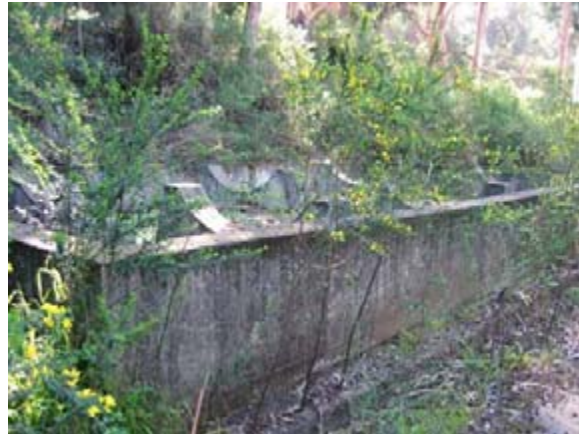
**Building No./Identifier: 503**

*Date of Construction (if known):* 1980  
*1994 Survey (Y/N):* N  
*Type (I, II, or III.):* n/a  
*Evaluation:* Not Historic  
*Height (in stories):* n/a  
*1949 Use:* n/a  
*1989 Use:* Oil Storage  
*Notes:* The former oil storage tanks have been removed and only the concrete foundations remain.

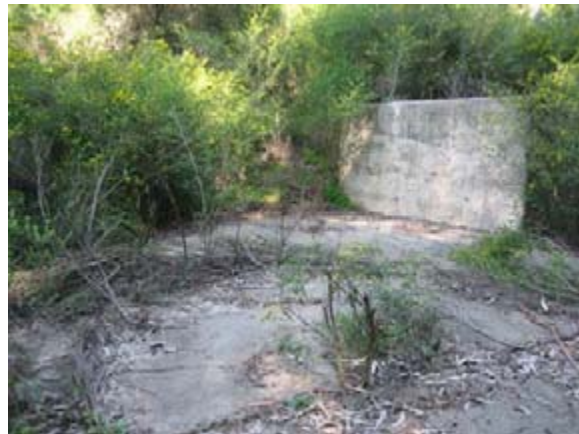
**Building No./Identifier: 504**

*Date of Construction (if known):* 1973  
*1994 Survey (Y/N):* N  
*Type (I, II, or III.):* n/a  
*Evaluation:* Not Historic  
*Height (in stories):* n/a  
*1949 Use:* n/a  
*1989 Use:* Distilled Oil Storage  
*Notes:* The former oil storage tanks have been removed and only the concrete foundations remain.

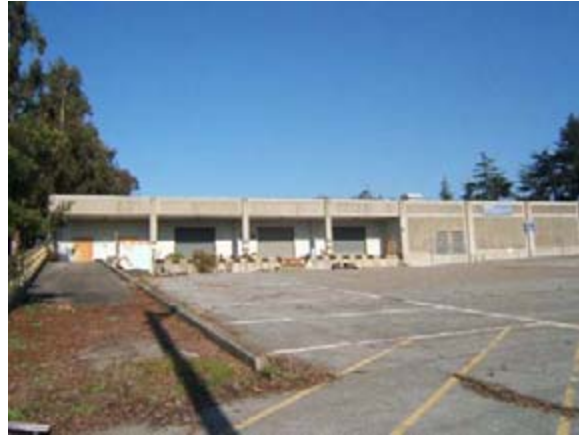
**Building No./Identifier: 505**

Building No. 505 is a reinforced concrete, windowless structure with a flat roof. It is built in an excavated site against a steep slope.

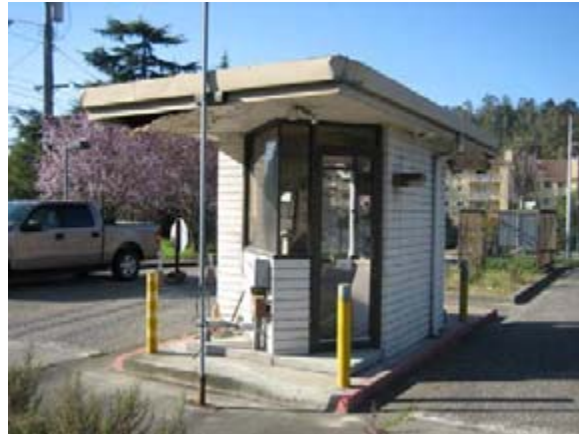
**Building No./Identifier: 506**

*Notes:* The small gatehouse is constructed of concrete blocks and has a flat roof with a projecting canopy. Features include aluminum sash and glazed doors in aluminum frames.

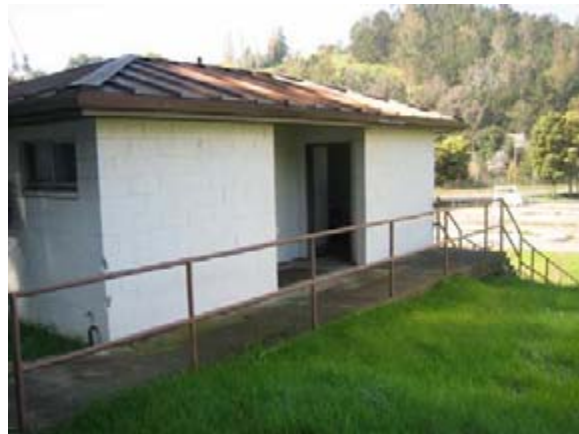
**Building No./Identifier: 507**

This bathroom features concrete block construction with a standing seam aluminum hip roof. It has metal doors and aluminum sash casement windows.

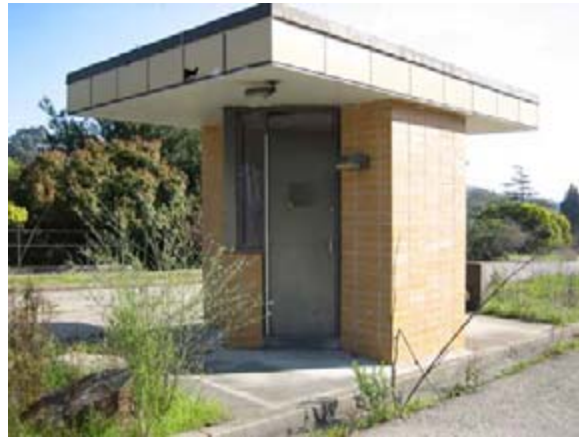
**Building No./Identifier: 508**

This gatehouse is of brick construction, and has a flat roof with a projecting canopy and metal flashing. It has an aluminum door and sash.

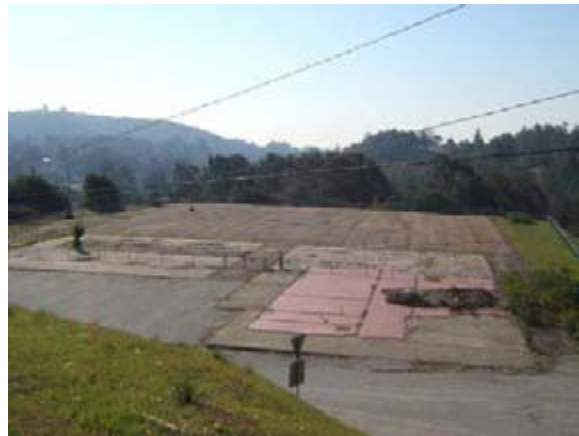
**Building No./Identifier: 509**

Building No. 509 is a large flat concrete slab previously used as a helicopter landing pad. Remnants of a previous structure on the site - including tile floors and framing members - are visible adjacent to the landing pad.

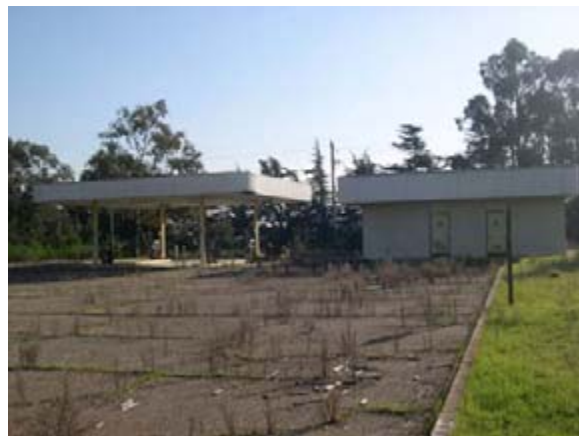
**Building No./Identifier: 510**

Building No. 510 consists of two adjacent one-story flat-roof structures: a gas pump canopy and a repair shop. The canopy shelters four gas pumps and is supported by metal posts that have been stuccoed. The shop has two aluminum roll-up garage doors on the east façade.

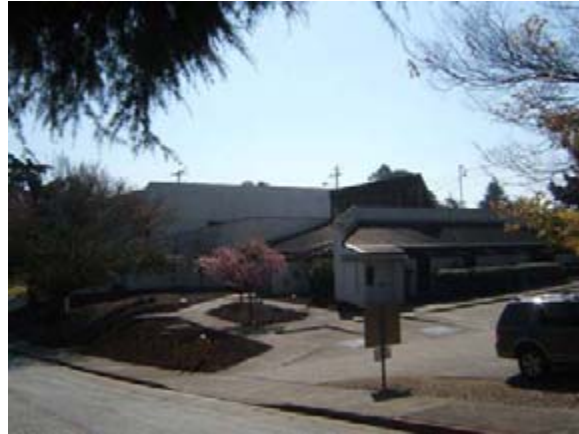
**Building No./Identifier: 511**

This reinforced concrete structure has large plate glass wood-frame windows and exposed rafter ends.

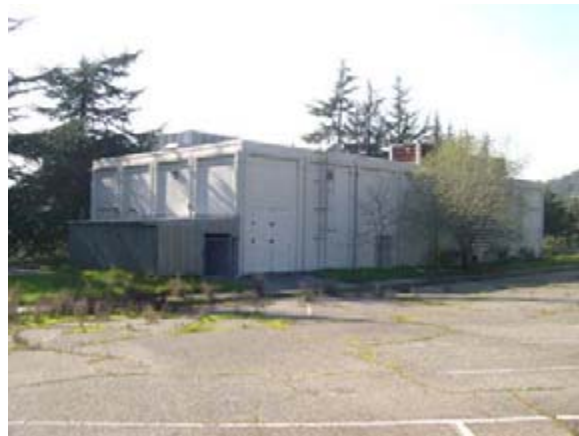
**Building No./Identifier: 512**

This structure is a concrete rectangle with concrete pilasters and mechanical equipment on the roof. There does not appear to be any windows on this building.

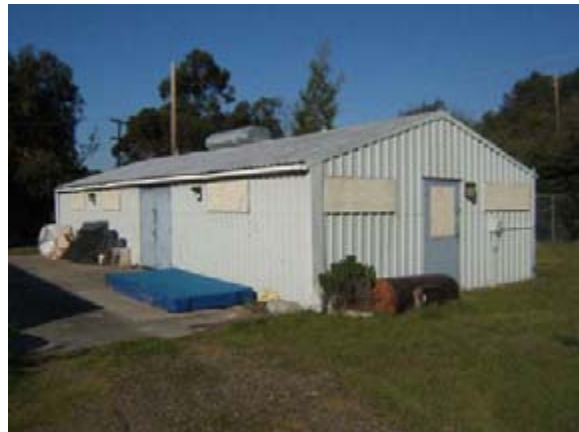
**Building No./Identifier: 519**

The building consists of a shed with standing seam aluminum siding and a corrugated metal roof.

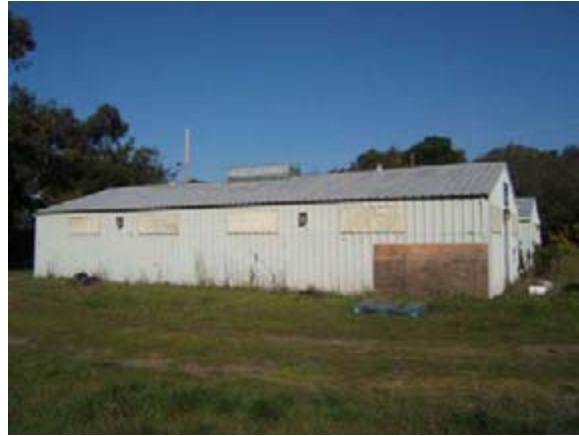
**Building No./Identifier: 520**

Building No. 520 consists of two adjacent sheds with standing seam aluminum siding and a corrugated metal roof.

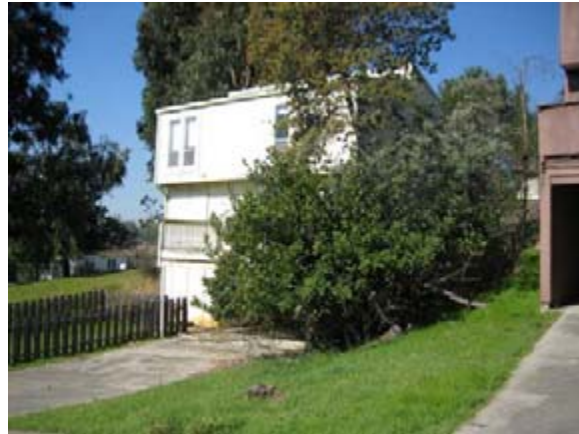
**Building No./Identifier: 4000**

Building No. 4000 is a two-story residential building with plywood sheathing and a shed roof.

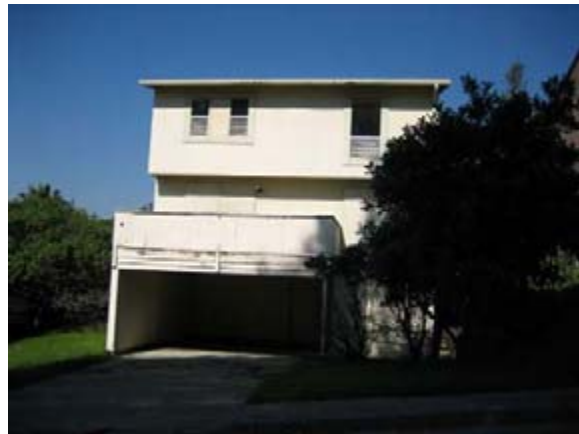
**Building No./Identifier: 4001**

Building No. 4001 is a two-story residential building with wood board sheathing and a gable roof.

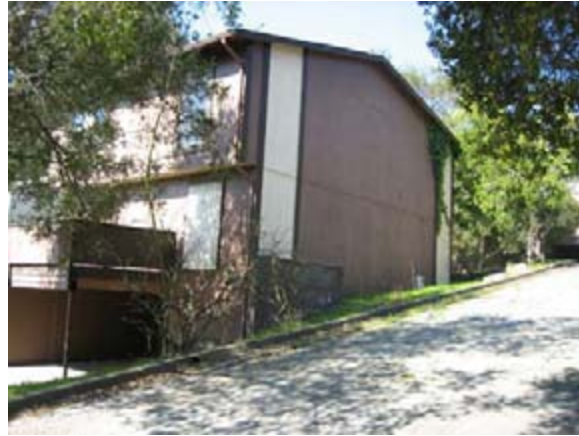
**Building No./Identifier: 4002**

Building No. 4002 is a two-story residential building with plywood sheathing and a shed roof.

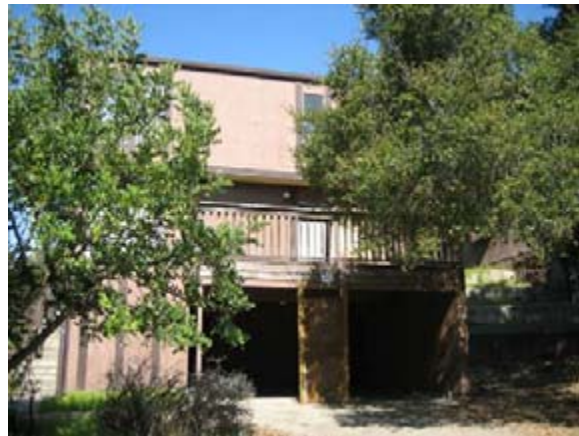
**Building No./Identifier: 4003**

Building No. 4003 is a two-story residential building with wood board sheathing and a gable roof.

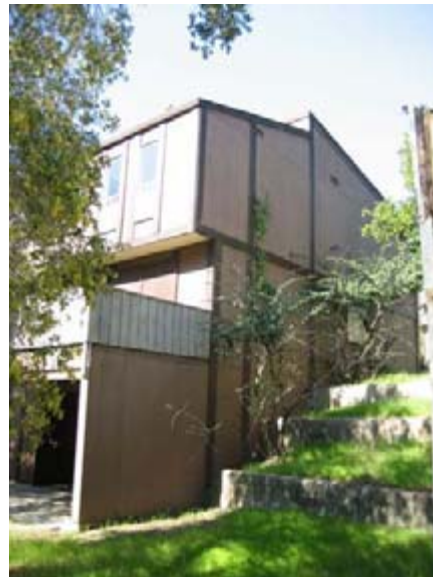
**Building No./Identifier: 4004**

Building No. 4004 is a two-story residential building with plywood sheathing and a shed roof.
