## Memorandum

**Subject:** Oak Knoll Mixed Use Development Project Tree Removal Impact Mitigation Plan

## Historic Resource Inventory

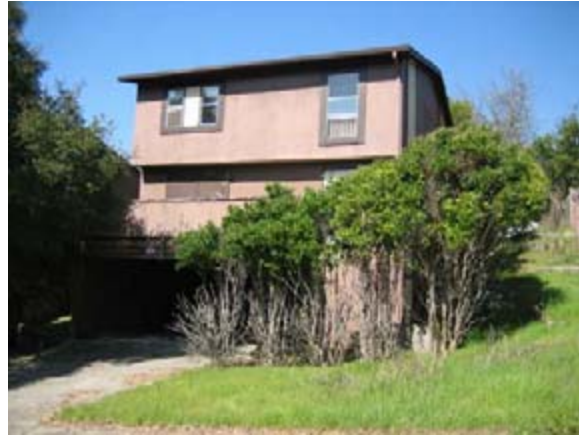
**Building No./Identifier: 4005**

Building No. 4005 is a two-story residential building with wood board sheathing and a gable roof.

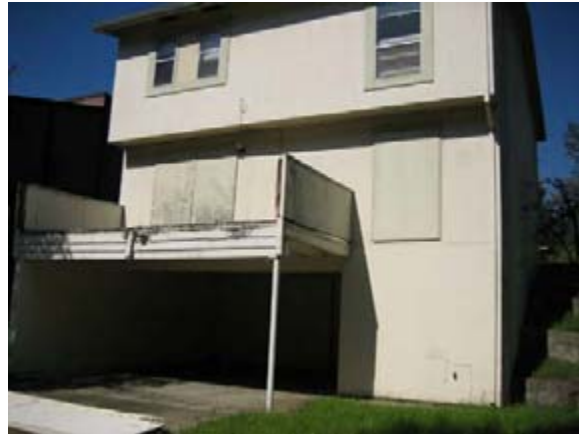
**Building No./Identifier: 4006**

Building No. 4006 is a two-story residential building with plywood sheathing and a shed roof.

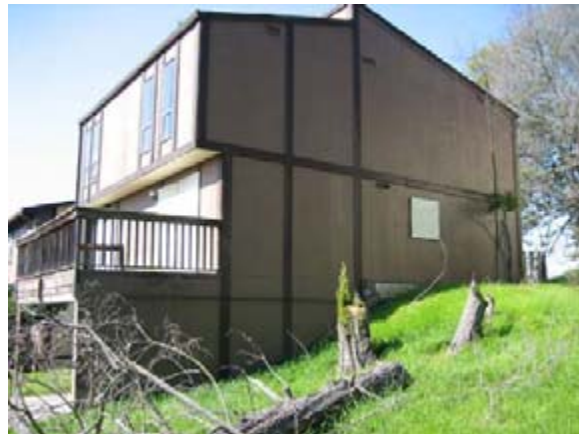
**Building No./Identifier: 4007**

Building No. 4007 is a two-story residential building with wood board sheathing and a gable roof.

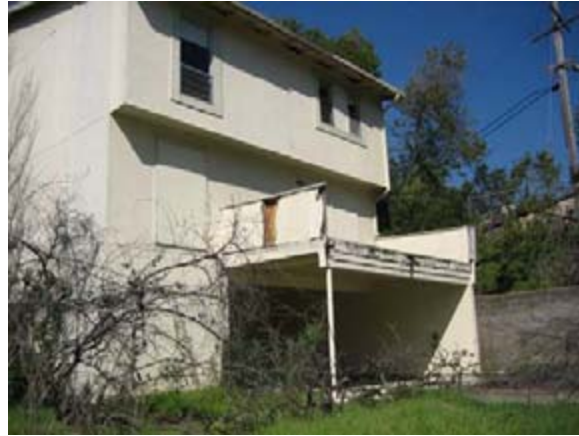
**Building No./Identifier: 4009**

Building No. 4009 is a two-story residential building with wood board sheathing and a gable roof.

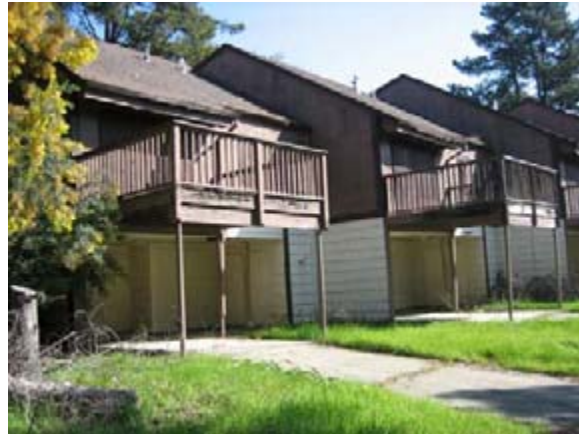
**Building No./Identifier: 9001-03-05-07**

Buildings No. 9001-9007 consists of four units connected in a staggered plan. The buildings have shed roofs, aluminum sash casement windows, shingle-clad first floors, plywood-clad second floors, and second-floor balconies.

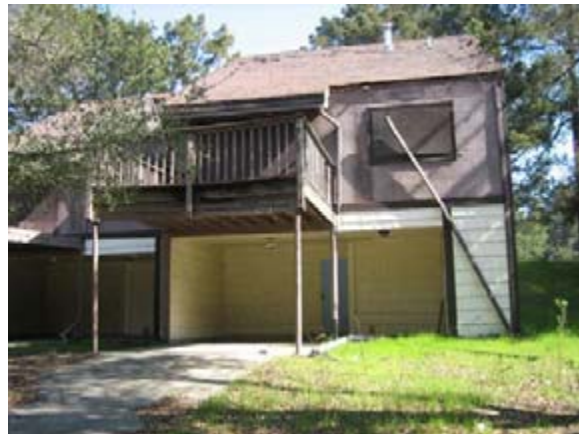
**Building No./Identifier: 9009-11-13-15**

Buildings No. 9009-9015 consists of four units connected in a staggered plan. The buildings have shed roofs, aluminum sash casement windows, shingle-clad first floors, plywood-clad second floors, and second-floor balconies.

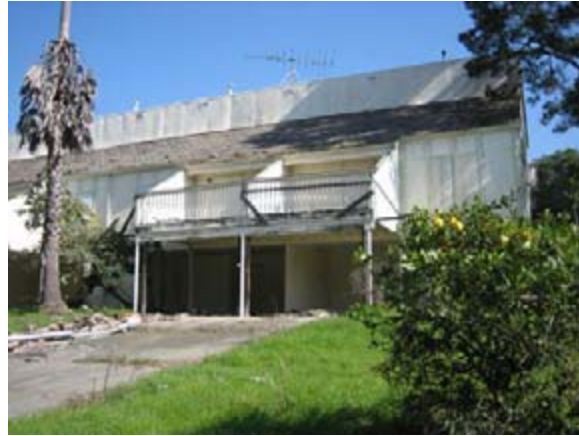
**Building No./Identifier: 9017-19-21-23**

Buildings No. 9017-9023 are a set of four units in a single building. The buildings have plywood siding, multiple shed roofs clad in composite shingles, and aluminum sash casement windows.

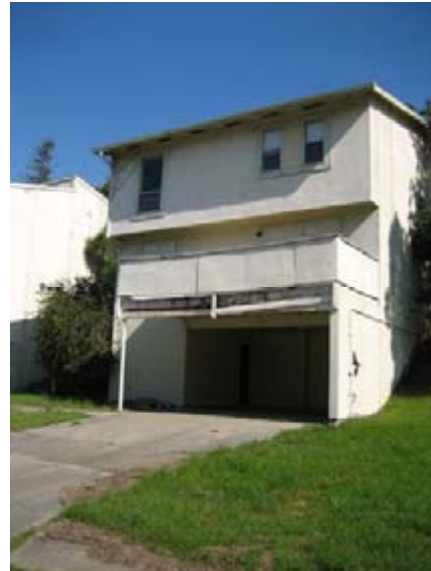
**Building No./Identifier: 9020**

Building No. 9020 is a two-story residential building with wood board sheathing, a gable roof, and single-hung aluminum sash windows.

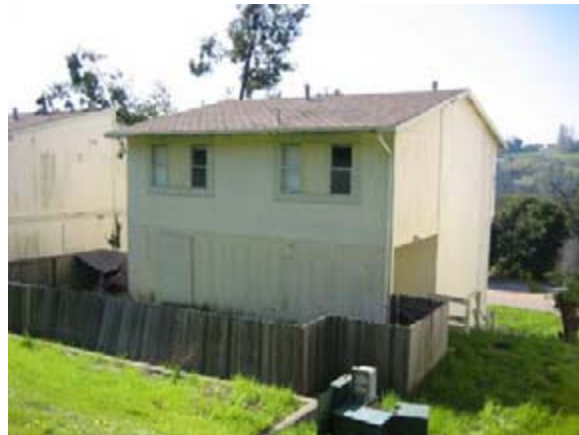
Building No. 9022 is a two-story residential building with wood board sheathing, a gable roof, and single-hung aluminum sash windows.

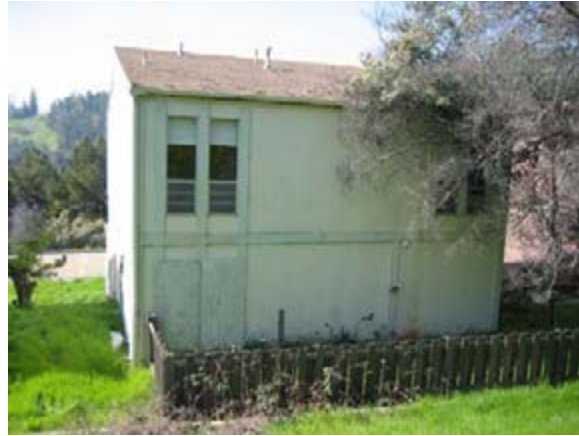
**Building No./Identifier: 9024**

Building No. 9024 is a two-story residential building with wood board sheathing, a gable roof, and single-hung aluminum sash windows.

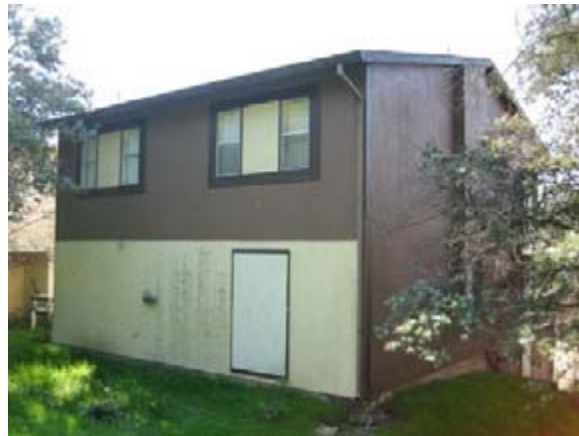
**Building No./Identifier: 9026**

Building No. 9026 is a two-story residential building with wood board sheathing, a gable roof, and single-hung aluminum sash windows.

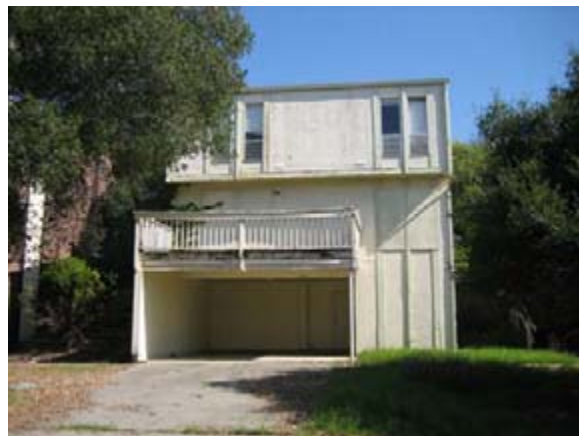
**Building No./Identifier: 9028**

Building No. 9028 is a two-story residential building with wood board sheathing, a gable roof, and single-hung aluminum sash windows.

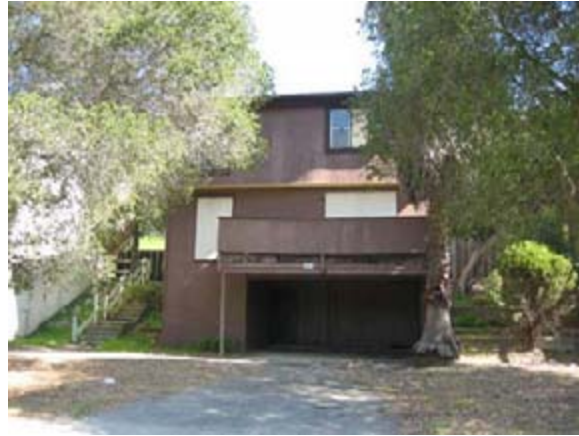
**Building No./Identifier: 9030**

Building No. 9030 is a two-story residential building with wood board sheathing, a gable roof, and single-hung aluminum sash windows.

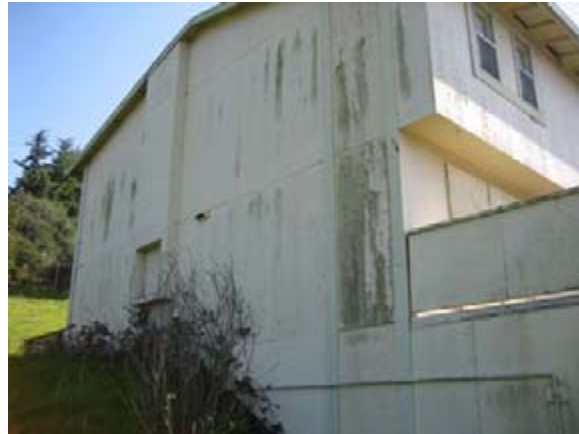
**Building No./Identifier: 9032**

Building No. 9032 is a two-story residential building with wood board sheathing, a gable roof, and single-hung aluminum sash windows.

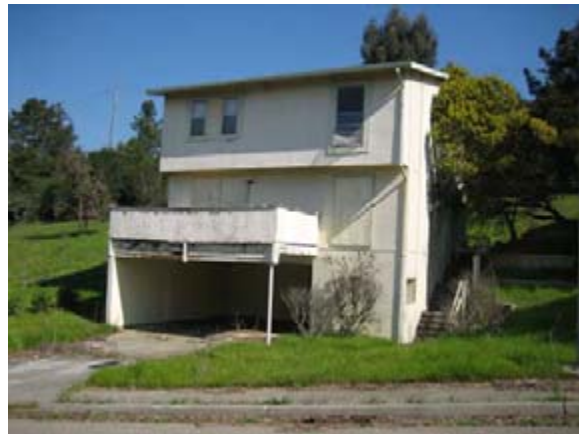
**Building No./Identifier: 9034**

Building No. 9034 is a two-story residential building with wood board sheathing, a gable roof, and single-hung aluminum sash windows.

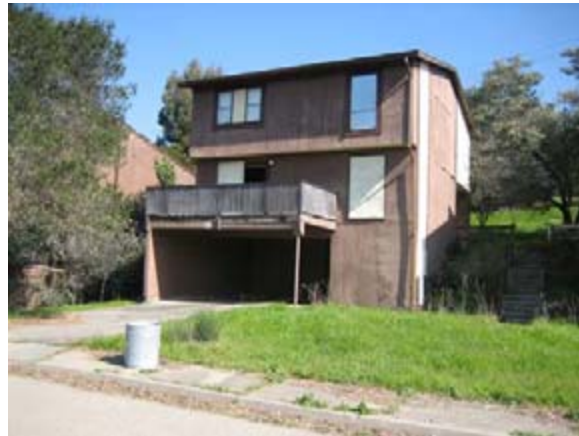
**Building No./Identifier: 9036**

Building No. 9036 is a two-story residential building with wood board sheathing, a gable roof, and single-hung aluminum sash windows.

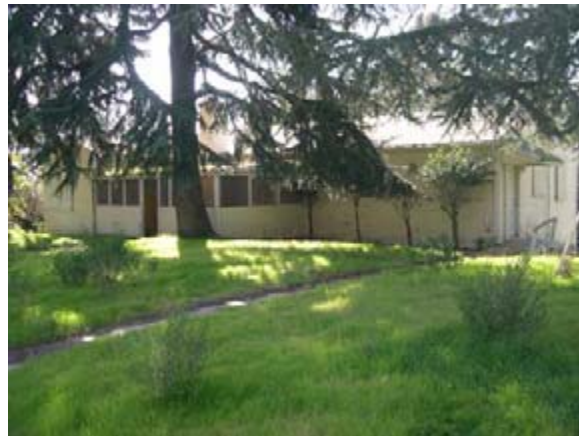
**Building No./Identifier: A**

Building No. A is a one-story residential building with original redwood channel siding, a gable roof with a wood fascia, paneled wood doors, double-hung wood sash windows, a stucco-clad chimney, and an enclosed porch with a shed roof.

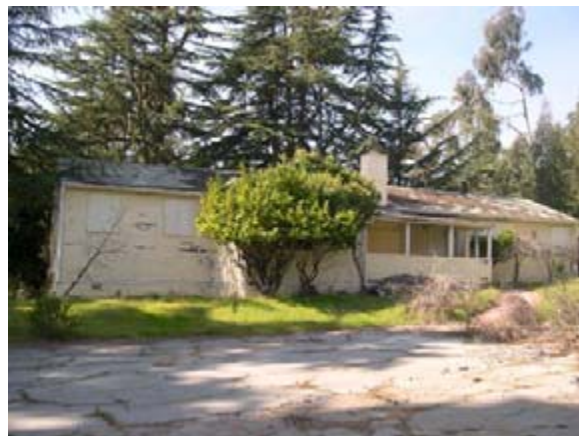
**Building No./Identifier: B**

Building No. B is a one-story residential building with original redwood channel siding, a gable roof with a wood fascia, paneled wood doors, double-hung wood sash windows, a stucco-clad chimney, and an enclosed porch with a shed roof.

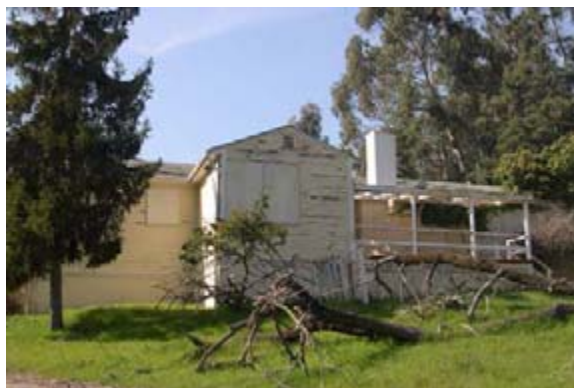
**Building No./Identifier: C**

Building No. C is a one-story residential building with original redwood channel siding, a gable roof with a wood fascia, paneled wood doors, double-hung wood-sash windows, a stucco-clad chimney, and an enclosed porch with a shed roof.

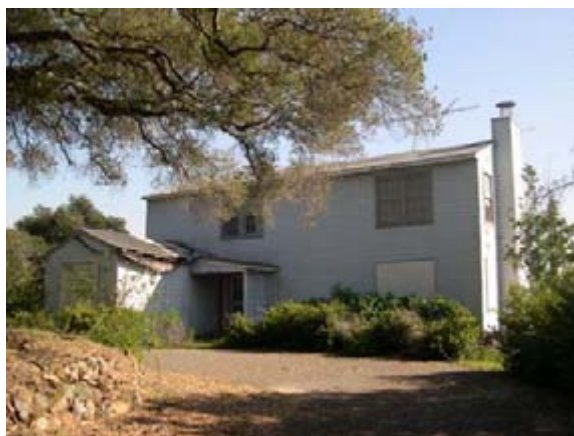
**Building No./Identifier: D**

Building No. D is on the ridge above the main hospital area. It is a two-story residential building with original redwood channel siding, six-over-six double-hung wood-sash windows, and paneled wood doors. Other features include a chamfered chimney, a second-story porch, and a redwood deck. At the rear is a brick patio.

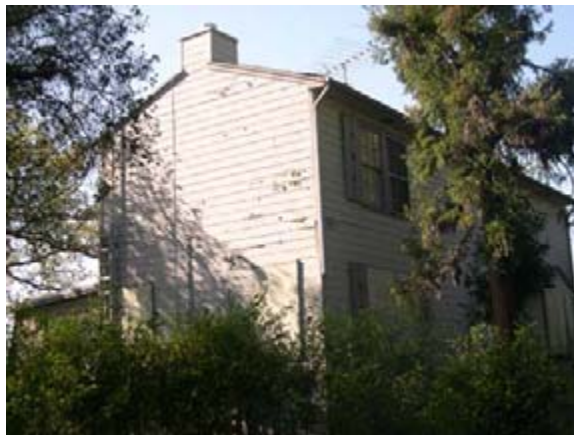
**Building No./Identifier: E**

Building No. E is on the ridge above the main hospital area. It is a two-story residential building with original redwood channel siding, six-over-six double-hung wood-sash windows, and wood paneled doors. At the rear is a two-story enclosed porch.

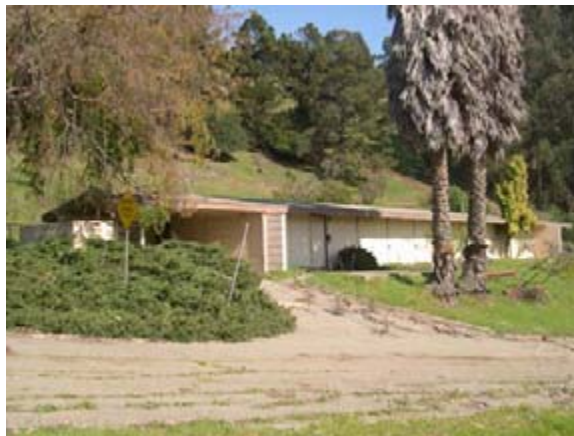
**Building No./Identifier: F-G**

*Notes:* Buildings No. F and G are part of a series of one-story duplex buildings. Each building is bilaterally symmetrical with a carport under the gable ends. The wood-frame structures have cement asbestos shingle siding and steel casement or fixed windows.

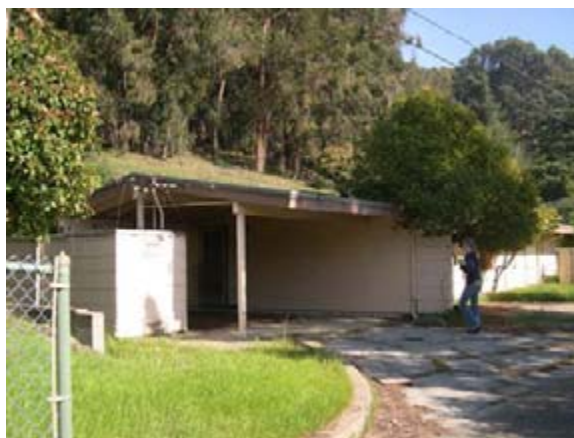
**Building No./Identifier: H-I**

Building Nos. H and I are part of a series of one-story duplex buildings. Each building is bilaterally symmetrical with a carport under the gable ends. The wood-frame structures have cement asbestos shingle siding and steel casement or fixed windows.

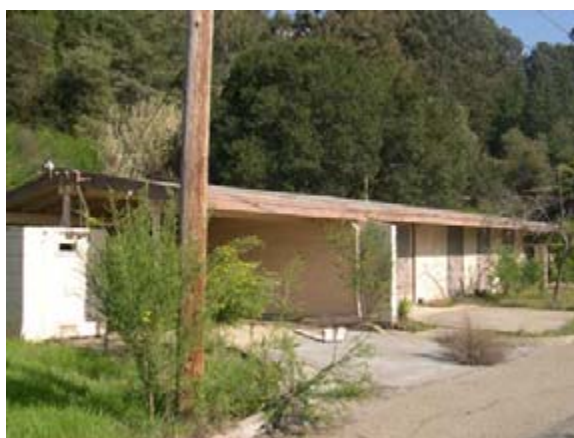
**Building No./Identifier: J-K**

Building Nos. J and K are part of a series of one-story duplex buildings. Each building is bilaterally symmetrical with a carport under the gable ends. The wood-frame structures have cement asbestos shingle siding and steel casement or fixed windows.

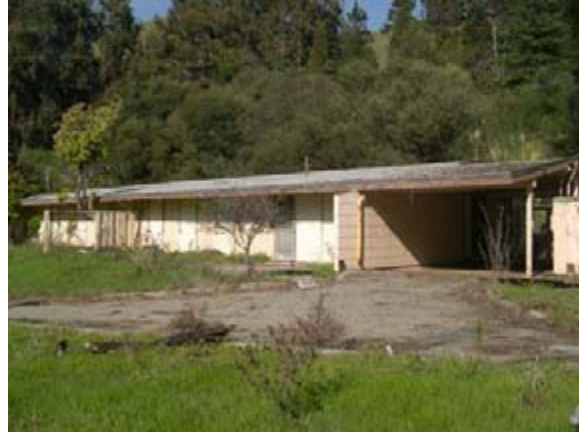
**Building No./Identifier: L-M**

Building Nos. L and M are part of a series of one-story duplex buildings. Each building is bilaterally symmetrical with a carport under the gable ends. The wood-frame structures have cement asbestos shingle siding and steel casement or fixed windows.

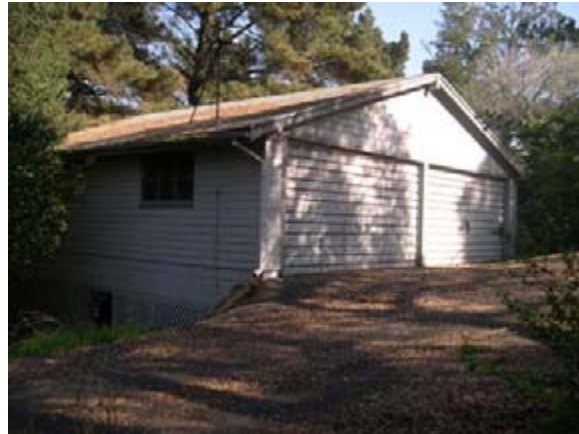
**Building No./Identifier: L63**

Building No. L63 serves as the garage for Building Nos. D and E. The building has channel redwood siding, a gable roof, six-light fixed wood windows, and two roll-up non-original garage doors.

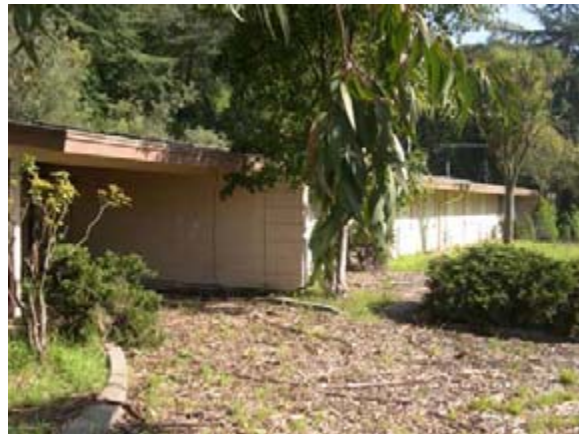
**Building No./Identifier: N-O**

Buildings No. N and O are part of a series of one-story duplex buildings. Each building is bilaterally symmetrical with a carport under the gable ends. The wood-frame structures have cement asbestos shingle siding and steel casement or fixed windows.

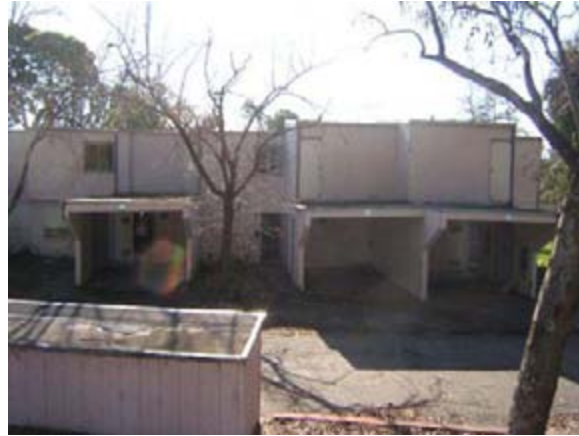
**Building No./Identifier: P**

Buildings No. P through W are eight buildings placed in a circle around a playground. Each building contains two-story apartment units with flat and shed roofs, wood plank siding, aluminum casement or sliding windows, and carports with roof decks.

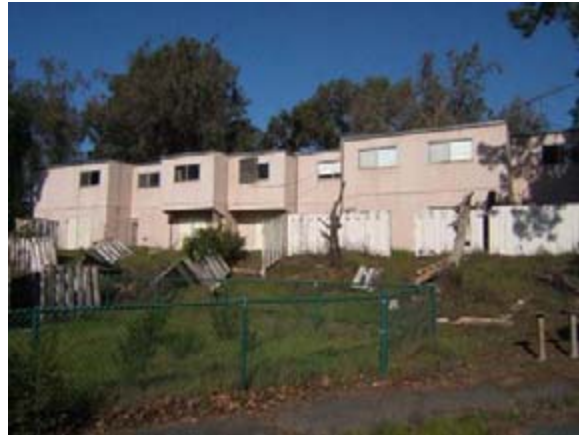
**Building No./Identifier: Q**

Buildings No. P through W are eight buildings placed in a circle around a playground. Each building contains two-story apartment units with flat and shed roofs, wood plank siding, aluminum casement or sliding windows, and carports with roof decks.

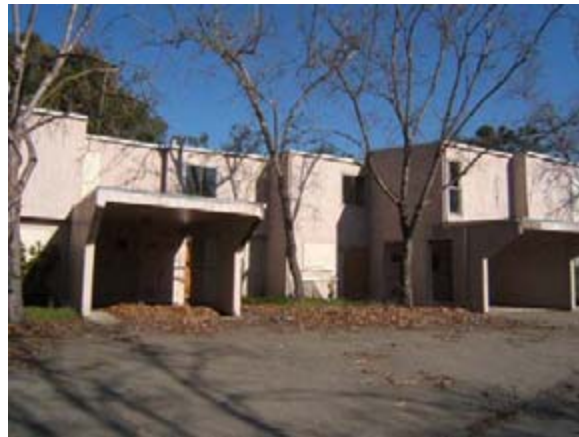
**Building No./Identifier: R**

Buildings No. P through W are eight buildings placed in a circle around a playground. Each building contains two-story apartment units with flat and shed roofs, wood plank siding, aluminum casement or sliding windows, and carports with roof decks.

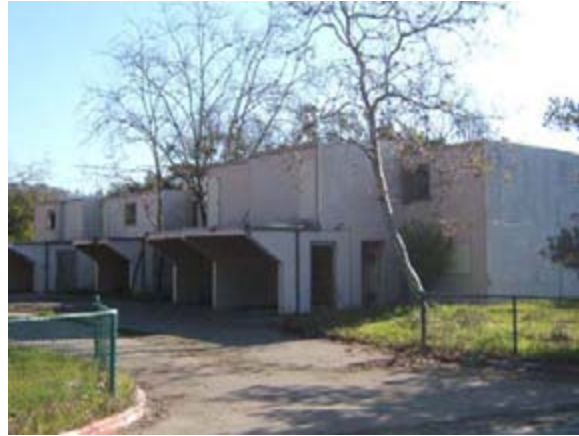
**Building No./Identifier: S**

Buildings No. P through W are eight buildings placed in a circle around a playground. Each building contains two-story apartment units with flat and shed roofs, wood plank siding, aluminum casement or sliding windows, and carports with roof decks.

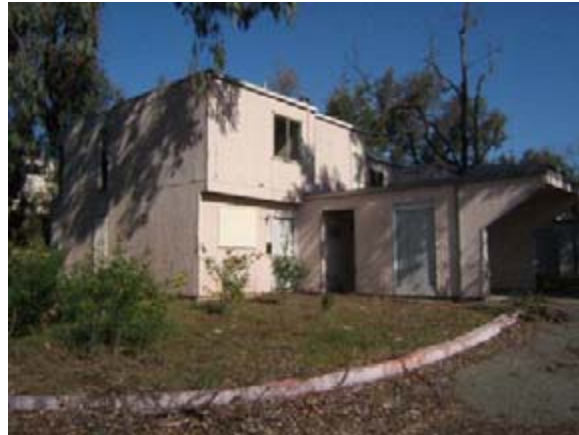
**Building No./Identifier: T**

Buildings No. P through W are eight buildings placed in a circle around a playground. Each building contains two-story apartment units with flat and shed roofs, wood plank siding, aluminum casement or sliding windows, and carports with roof decks.

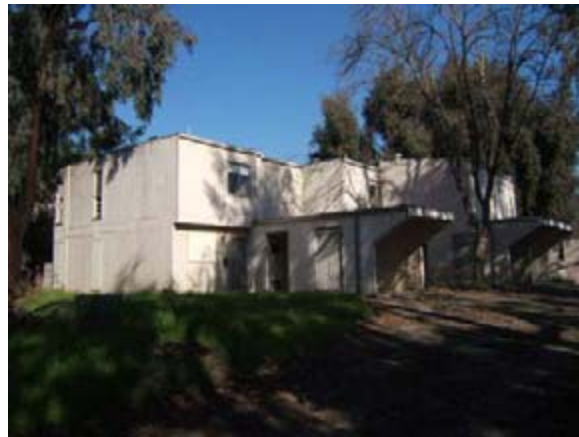
**Building No./Identifier: U**

Buildings No. P through W are eight buildings placed in a circle around a playground. Each building contains two-story apartment units with flat and shed roofs, wood plank siding, aluminum casement or sliding windows, and carports with roof decks.

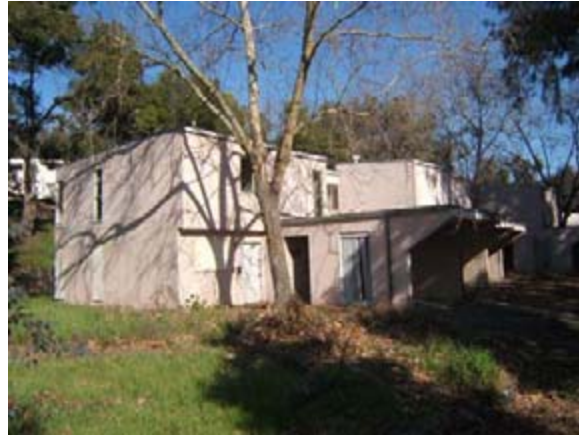
**Building No./Identifier: V**

Buildings No. P through W are eight buildings placed in a circle around a playground. Each building contains two-story apartment units with flat and shed roofs, wood plank siding, aluminum casement or sliding windows, and carports with roof decks.

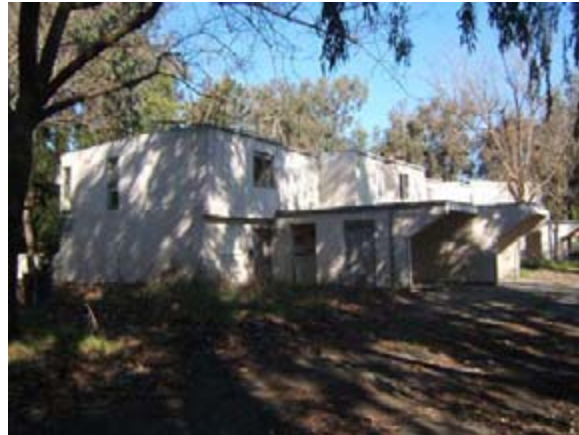
**Building No./Identifier: W**

Buildings No. P through W are eight buildings placed in a circle around a playground. Each building contains two-story apartment units with flat and shed roofs, wood plank siding, aluminum casement or sliding windows, and carports with roof decks.

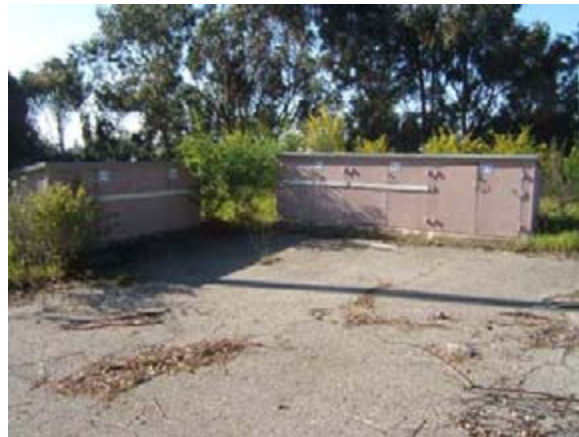
**Building No./Identifier: X**

Building No. X is a series of storage bins located next to Building Nos. P through W.

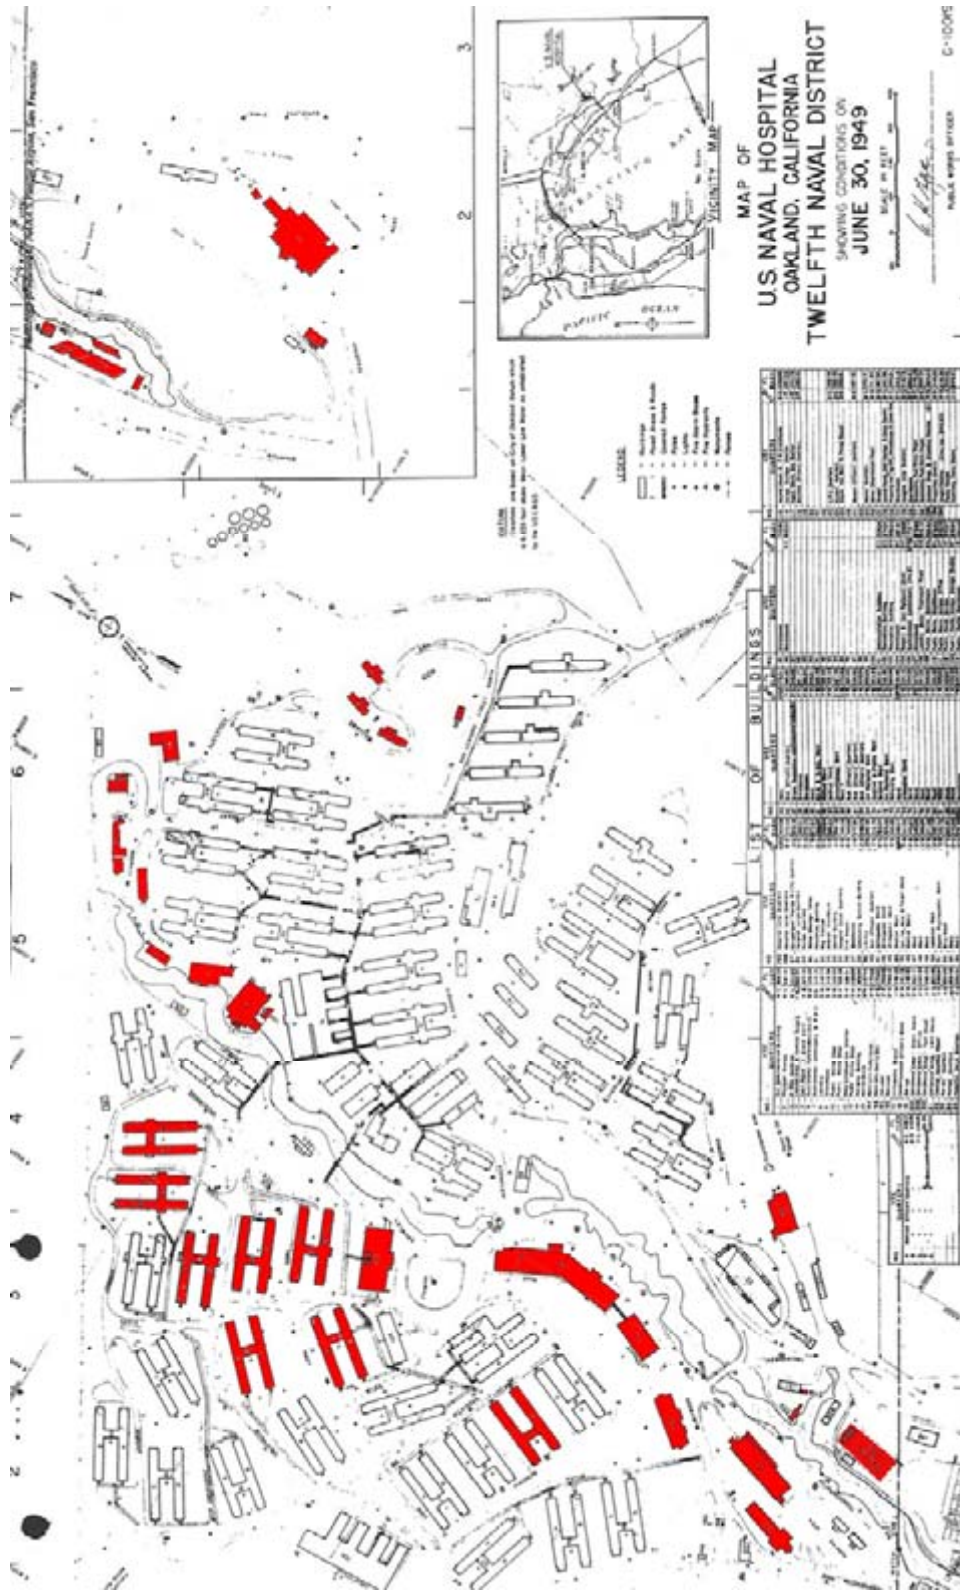
Figure 1. 1949 Map of the U.S. Naval Hospital in Oakland showing the original site and the extant World War II-era properties (highlighted in red), annotated by Page & Turnbull.  
(Source: National Archives and Records Administration in San Bruno)

- Figure 1 - 1949 Map of the U.S. Naval Hospital in Oakland showing the original site and the extant World War II-era properties (highlighted in red), annotated by Page & Turnbull.
- Figure 2 - Vicinity Map showing the site of the former U.S. Naval Hospital in Oakland.
- Figure 3 - 1945 Aerial Photograph of the former U.S. Naval Hospital in Oakland and the former U.S. Naval Psychiatry Hospital in Oakland
- Figure 4 - 1963 Aerial Photograph of the U.S. Naval Hospital in Oakland
- Figure 5 - 1973 Photograph of U.S. Naval Hospital in Oakland.
- Figure 6 - 1983 Landscape Character Map
