**Feasibility Study for Adaptive Reuse
of the Existing Oakland Army Base Warehouses**

RE: Feasibility Study of Potential Reuse of Existing Warehouses

Seismic Retrofit and Rehabilitation Report
Oakland Army Base Warehouse Buildings
Oakland, CA

Warehouse Deconstruction Study

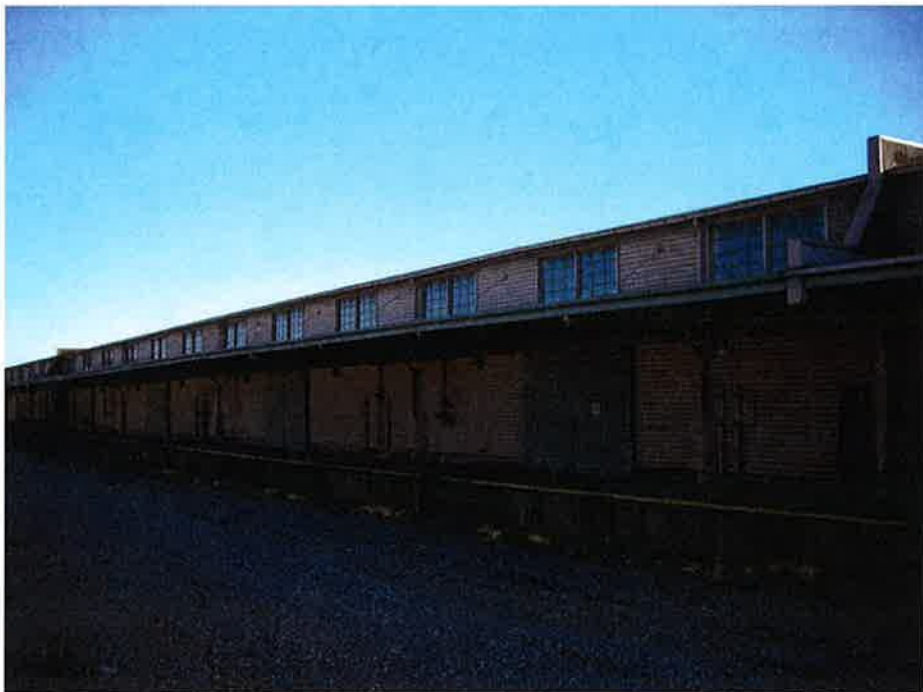
Photo 2: Side Wall Elevation (South Wall)

All walls have 3x8 studs at 4'± on center with diagonal sheathing under horizontal siding. The walls are not insulated, and it was not clear if a moisture barrier was installed between the horizontal siding and diagonal sheathing.

Additional recommendations for rehabilitation of the structures include replacement of damaged and/or deteriorated exterior siding, adding and/or repairing weatherproofing to the walls of the structure, replacing damaged windows, repairing or replacing doors, replacing the roofing, and repairing damaged concrete stem walls. In addition,
