**FEASIBILITY STUDY FOR ADAPTIVE REUSE OF THE
EXISTING OAKLAND ARMY BASE WAREHOUSES**

April 13, 2012

RE: Feasibility Study of Potential Reuse of Existing Warehouses

Seismic Retrofit and Rehabilitation Report
Oakland Army Base Warehouse Buildings
Oakland, CA

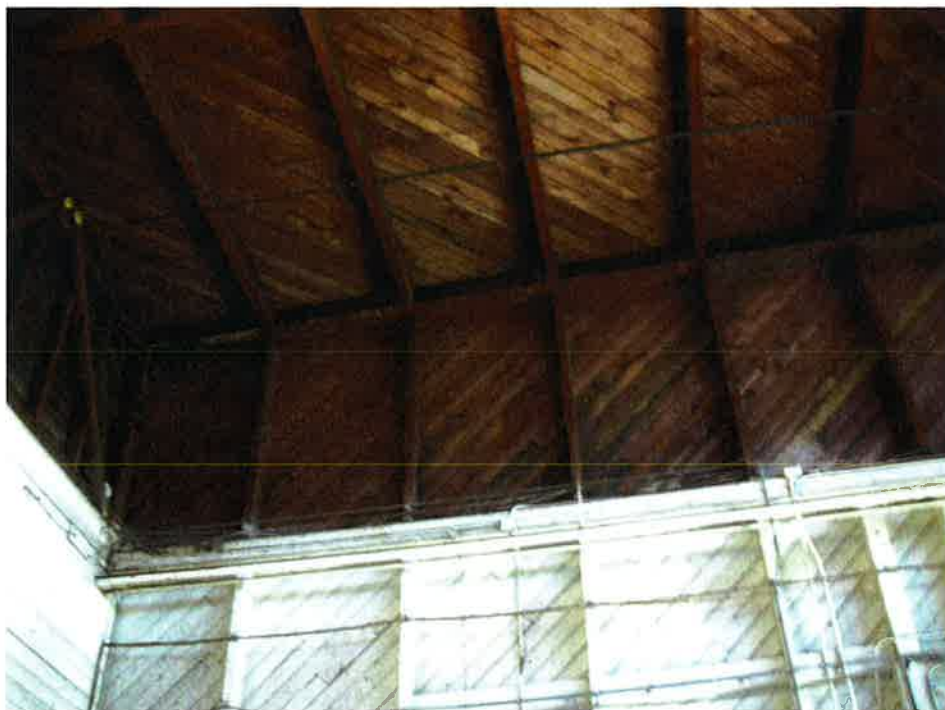
Photo 5: Wall/Roof Sheathing

Some leaks were observed in the roof and exterior walls. At one location in the building observed, the leaking roof has caused significant deterioration of the diagonal sheathing at the exterior wall. There are also damaged windows that allow rain inside the building. The painted exterior horizontal siding is showing some signs of wear and deterioration, especially at unprotected end walls. The exterior finishes on the entire structure should be inspected and repaired. If no waterproofing exists under the exterior horizontal siding, consideration should be given to removing the siding, repairing the diagonal sheathing, adding building paper, and replacing the horizontal siding.
