WORK PROGRAM 295 MACARTHUR BLVD, OAKLAND

Exterior Details and Work Program Summary:

RE: Structural Observation
295 MacArthur Blvd
Oakland, CA 94610

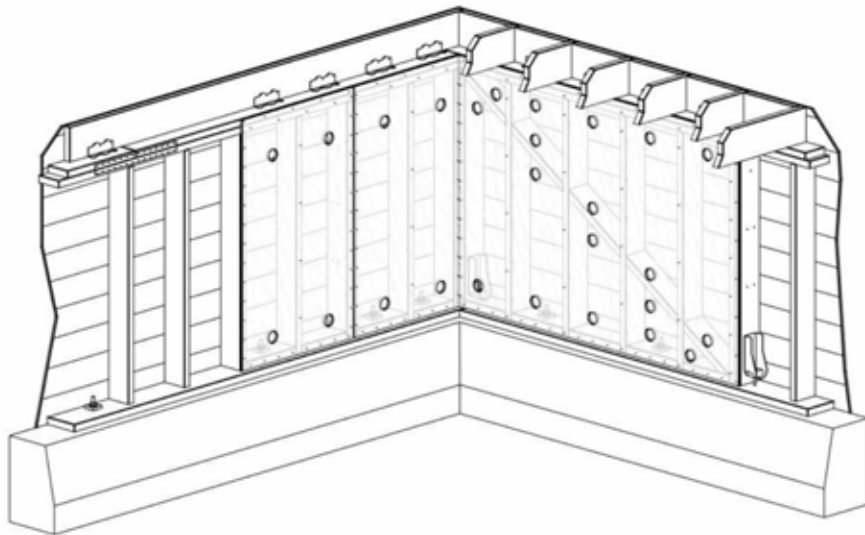
Image: Wood-frame shear wall installed into existing concrete footing

- **Retrofit Scope.** To retrofit the subject buildings, wood-frame shear walls are installed into the existing concrete foundation. This is the most cost-effective retrofit technique. Work is only performed within the ground floor, and not above, within habitable units. Shear wall segments are installed on the interior side of existing walls, typically around the building perimeter and existing garage space. Their assembly involves adding framing, fasteners, hold-downs, and plywood to the existing typical stud framing like this:
