## RIFLE RANGE CREEK: Hydrology Report Restoration Plan Preliminary Creek Protection Plan

**Oak Knoll Mixed Use Community Development Project** Oak Knoll Venture Acquisition LLC

ESA

Revised February 24, 2016

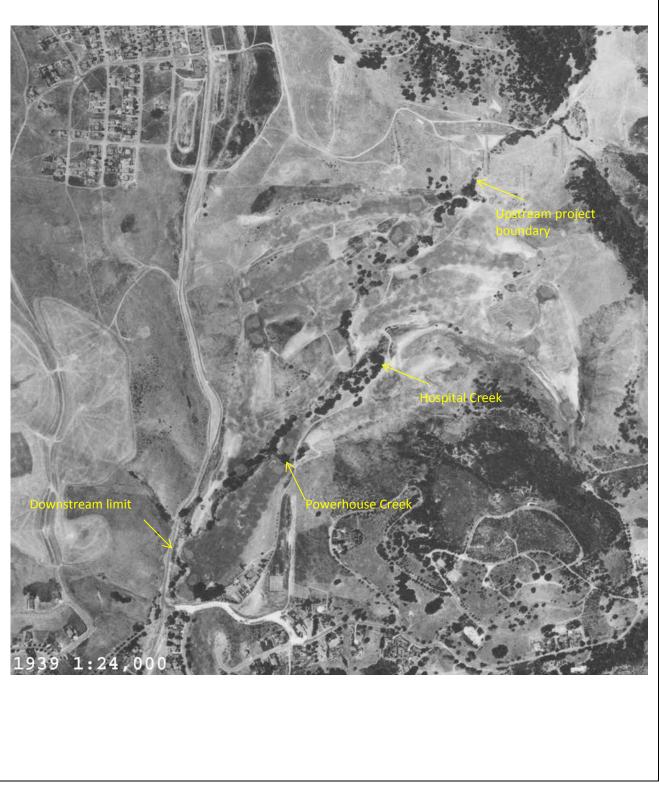
Oak Knoll . D140419 **Figure 2** 1939 Aerial photo

As with other East Bay creeks, Rifle Range Creek has been influenced by a pattern of grazing, urbanization and hydrologic modifications in the watershed. Earliest records of the project site show it was part of the 1820 Spanish land grant Rancho San Antonio, and was used for cattle ranching and timber extraction. USGS topographic maps and aerial photos from 1897 to 1939 (**Error! Reference source not found.**) show no urban development in the watershed prior to the construction of the Oakland Naval Hospital. The 1939 aerial photo shows the site undeveloped but suggests it was heavily grazed. A 1947 aerial photo (**Error! Reference source not found.**) shows two subdivisions east and west of the hospital.

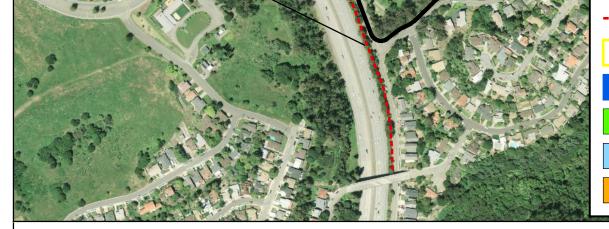
Figure 3. Creek and Riparian Overview Map

Existing Culvert to be Removed

Rifle Range Creek flows from north to south through the central portion of the Project Area and is a notable natural feature on the site (Figure 3). The creek is the largest and northernmost of three tributaries to Arroyo Viejo that originate in the Oakland hills. Rifle Range Creek and its tributaries are the only Section 404 jurisdictional Waters of the United States located in the Project Area (Figure 4). The principal hydrologic sources for the Project Area are direct precipitation and surface runoff.

Rifle Range Creek flows across the Project Area, entering and exiting the property via culverts that run under urban development (Figure 3 and 4). Rifle Range Creek has two tributaries, Powerhouse Creek and Hospital Creek. Rifle Range Creek flows west from the Oakland hills and is part of the Arroyo Viejo watershed. Upstream of the Project Area, an in-stream Alameda County flood control detention basin regulates stormwater flows and has altered sediment transport into the downstream reaches of the creek.

The aboveground portions of Rifle Range Creek within the Project Area total approximately 2,779 linear feet, and have been divided into several reaches as shown on the delineation map (Figure 3). The reaches are numbered 1 through 6 starting downstream and moving upstream. Reach 5 and portions of other reach have been culverted and are indicated with a solid line on Figure 3. Each reach consists of a mix of riffles, runs, and pools. Patches of wetland vegetation are present within some reaches, but the creek channel is primarily unvegetated perennial stream habitat.
