Mountain View Cemetery Expansion Project

Draft Environmental Impact Report

Technical Appendices

Lead Agency: City of Oakland

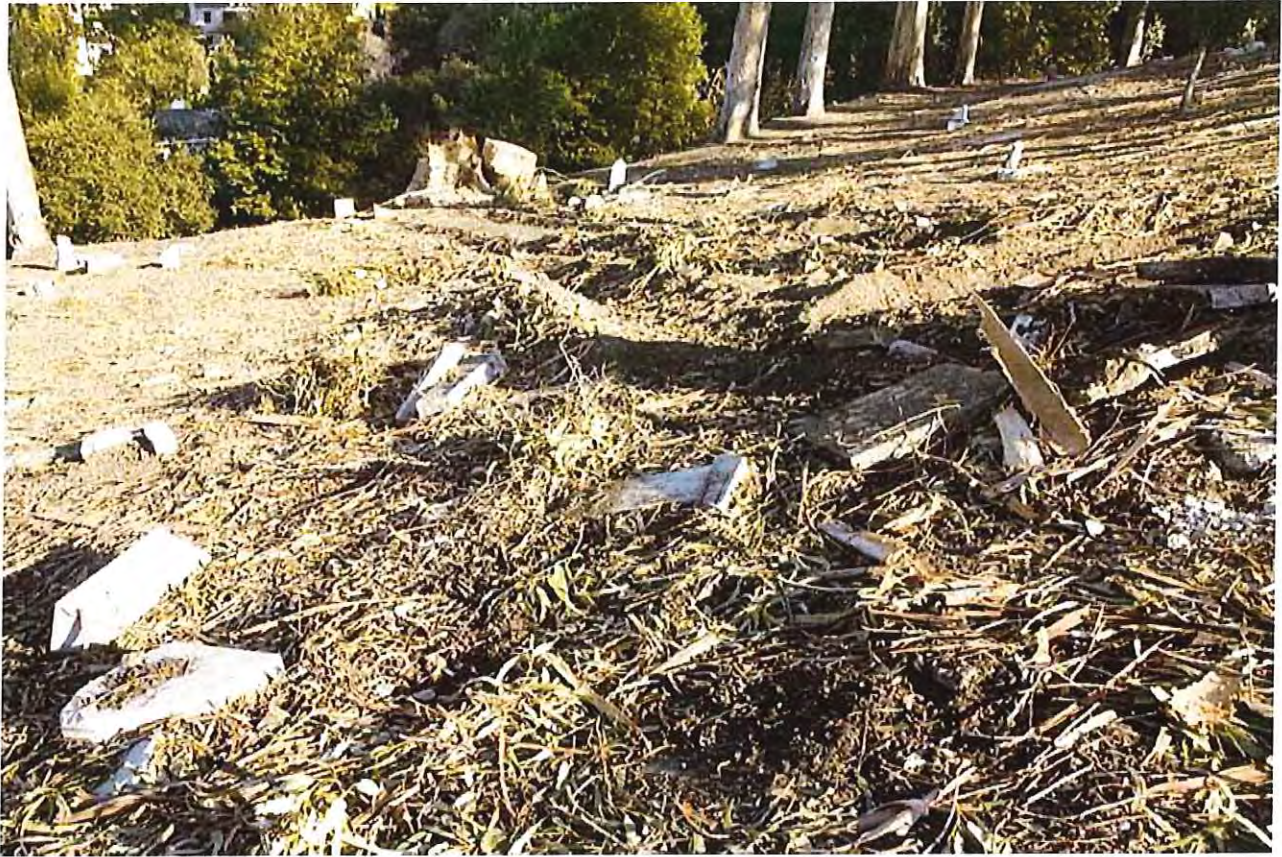
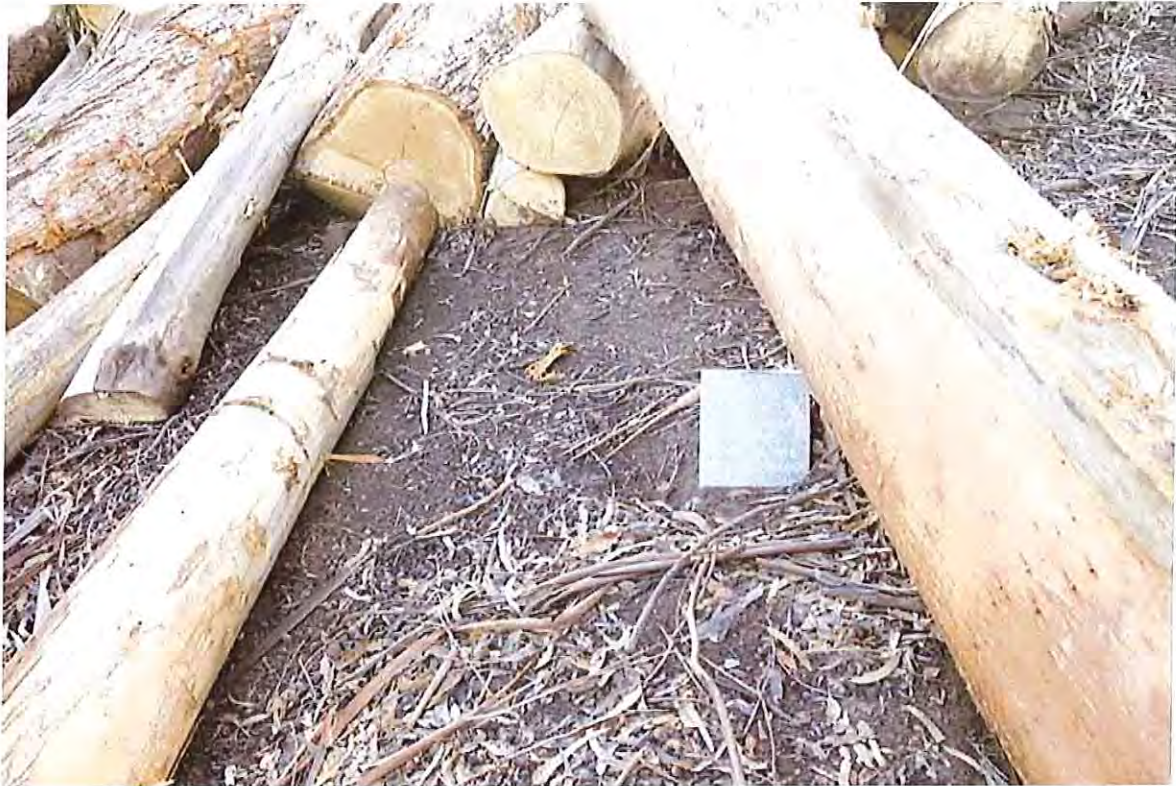
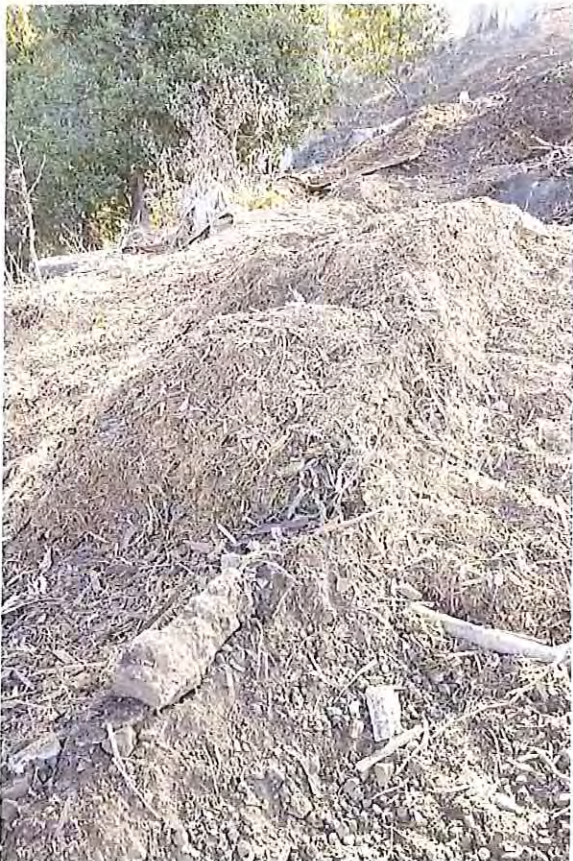
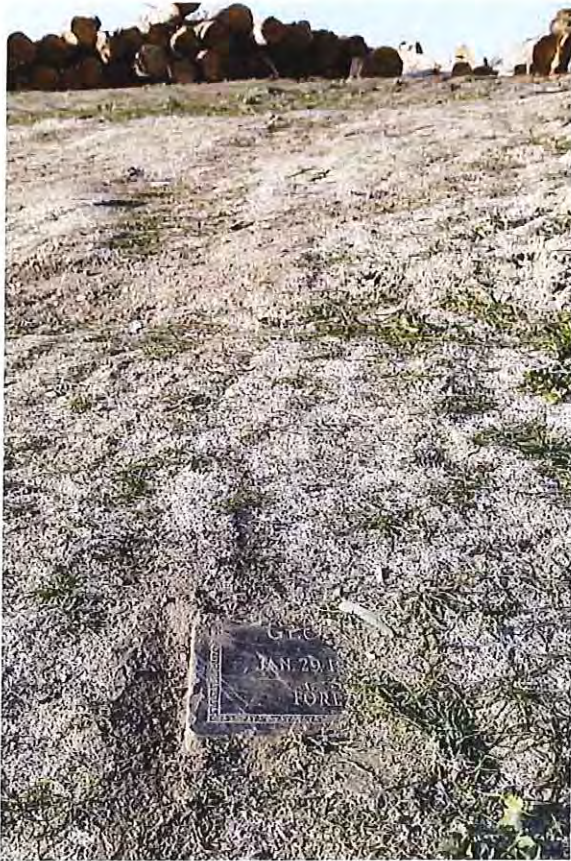
ATTACHMENT C

Additional images of headstone debris after tree removal. Note where heavy equipment has run over and placed logs on top of headstones.

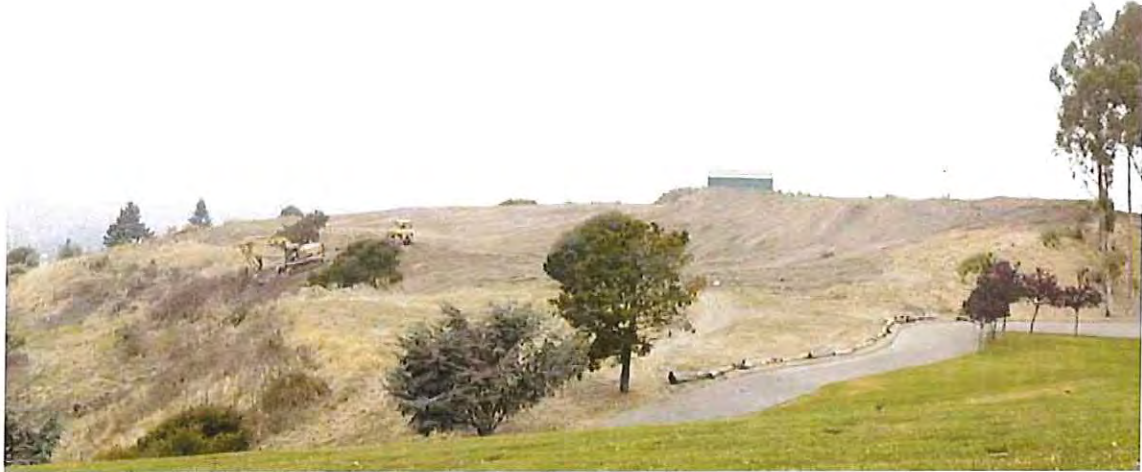
Photos of Unpermitted Grading at MVC.

Initial grading at top of hillside. Eventually, entire hillside graded.

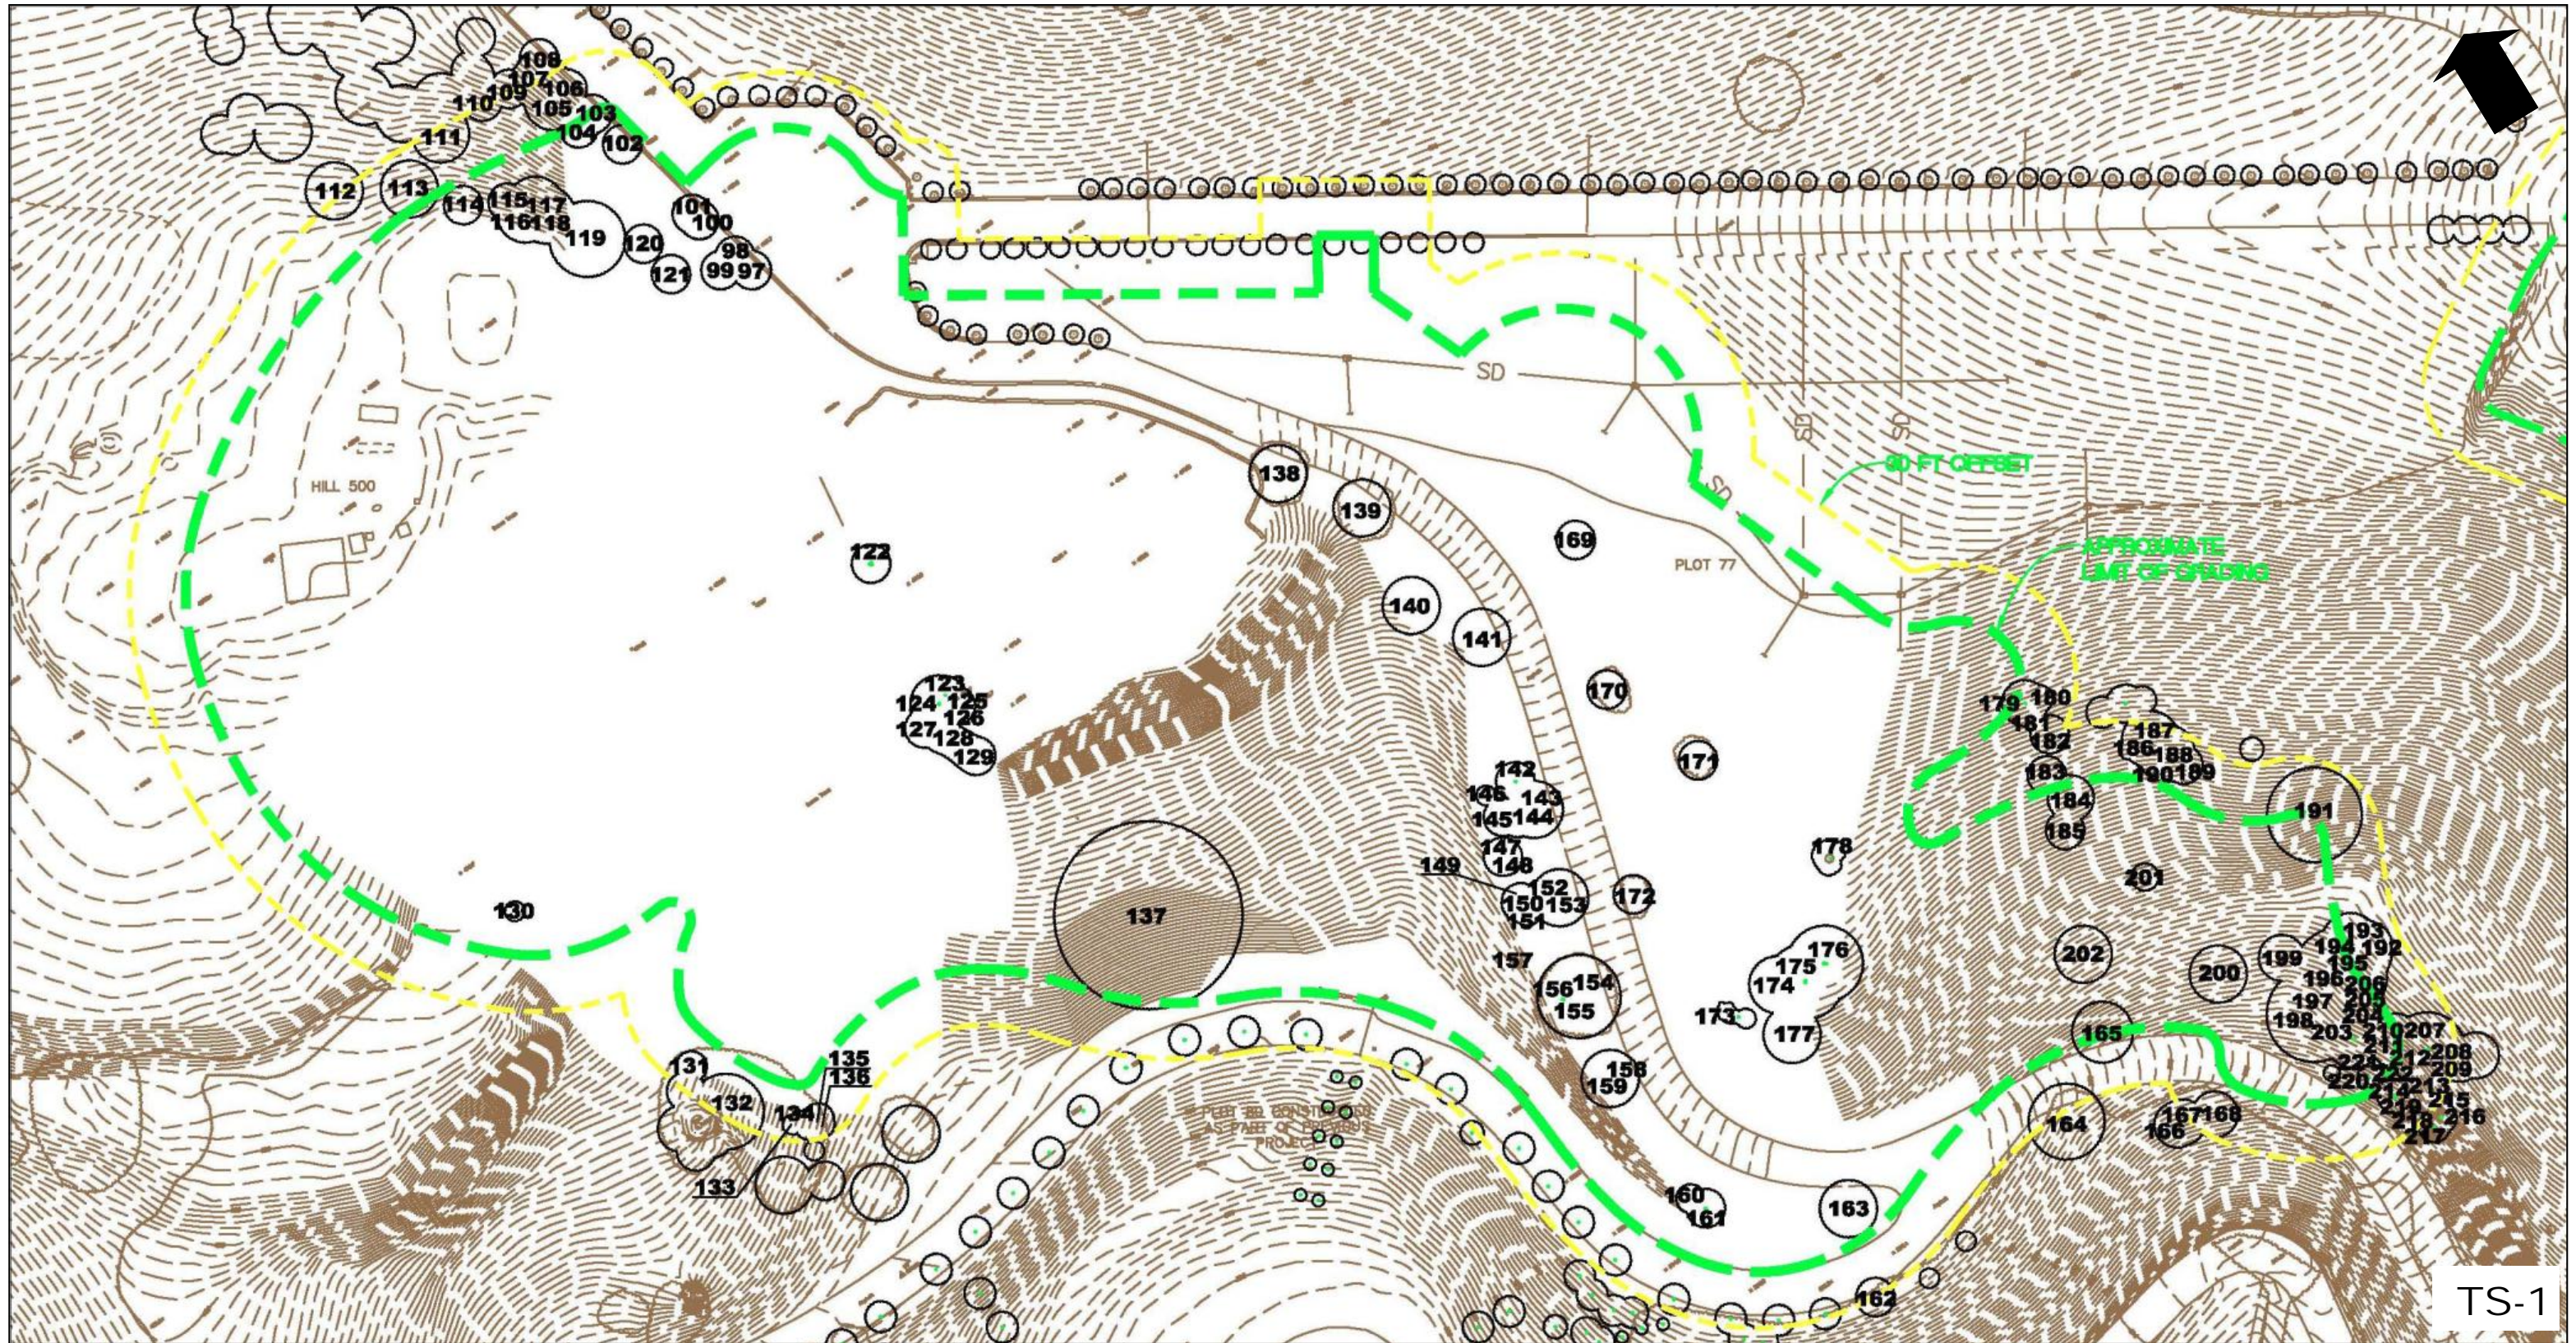
Numbered tree locations are approximate.

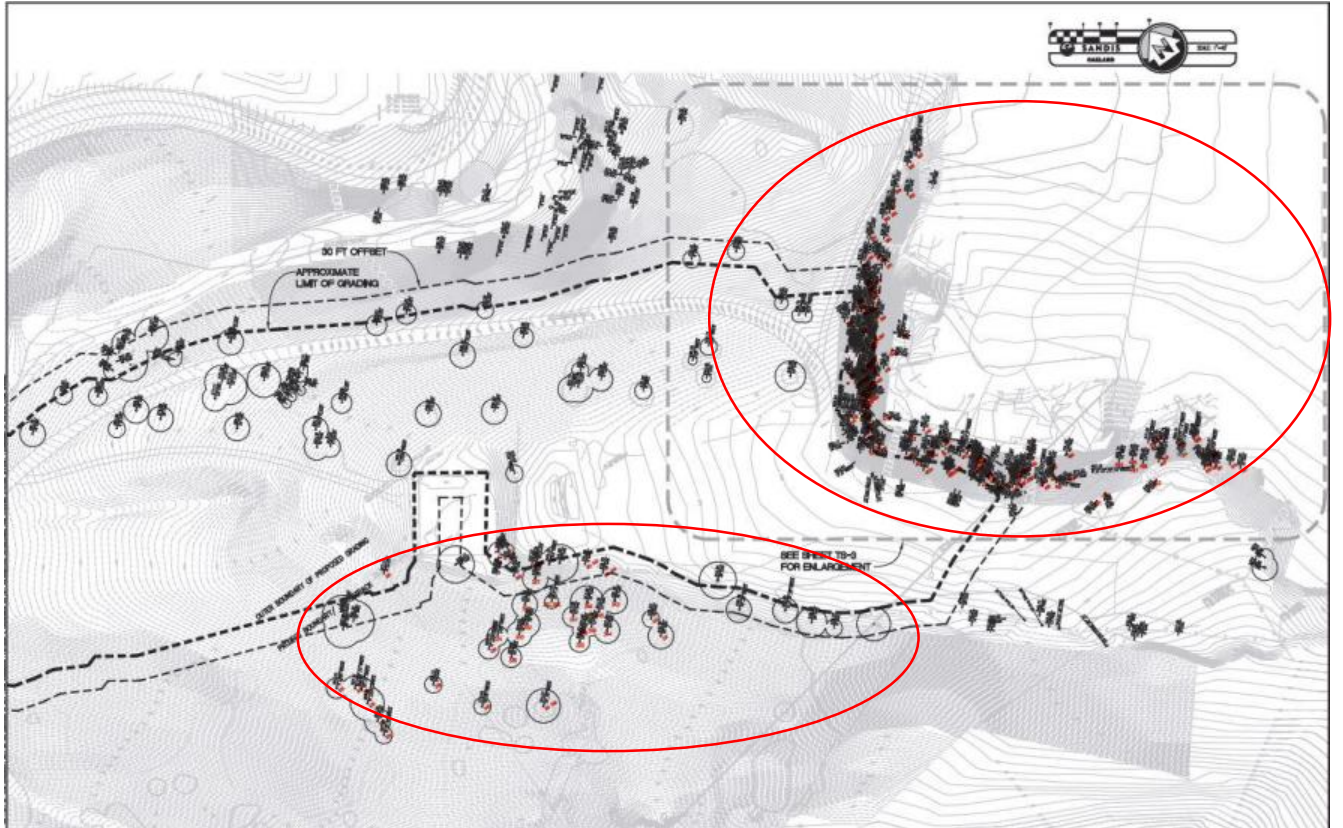
Tree locations for trees # 321-513.

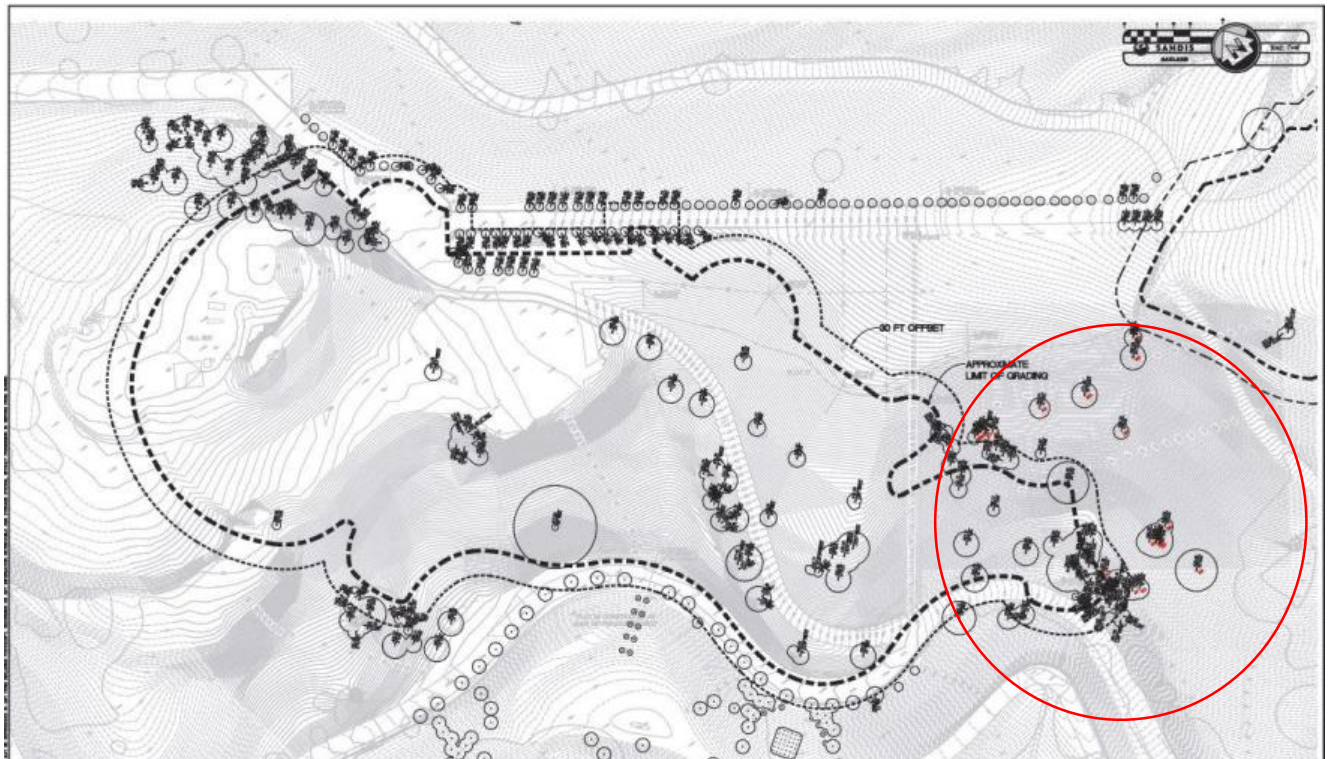
Tree locations for trees # 300-320.

ID #	Tree Species	dbh (inches)	Condition	Trunk
300	Coast Live Oak	15.5	Fair	Multi-stem
301	Coast Live Oak	14	Fair	Multi-stem
302	Coast Live Oak	28.5	Poor	Multi-stem
303	Coast Live Oak	22.5	Fair	Multi-stem
304	Coast Live Oak	6.5	Fair	
305	Coast Live Oak	12	Good	Multi-stem
306	Coast Live Oak	10	Fair	
307	Coast Live Oak	17	Fair	Multi-stem
308	Coast Live Oak	21.5	Fair	Multi-stem
309	Coast Live Oak	7.5	Poor	
310	Coast Live Oak	46.5	Fair	Multi-stem
311	Coast Live Oak	10.5	Good	
312	Coast Live Oak	12.5	Good	
313	Coast Live Oak	4	Fair	
314	n/a	n/a	n/a	n/a
315	Coast Live Oak	22	Fair	Multi-stem
316	Coast Live Oak	13.5	Fair	Multi-stem
317	Coast Live Oak	24.5	Fair	Multi-stem
318	Coast Live Oak	5.5	Fair	
319	Coast Live Oak	17.5	Fair	Multi-stem
320	Coast Live Oak	2.5	Fair	
321	Olive	60	Fair	Multi-stem
322	Coast Live Oak	36	Fair	Multi-stem
323	Coast Live Oak	33	Good	Multi-stem
324	Coast Live Oak	24	Good	Multi-stem
325	Coast Live Oak	52	Good	Multi-stem

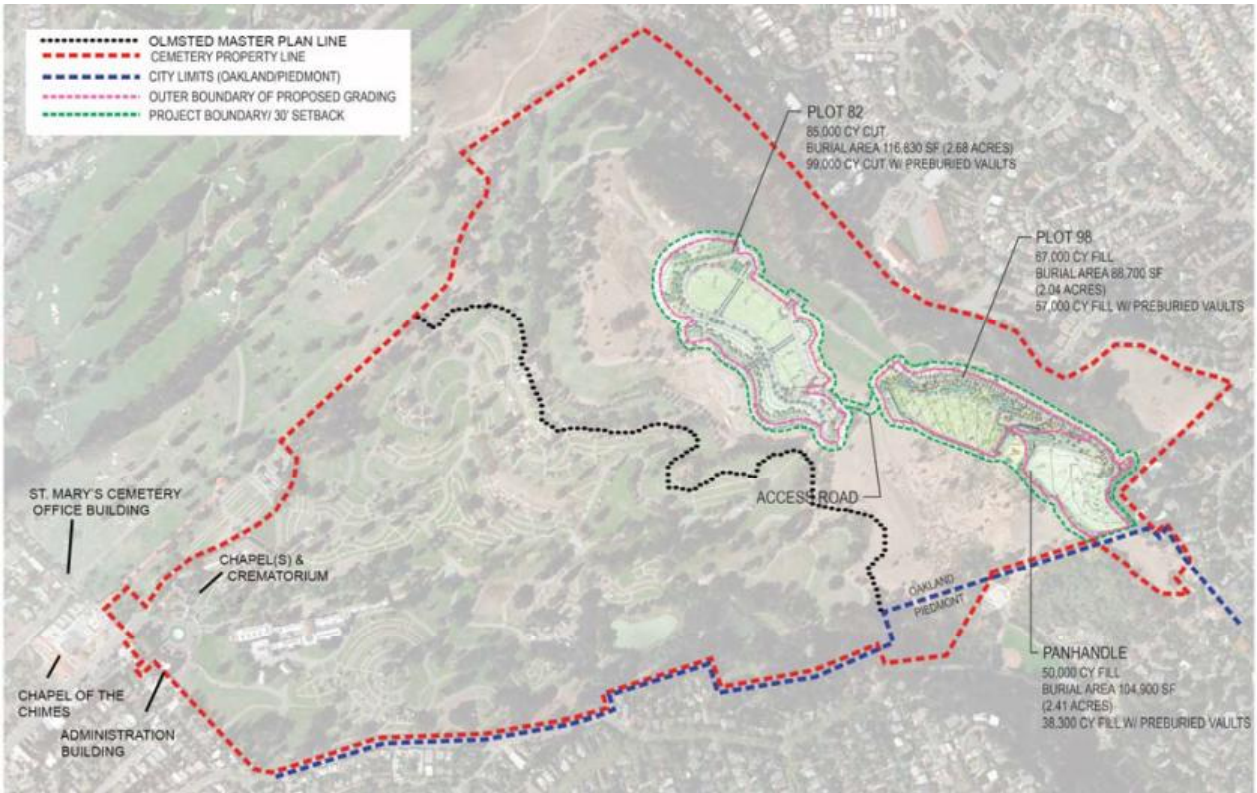
Figure 1. Site map showing cemetery boundaries, locations of identified historic buildings, and locations of portions for development. Source: SWA, edited by Page & Turnbull November 2014.

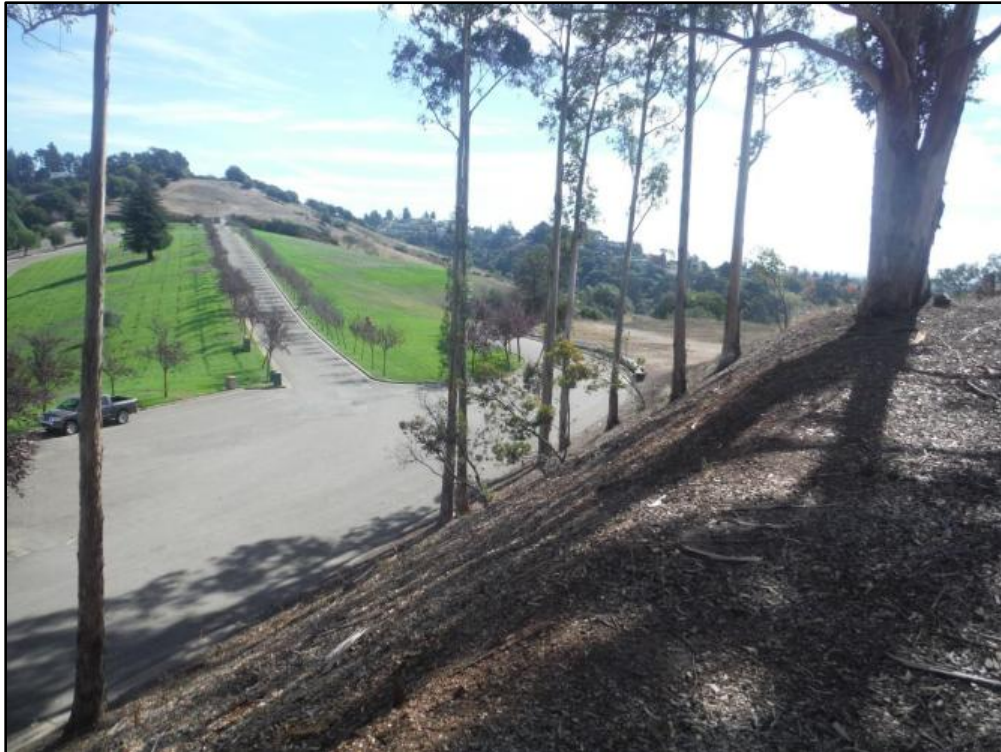
Photo 2: View E, Showing steep slope at NW corner of New Plot 82.

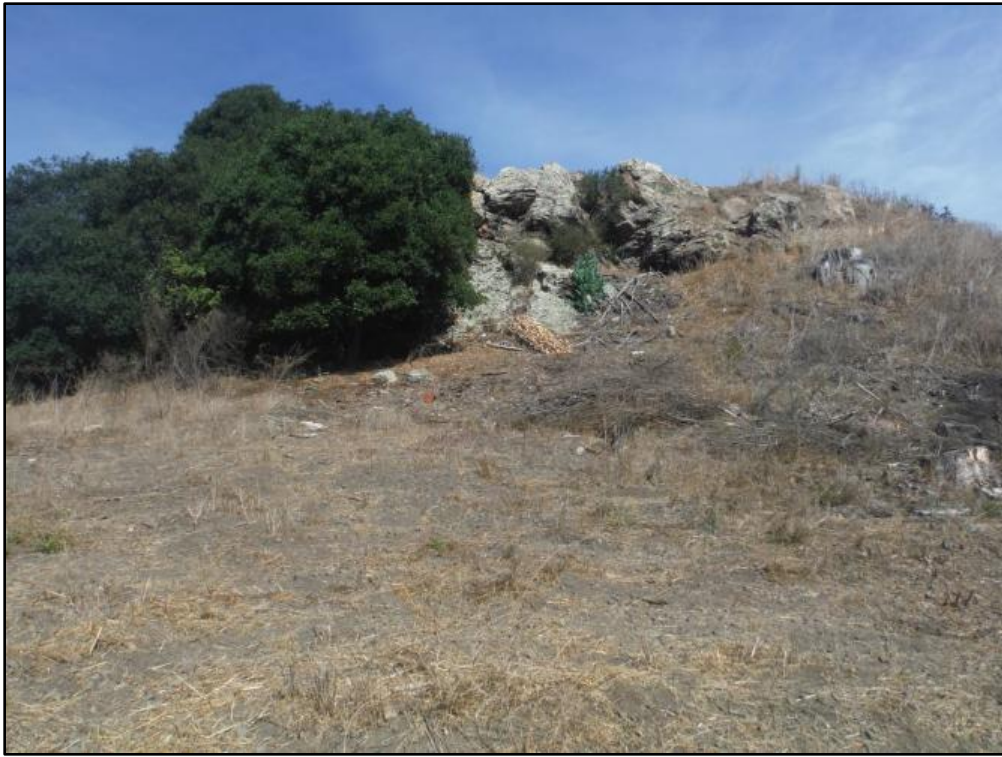
Photo 3: View NE within New Plot 82, showing bedrock outcrop.

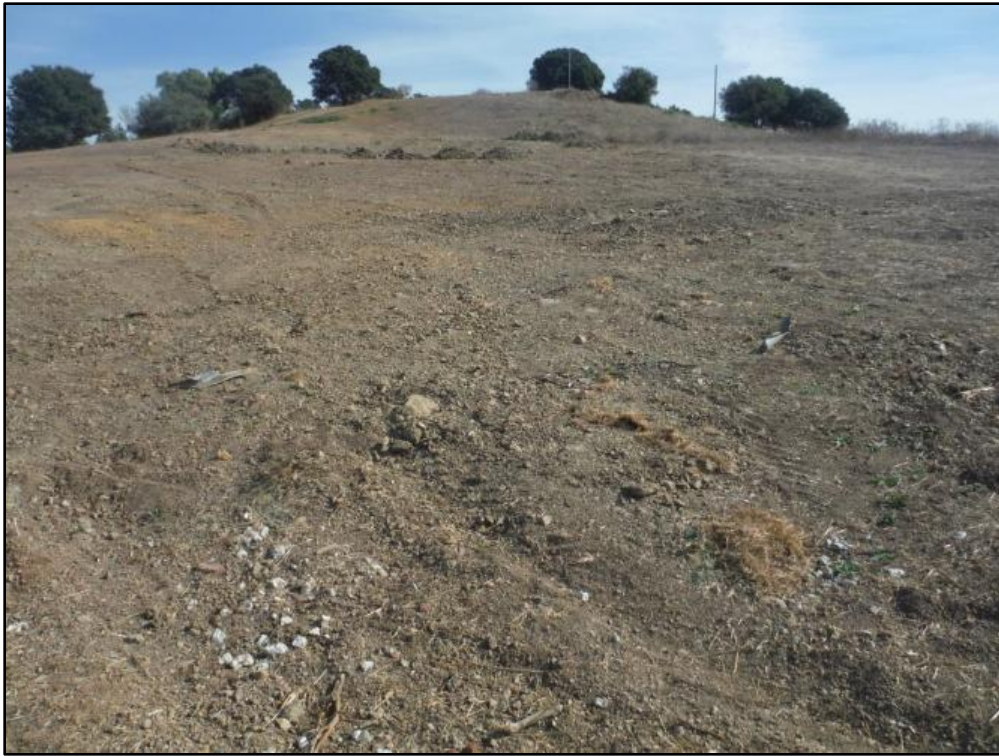
Photo 5: View SE, Showing ground disturbance at western edge of Plot 98.

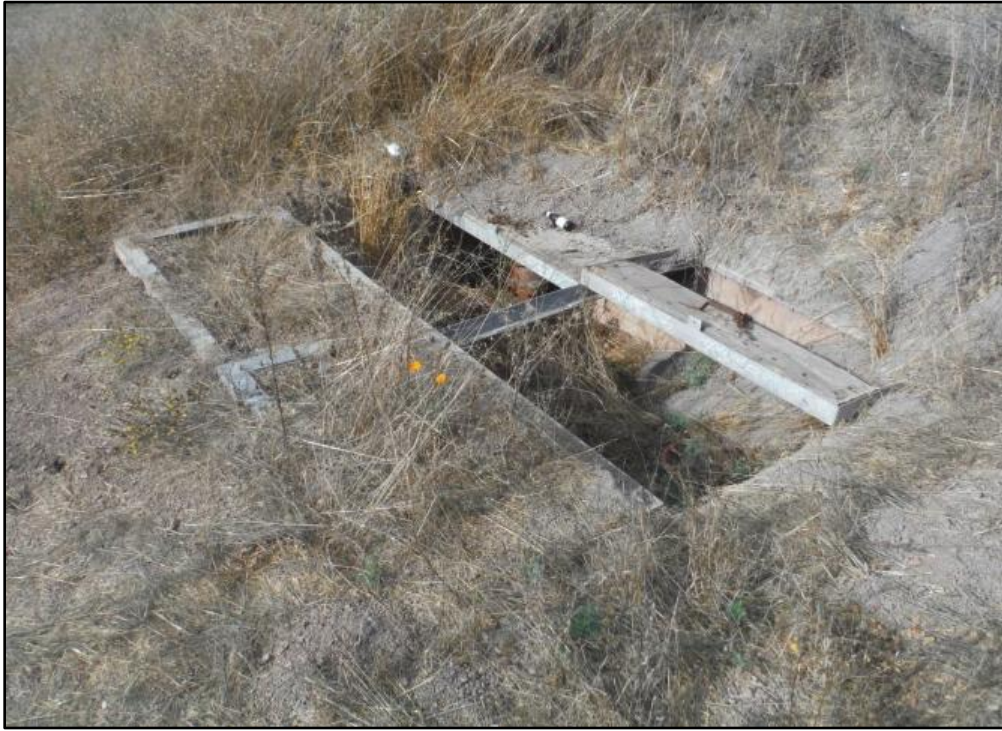
Photo 7: View N, showing board-formed vault with water main.

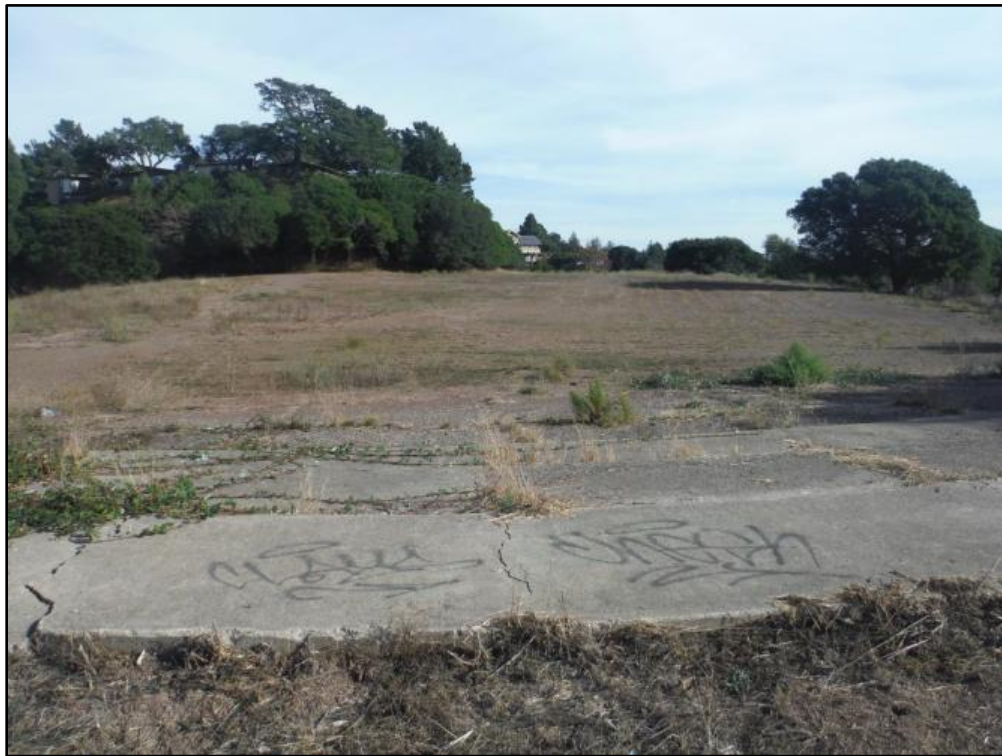
Photo 8: View SE, Showing stepped semi-circular concrete structure and asphalt slab.

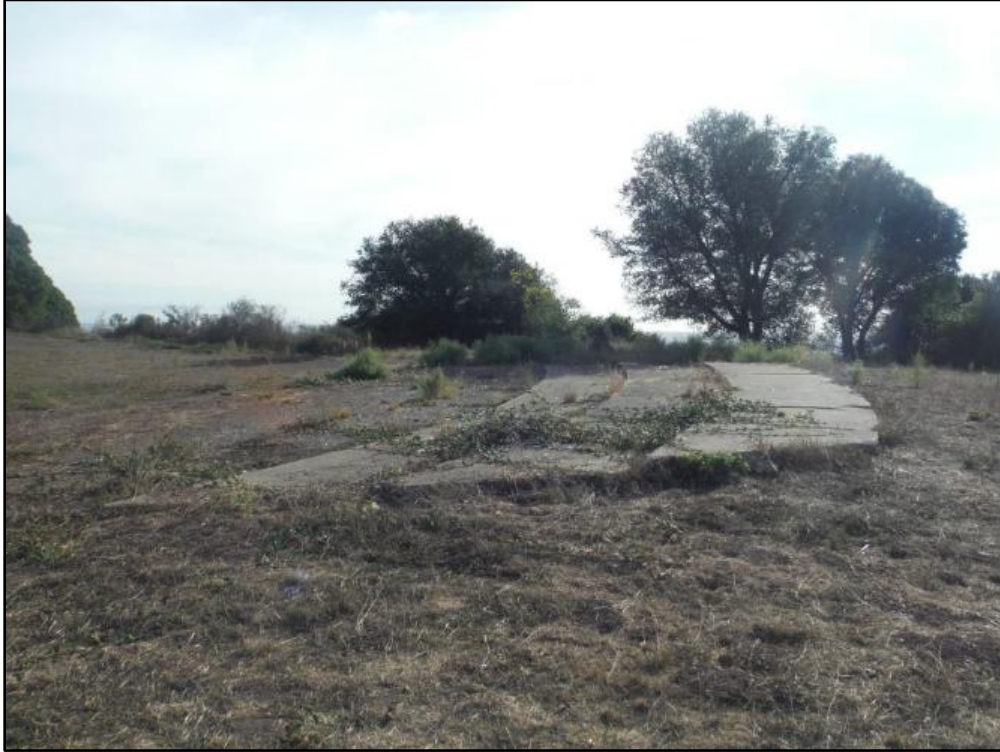
Photo 9: View S, showing concrete stepped, semi-circular structure and asphalt slab.

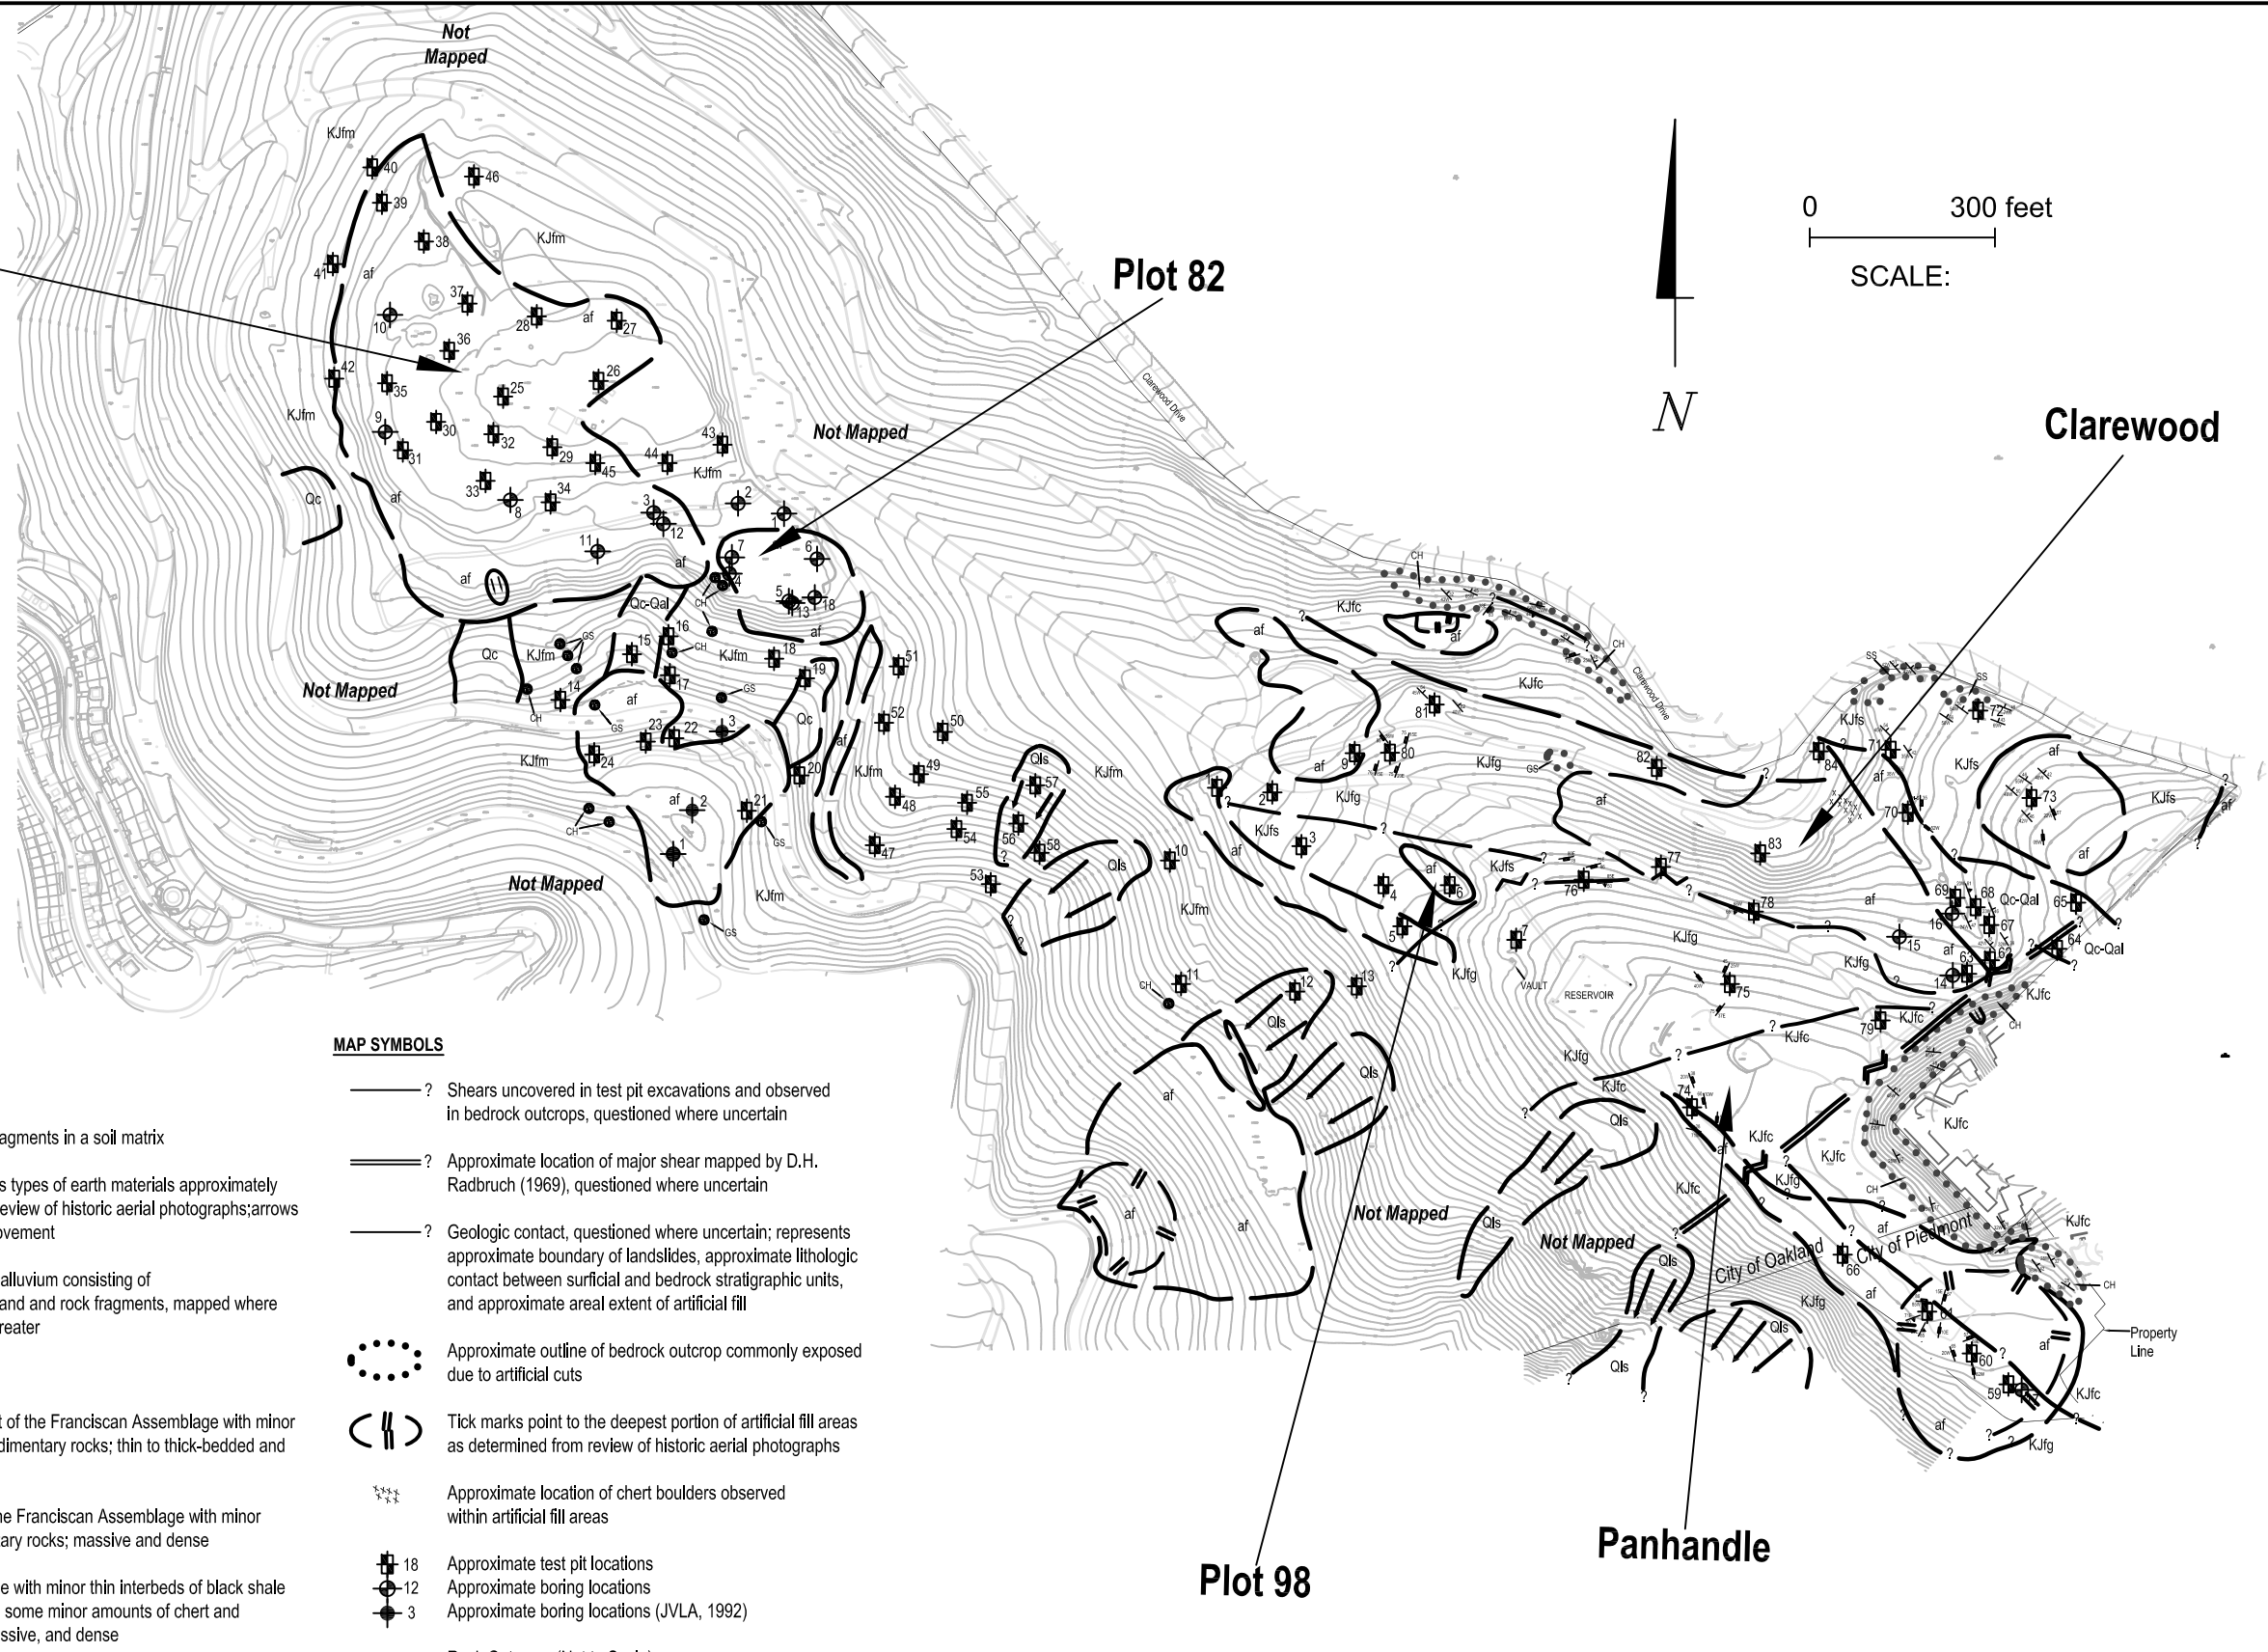
Mountain View Cemetery Oakland, California		Site Plan and Geologic Map	
Hultgren - Tillis Engineers		Project No. 346.13	Plate No. 4

- ↘ Strike of vertical joints
- ↘ Strike and dip of shears

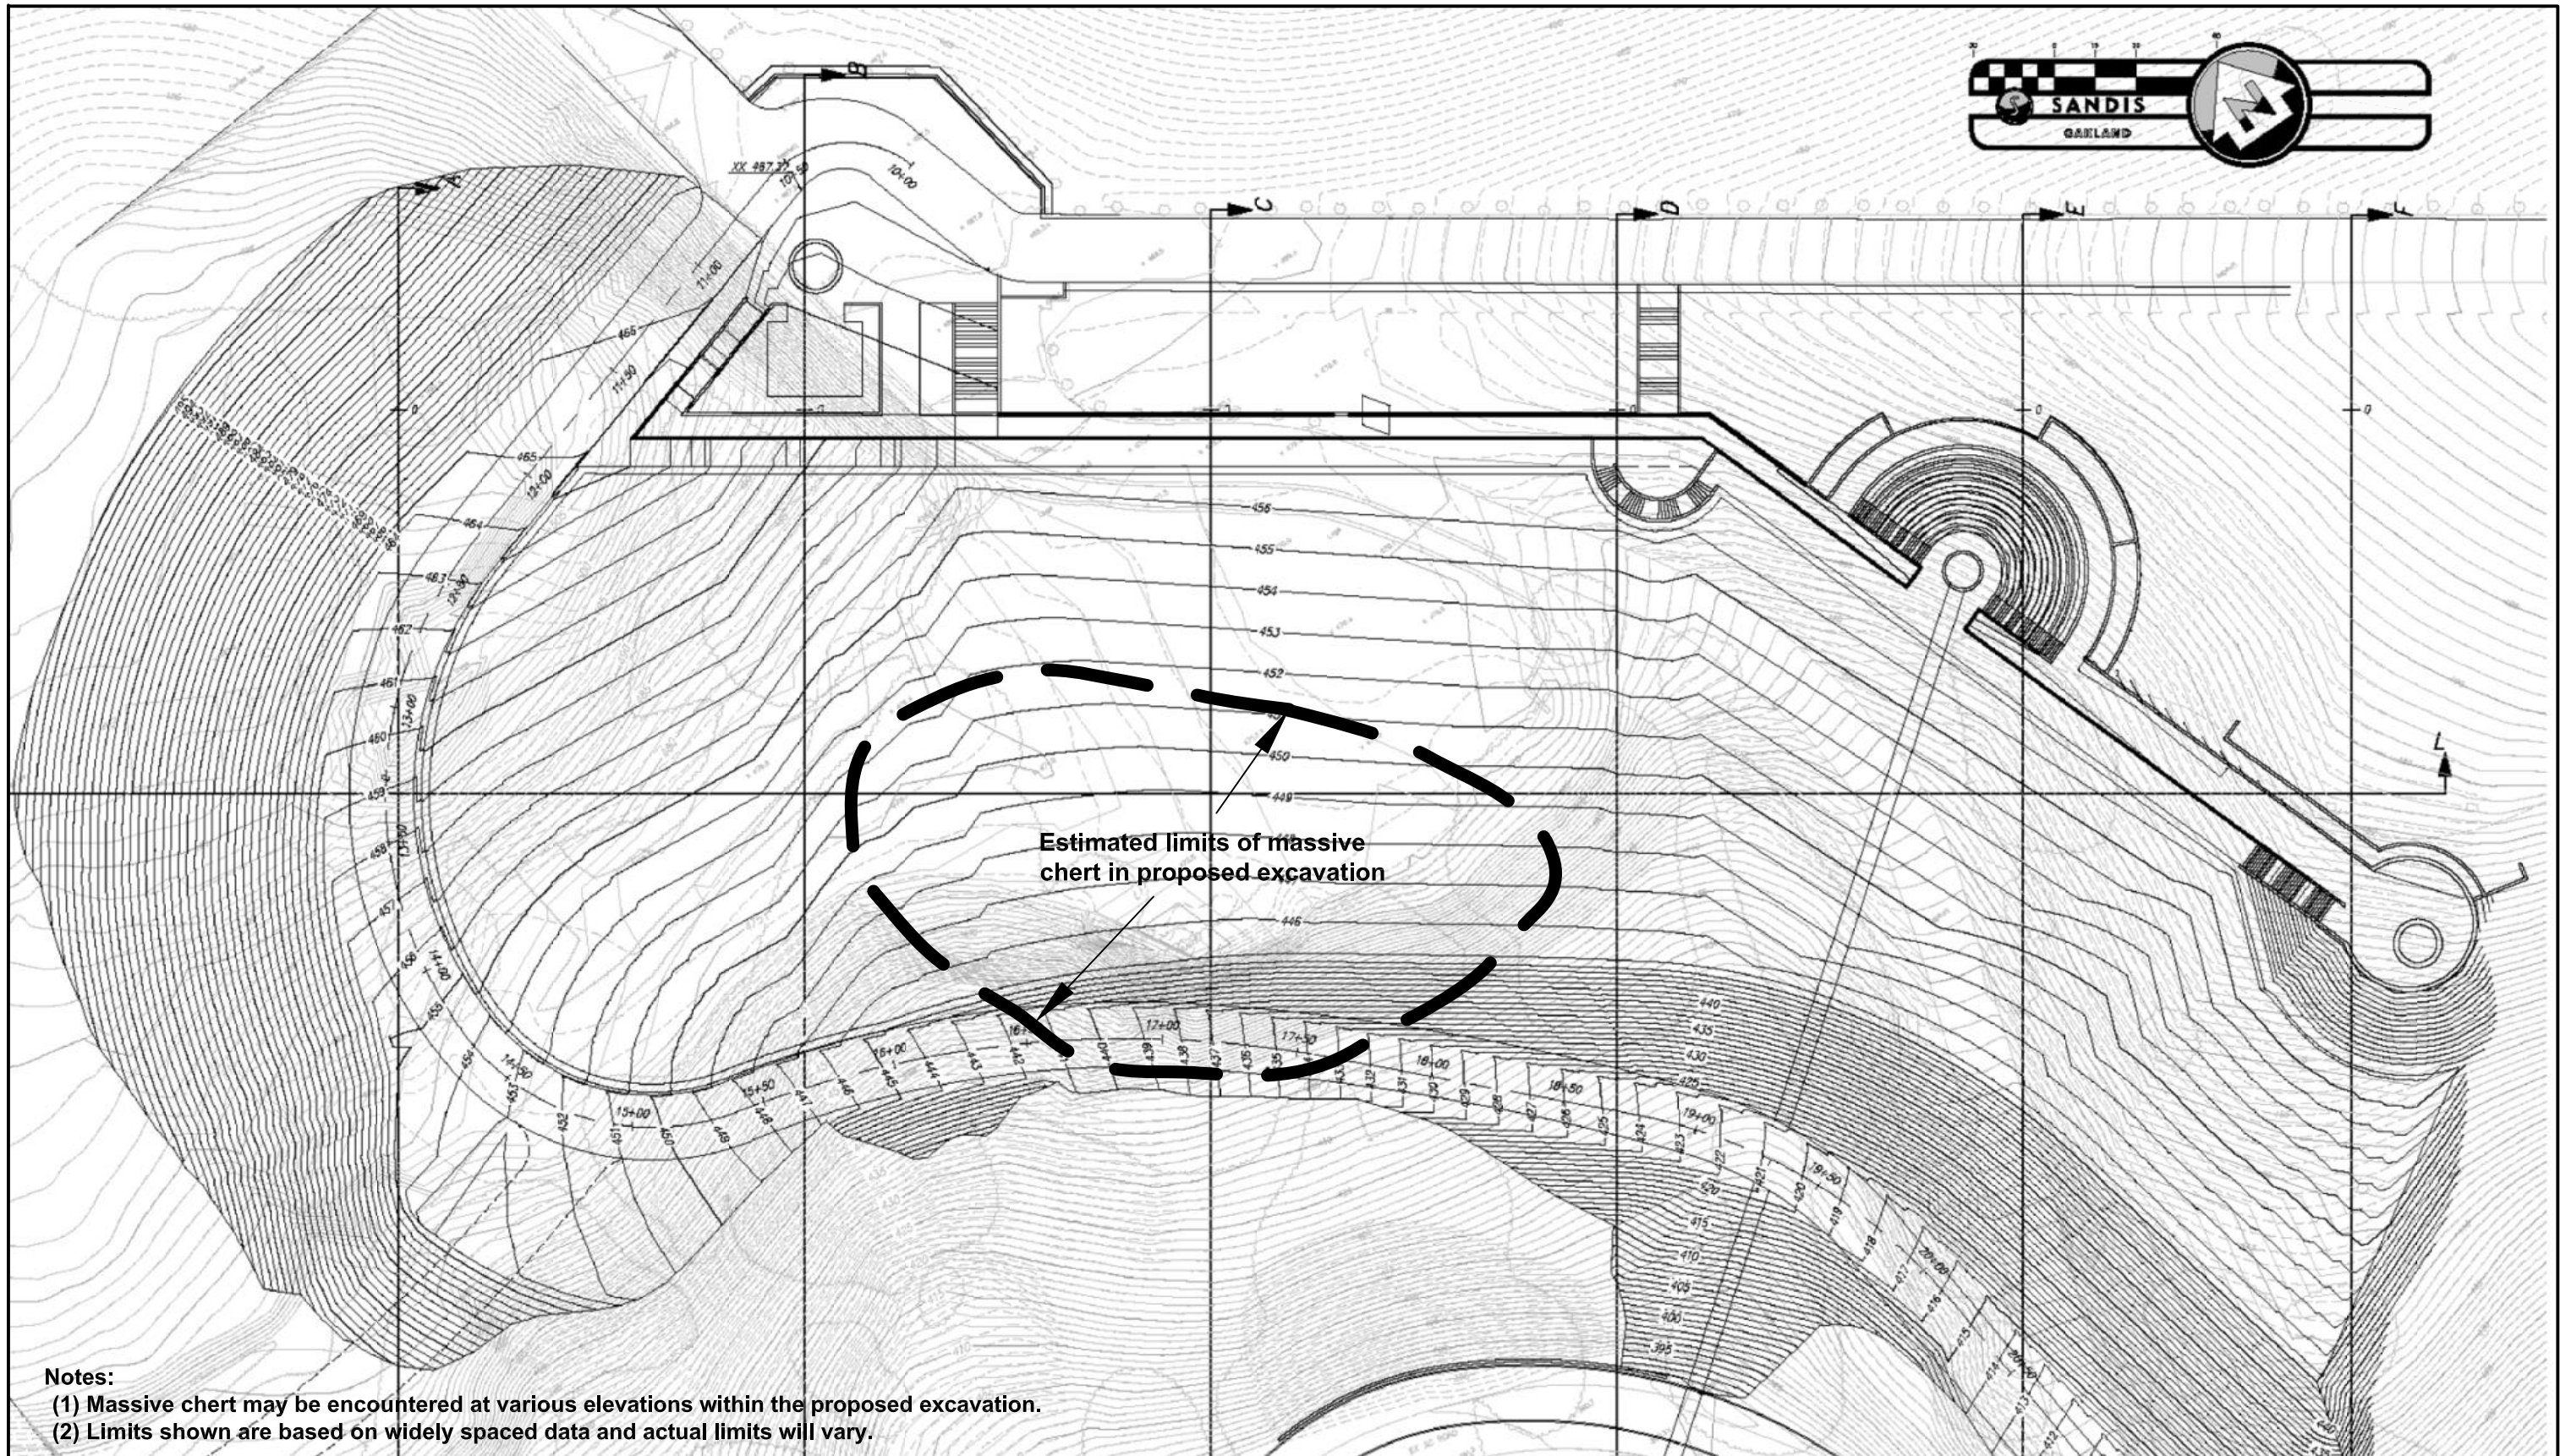
Estimated limits of massive chert in proposed excavation
