Mountain View Cemetery Expansion Project

Draft Environmental Impact Report

Technical Appendices

Lead Agency: City of Oakland

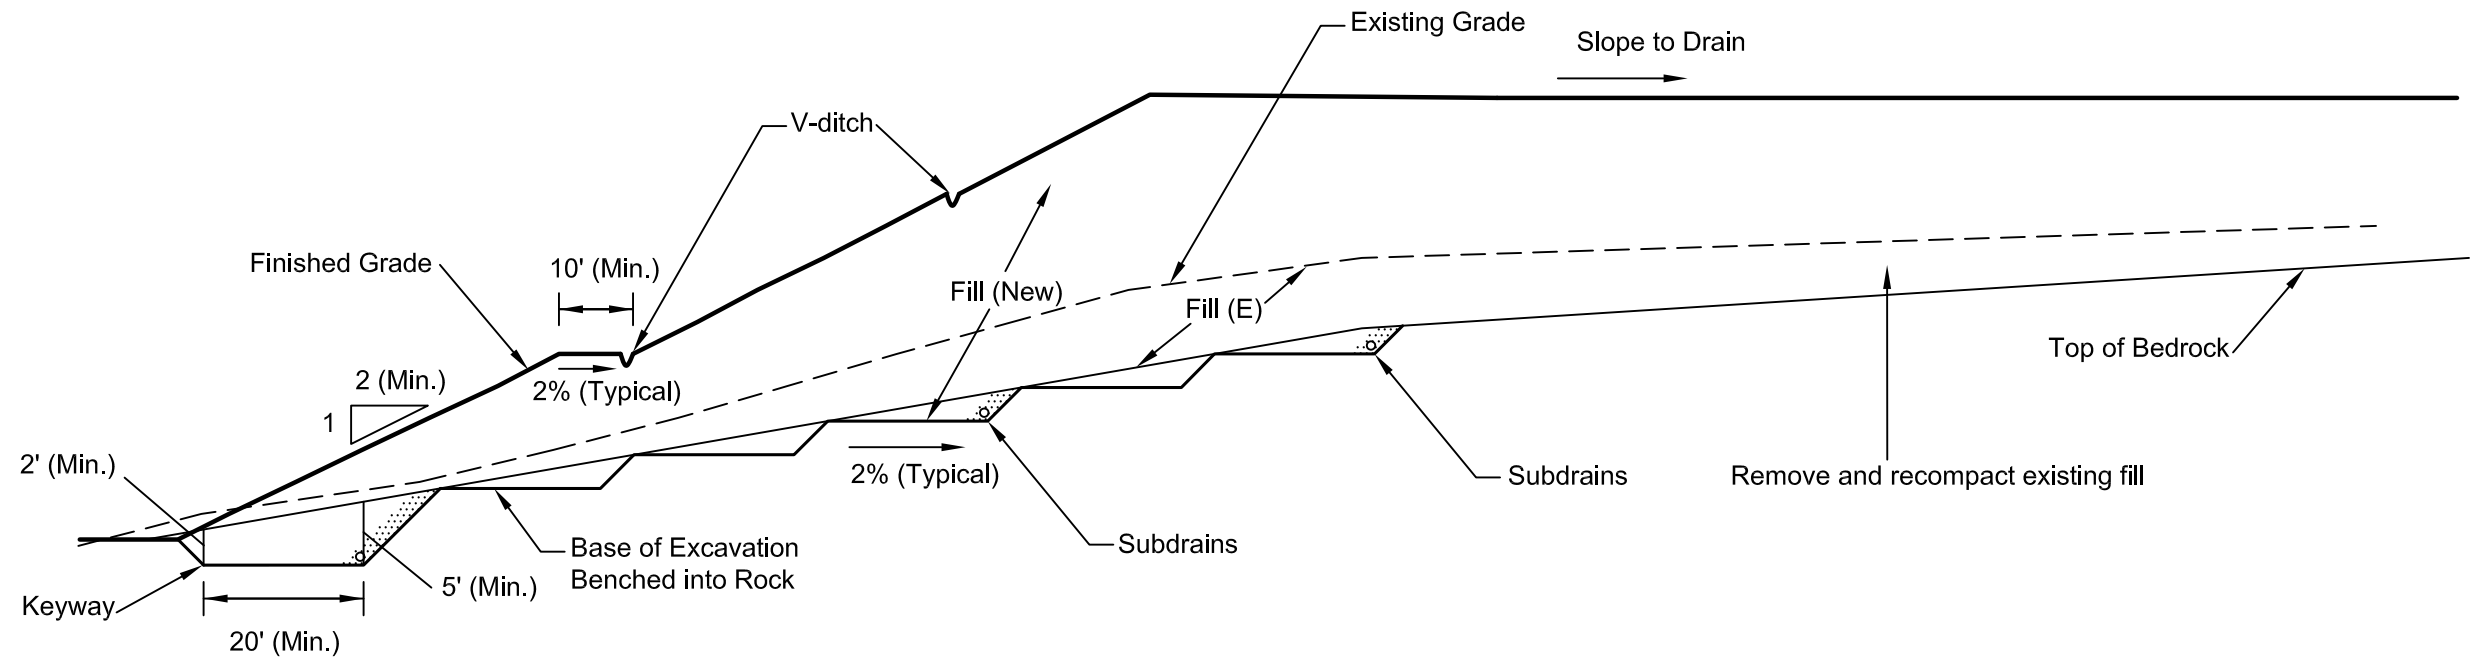
Typical Fill Cross-Section

- Notes
- (1) Remove existing fill.
 - (2) Excavate keyway into rock.
 - (3) Place subdrains at back of keyway and benches.
 - (4) Place existing fill in thin lifts, moisture condition and compact.
 - (5) Excavate benches into rock.
 - (6) Place intermediate surface drainage benches at about 25 feet vertical intervals.
 - (7) Install V-ditches at top and toe of slope and on intermediate benches.

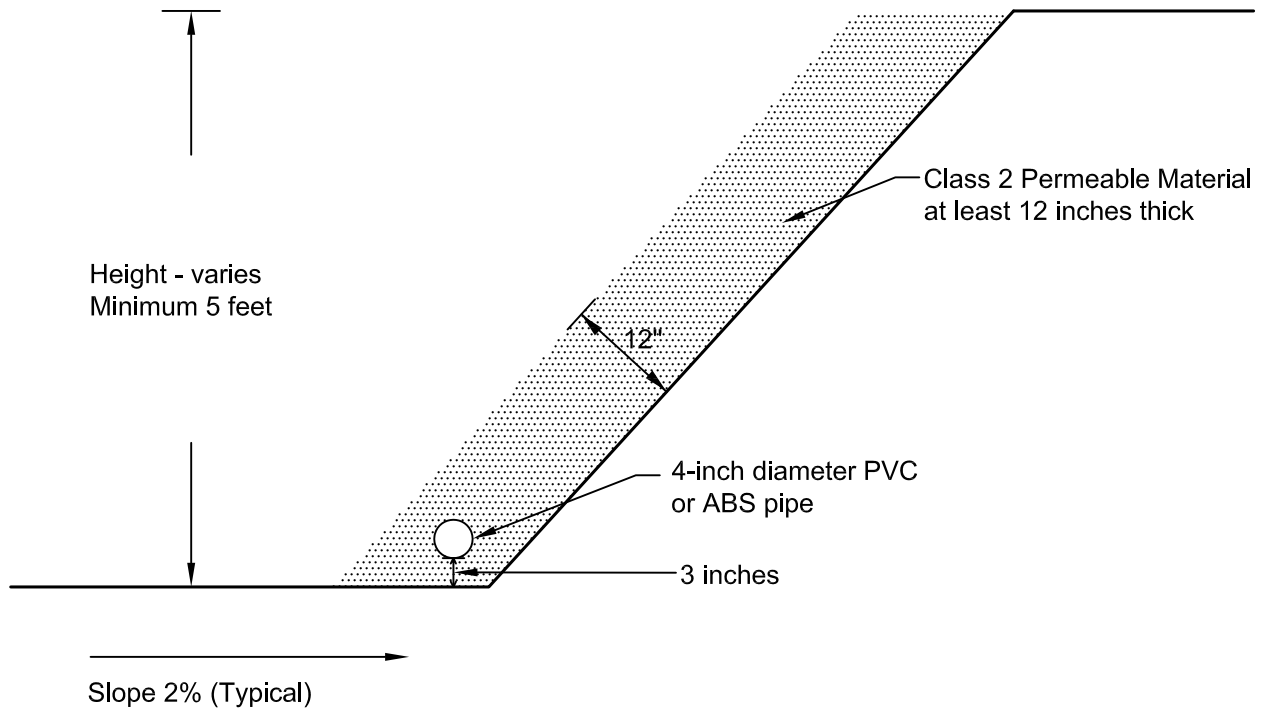
Plate No. 8

- Notes
- (1) Bench into bedrock.
 - (2) Subdrains should include drainage material that covers 50 percent of the slope height as measured from the keyway to top.
 - (3) Subdrains should consist of 4-inch diameter perforated ABS or PVC pipe meeting SDR 23.5. Drainage material should be Caltrans Class 2 Permeable Material.
 - (4) 1% fall (minimum) on all subdrain benches and subdrain lines.
 - (5) All perforated pipe placed perforations down.
 - (6) All pipe joints shall be glued.
 - (7) All subdrains should discharge to a suitable outlet.
